DESIGN AND CONSTRUCTION OF SEEPAGE CUT-OFF WALLS UNDER A CONCRETE DAM IN NEW ZEALAND WITH A FULL RESERVOIR

*Peter D Amos¹, Donald A. Bruce², Marco Lucchi³,
Tom Newson⁴, Nick Wharmby⁵*

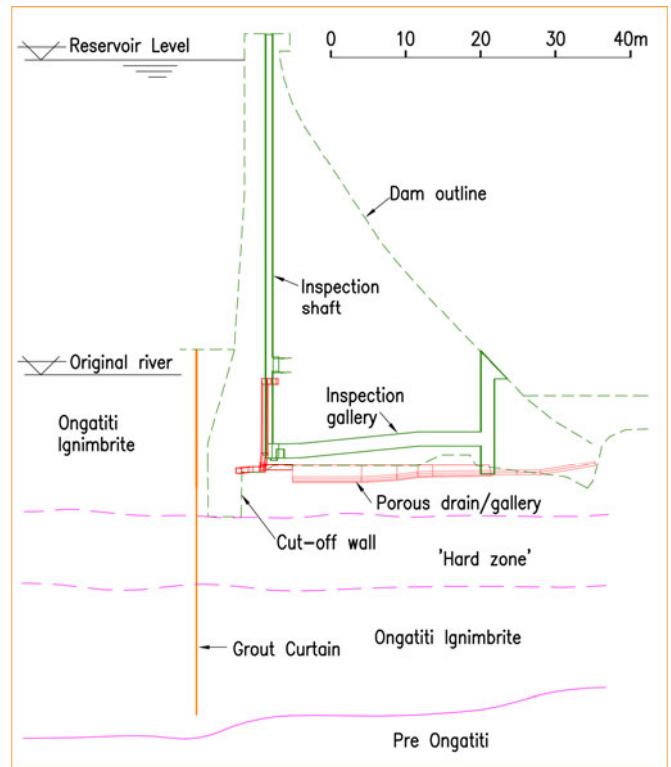
Figure 2. Cross Section of Arapuni Dam (Note the spatial separation of the grout curtain from the dam)

The 600mm high x 600mm wide "no-fines concrete" porous drain network ([Figure 2](#)) is the main uplift control at the dam/foundation interface. The underdrain includes a continuous drain, known as the circumferential drain, sited parallel to, and immediately downstream of, the original cutoff wall. Radial porous drains discharge seepage water to the downstream toe, where seepage is measured at v-notch weirs.

In June 1930 the reservoir was completely dewatered for a number of repairs including construction of a grout curtain along the upstream heel of the dam and along the front of both abutment cutoff walls (Furkett, 1934). The grout curtain was a single row cement curtain with mostly vertical grout holes at 3m centres. It was constructed just upstream of the dam and cutoff walls, as shown on [Figure 4](#), but is not physically connected to the dam. [Figure 3](#) shows the extent of the grout curtain and original dam cutoff walls.

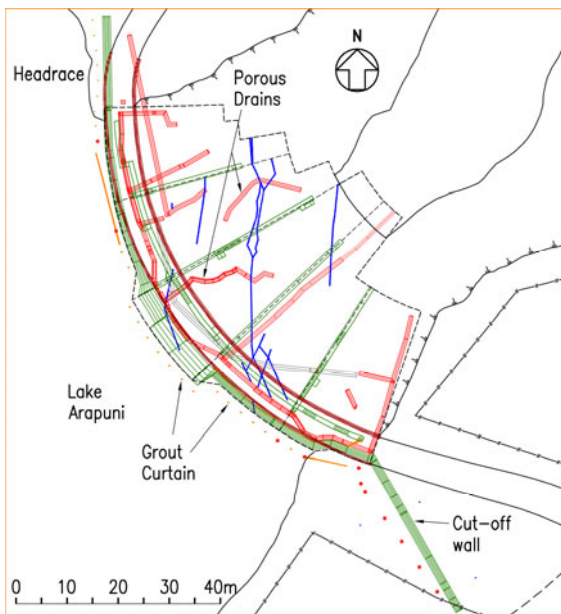
Figure 3. Plan view of Arapuni Dam (The positions of the foundation fractures noted during construction are shown. The diversion tunnel is south of the right abutment cut off wall)

Handman (1929) discusses the dam's construction. Original features of the dam include concrete cutoff walls and a network of porous (no-fines) concrete drains at the dam/foundation interface (the "underdrain"). The original cutoff walls extend beneath the dam to a depth of 65m below the dam crest and extend 20m and 33m into the left and right abutments respectively, for the full height of the dam as shown on [Figure 3](#). There was no grout curtain constructed during original construction.

At interfaces between ignimbrite sheets there tends to be unwelded material, either airfall tephras or unwelded ignimbrite. The most extensive interface deposit is between the Ahuroa and Ongatiti ignimbrite units, known as the Powerhouse Sediments (Figure 3), with a thickness of 4 to 8m.

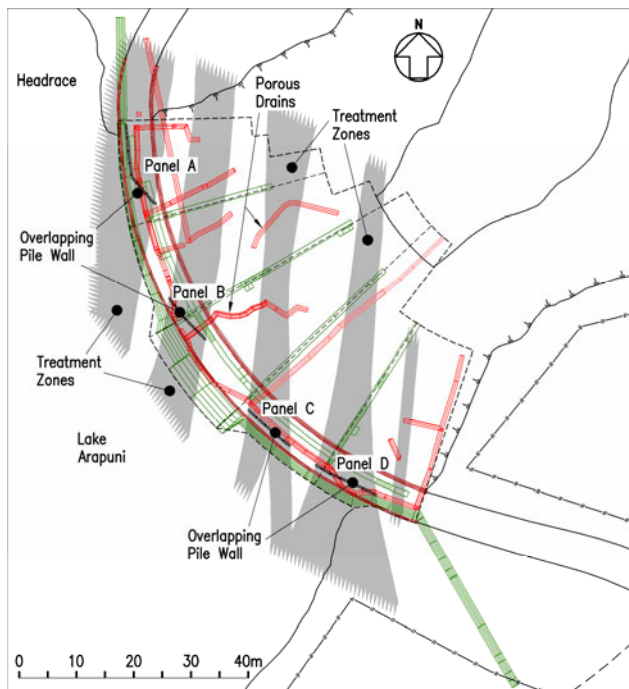
Figure 5. Plan of long-term seepage control remedial works, with cutoff walls, treatment zones and underdrain

The investigation findings allowed the remedial works to specifically target each of the four sets of identified vertical fractures and treat the open or infilled joint by removing infill and replacing the joint material with grout or concrete in order to create stable permanent barriers. The cutoff walls were located as far upstream as possible to restore the normally accepted uplift profile under the dam ([Figures 5 and 6](#)).

The overlapping bored pile wall at Arapuni Dam consists of 400mm diameter holes drilled at 350mm centres (Figure 9) to form the required overlap. The holes were drilled from the dam crest (i.e. above reservoir level) to minimise construction and personnel safety risks. The overlap was controlled by the use of a 400mm diameter guide piece attached to the drill string but running in the adjacent completed hole. Four discrete lengths of the wall were installed, to specifically target the four fissure systems shown in Figure 5 as follows:

- Panel A – 15.45 m
- Panel B – 9.85 m
- Panel C – 9.85 m
- Panel D – 11.95 m

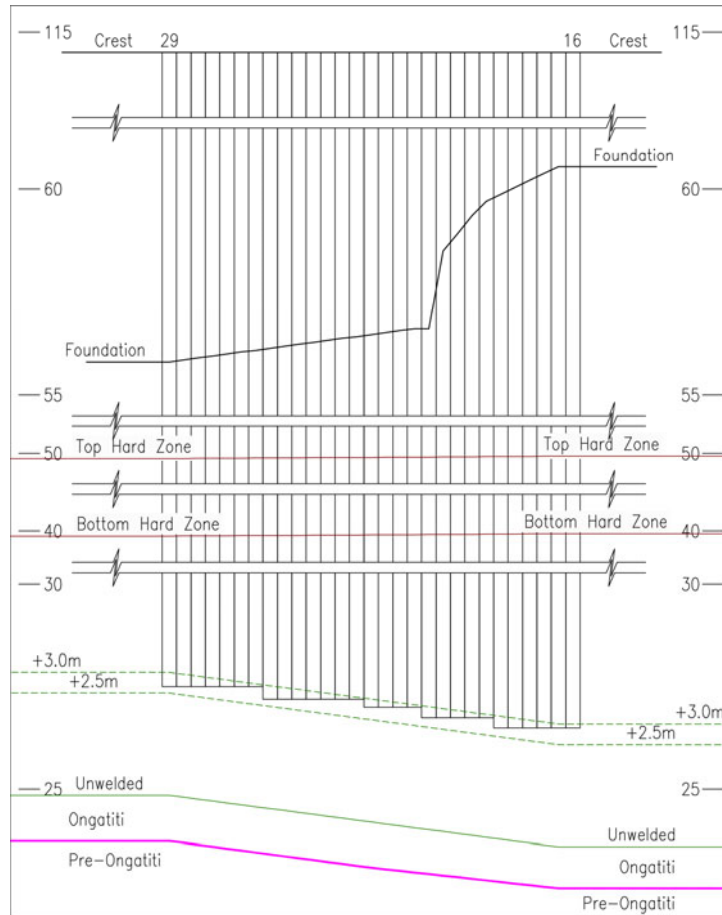
Figure 11. Typical Elevation of a Treatment Panel (Panel B)

Total depth of the cutoff panels was set by the depth of the vertically jointed Ongatiti Ignimbrite. The panels terminate just above the interface with the underlying Pre-ongatiti Ignimbrite unit to avoid disturbance of the unwelded sediments between the ignimbrite units (Figure 11).

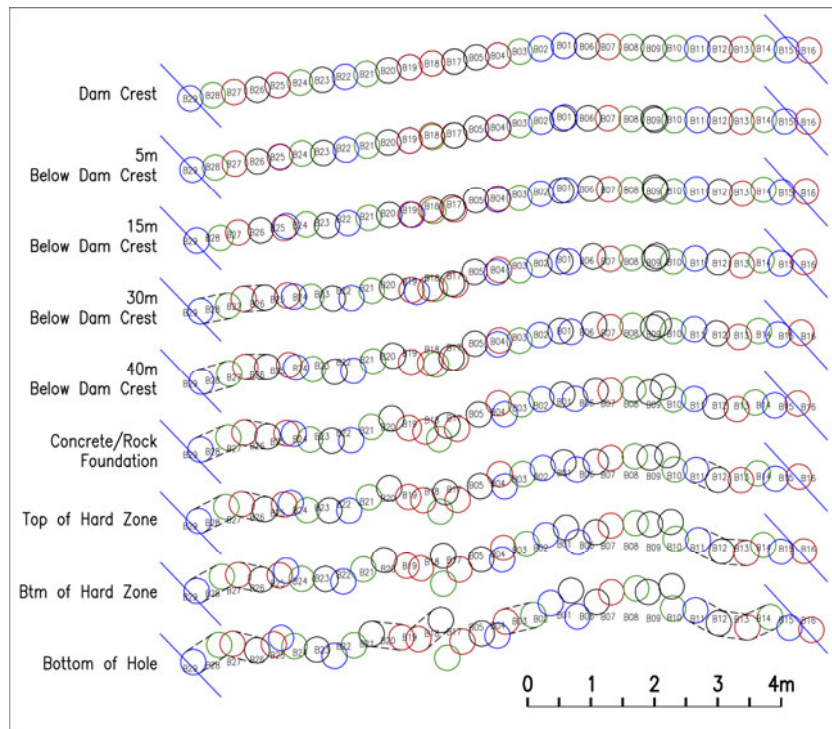
Figure 12. Elevation of Treatment Panel B, showing the relationship between inclinometer readings at depth for each drill hole

1. Verticality, Continuity and Closure of the Treatment Zone
 - Readings from a bi-axial inclinometer taken at 2m intervals inside the drillrods as drillholes were being advanced to determine hole location with respect to the target zone for the cutoff (Figure 12).
 - Underwater camera surveys of slot walls to check rock conditions and verify fracture presence in rock face.
 - Sweeping each drilled slot with a steel frame to check that the slot met the minimum cutoff panel dimensions before backfilling.
