DESIGN AND CONSTRUCTION OF DEEP SECANT PILE SEEPAGE CUT-OFF WALLS UNDER THE ARAPUNI DAM IN NEW ZEALAND

Peter D Amos¹,
Donald A. Bruce²,
Marco Lucchi³,
Neil Watkins⁴,
Nick Wharmby⁵

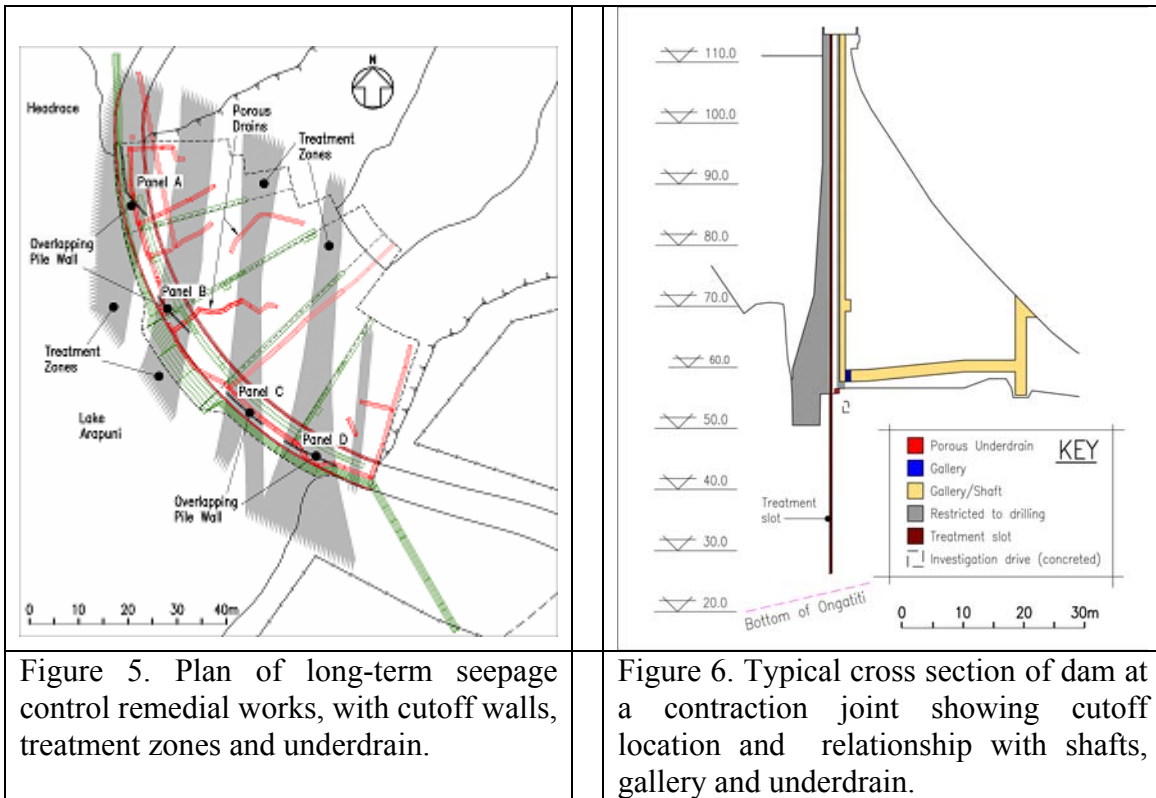
The investigation findings allowed the remedial works to specifically target each of the four sets of identified vertical fractures and treat the open or infilled joint by removing infill and replacing the joint material with grout or concrete in order to create stable permanent barriers. The cutoff walls were located as far upstream as possible to restore the normally accepted uplift profile under the dam (Figures 5 and 6).

Figure 5. Plan of long-term seepage control remedial works, with cutoff walls, treatment zones and underdrain.

The overlapping bored pile wall at Arapuni Dam consists of 400mm diameter holes drilled at 350mm centres (Figure 8) to form the required overlap. The holes were drilled from the dam crest (i.e. above reservoir level) to minimize construction and personnel safety risks. The overlap was controlled by the use of a 400mm diameter guide piece attached to the drill string but running in the adjacent completed hole. Four discrete lengths of the wall were installed, to specifically target the four fissure systems shown in Figure 5 as follows:

Panel A	15.45 m
Panel B	9.85 m
Panel C	9.85 m
Panel D	11.95 m

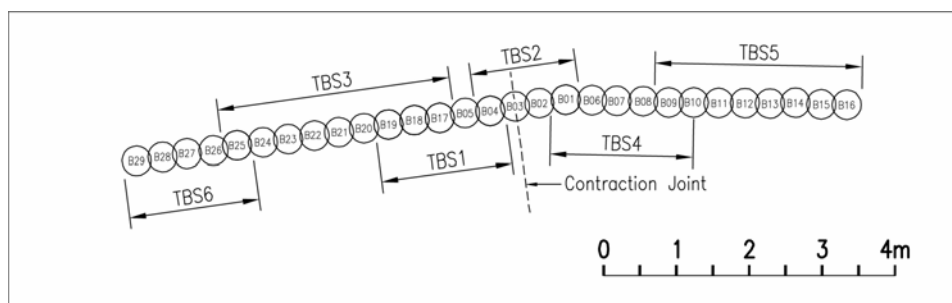
Figure 8. Plan of Treatment Panel B showing Slot sequence

Each of the four cutoff walls was constructed in discrete segments or slots (Figure 8) to both:

- limit construction-induced tensile stresses on the unreinforced concrete dam face upstream of the cutoff wall; and
- limit the potential for weak foundation rock to collapse into the open cutoff slot before concreting.

A slot would be completed and backfilled with concrete before progressing to the next slot.

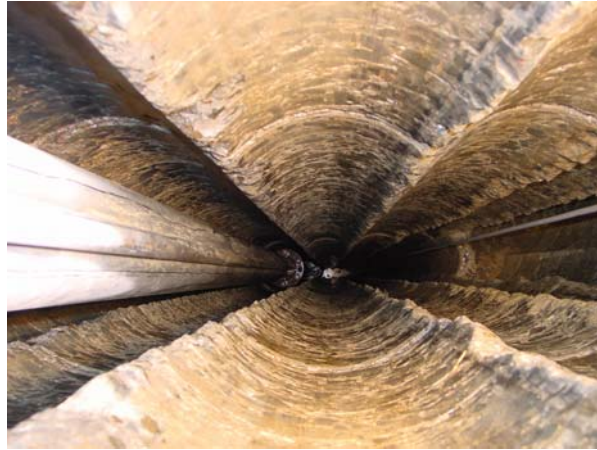
Figure 10. Downhole photograph of overlapping drill holes

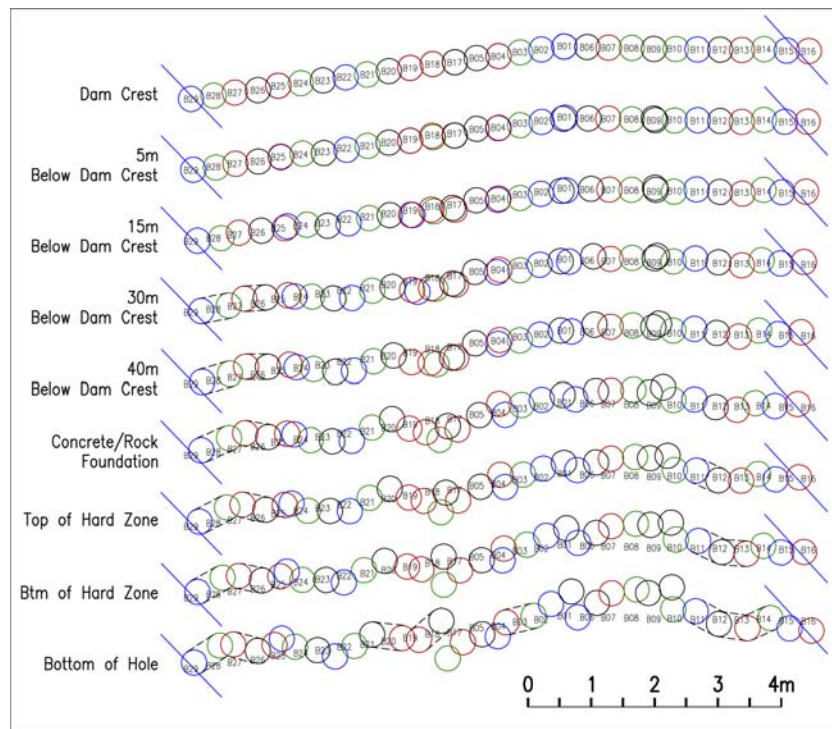
- Readings from a bi-axial inclinometer taken at 2m intervals inside the drillrods as drillholes were being advanced to determine hole location with respect to the target zone for the cutoff (Figure 12).
- Underwater camera surveys of slot walls to check rock conditions and verify fracture presence in rock face.
- Sweeping each drilled slot with a steel frame to check that the slot met the minimum cutoff panel dimensions before backfilling.

Figure 12. Elevation of Treatment Panel B, showing the relationship between inclinometer readings at depth for each drill hole
