# Use of Innovative Numerical Modelling and Rock Mass Characterization Approaches for Design of Foundations within Weak Coralline Limestones

Carter, T.G<sup>1</sup>., Carvalho, J.L<sup>1</sup>., Dittrich, J.P<sup>1</sup>., Cottrell, B.J<sup>1</sup>., Leew, B<sup>2</sup>. and Cirulis, K<sup>1</sup>.

*Golder Associates Ltd., Mississauga, Ontario<sup>1</sup> and Calgary, Alberta<sup>2</sup>, Canada*

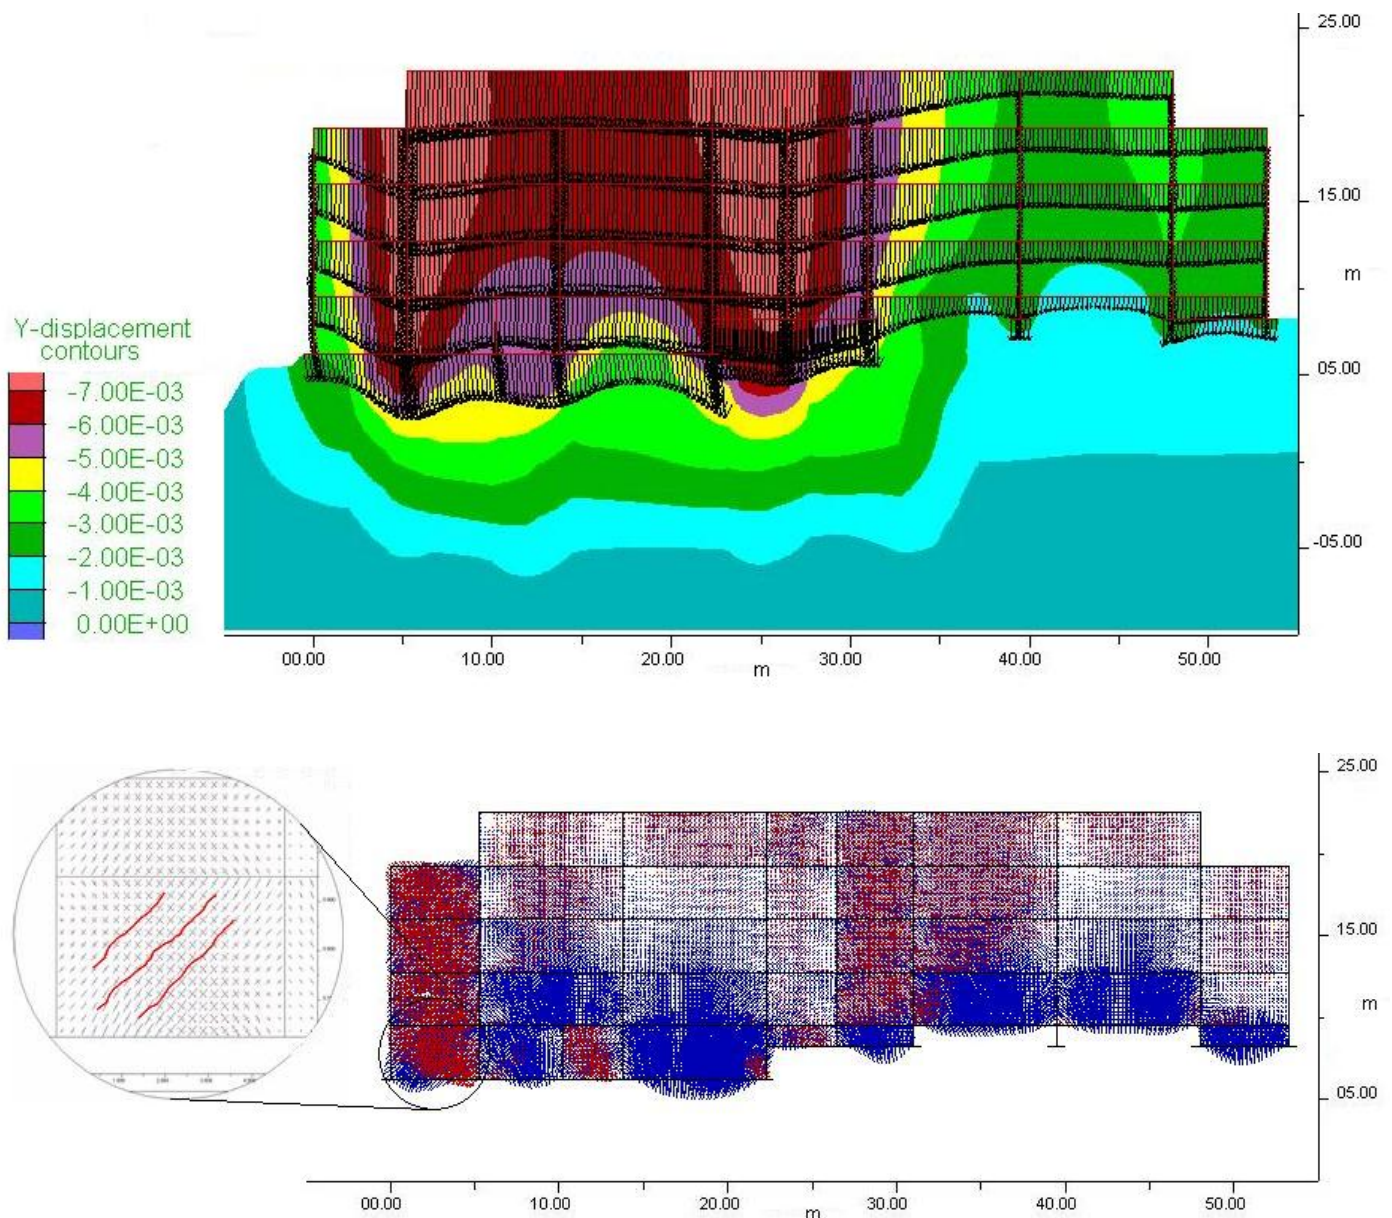
By contrast, as shown on Figure 2, the results of the analyses of the north-south section show more severe differential settlements and shear loading on the walls than east-west section. Based on close examination of the results and comparison with the observed crack patterns it is inferred that the higher differential settlements, which appear to preferentially occur towards the north end of the building, occur as a result of higher loads in the inner bearing walls in association with the poorer ground in this area. This differential settlement results in shear loads in the walls of the three northernmost bays. The principal stresses in the walls are oriented diagonally with the tensile direction dipping to the south in the highest loaded walls. This result in potential crack patterns which have the cracks dipping to the north (towards the gully) and similar to those patterns observed on the structure.

Figure 2 – Vertical displacements and principal stress directions – walls of first bay from the North end experience highest shear stress, consistent with the differential displacements.

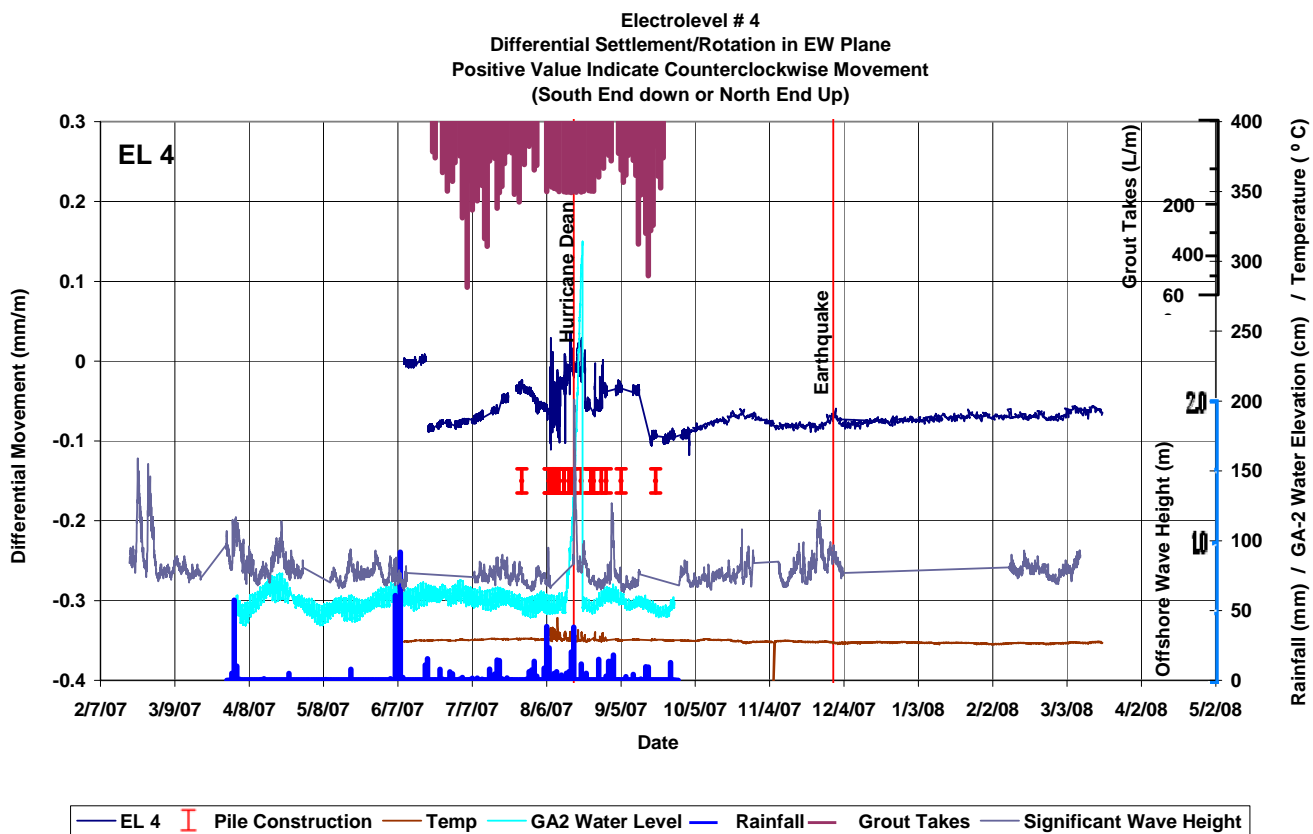
The instrumentation monitoring of the building behaviour during the course of construction confirmed the modelling assessments. The monitoring data (as seen in the typical electrolevel data plot on Figure 8) showed the building responding to the grouting by initial downward (i.e. settlement) movement as a result of the drilling/injection/flushing/disturbance to the poor subsoils by the micropiling operations, followed by upward (i.e. heave) movement as a result of the pressure grouting operations. In general, the geometry of the voided zones assumed in the modelling were matched by the zones of higher takes from the grouting and the expected behaviour of the building remediation well replicated, with increasing stabilization being achieved throughout the remediation program (see Figure 8), as each area of the building was underpinned and grouted, with completion of the improvement in the north zone of the building achieved in September 2007 right at the end of the remediation construction program.

Figure 8 – Monitoring data plot from electrolevel during and after completion of construction.
