# Comprehensive Foundation Rehabilitation at Bear Creek Dam

JOHN E. CHARLTON<sup>1</sup>

*Paul C. Rizzo Associates, 101 Westpark Boulevard, Suite B, Columbia, SC 29210*

**Key Terms:** *Packstone, Grouting, Dental Concrete, Cutoff Panel, Karst*

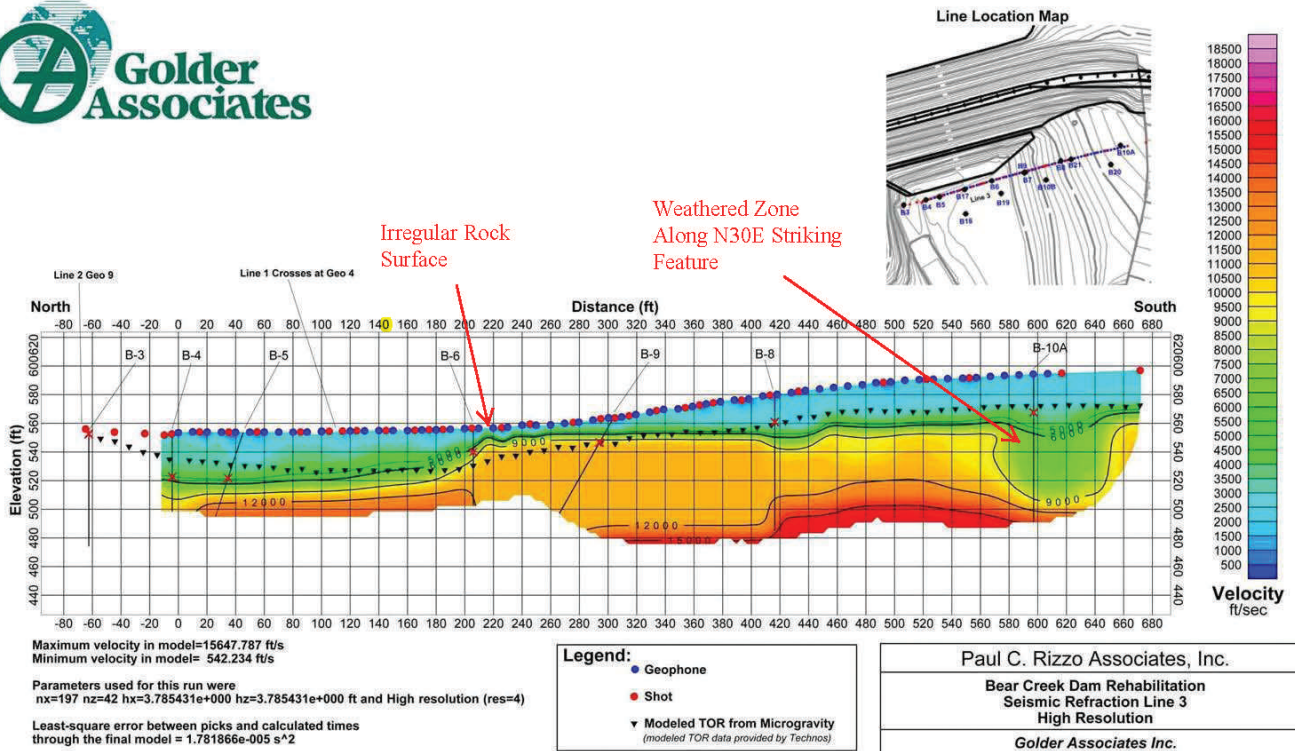
Figure 1. Seismic refraction line along RCC berm foundation centerline (work performed by Golder Associates, Inc.).

These surveys were not as successful in establishing discrete zones of deeper weathering not completely related to limestone dissolution along N30E solution features. The refraction survey method did, however, pick up the location of a large zone of weathered rock that exists near RCC station 9+20 along the RCC crest centerline and that extends to the southwest under the spillway. In addition, the very irregular top-of-rock surface between RCC station 5+00 and 6+50 appears to be accurately captured and portrayed, to some extent, in the Golder seismic refraction lines presented in Figure 1 (and shown after excavation in Figure 2).

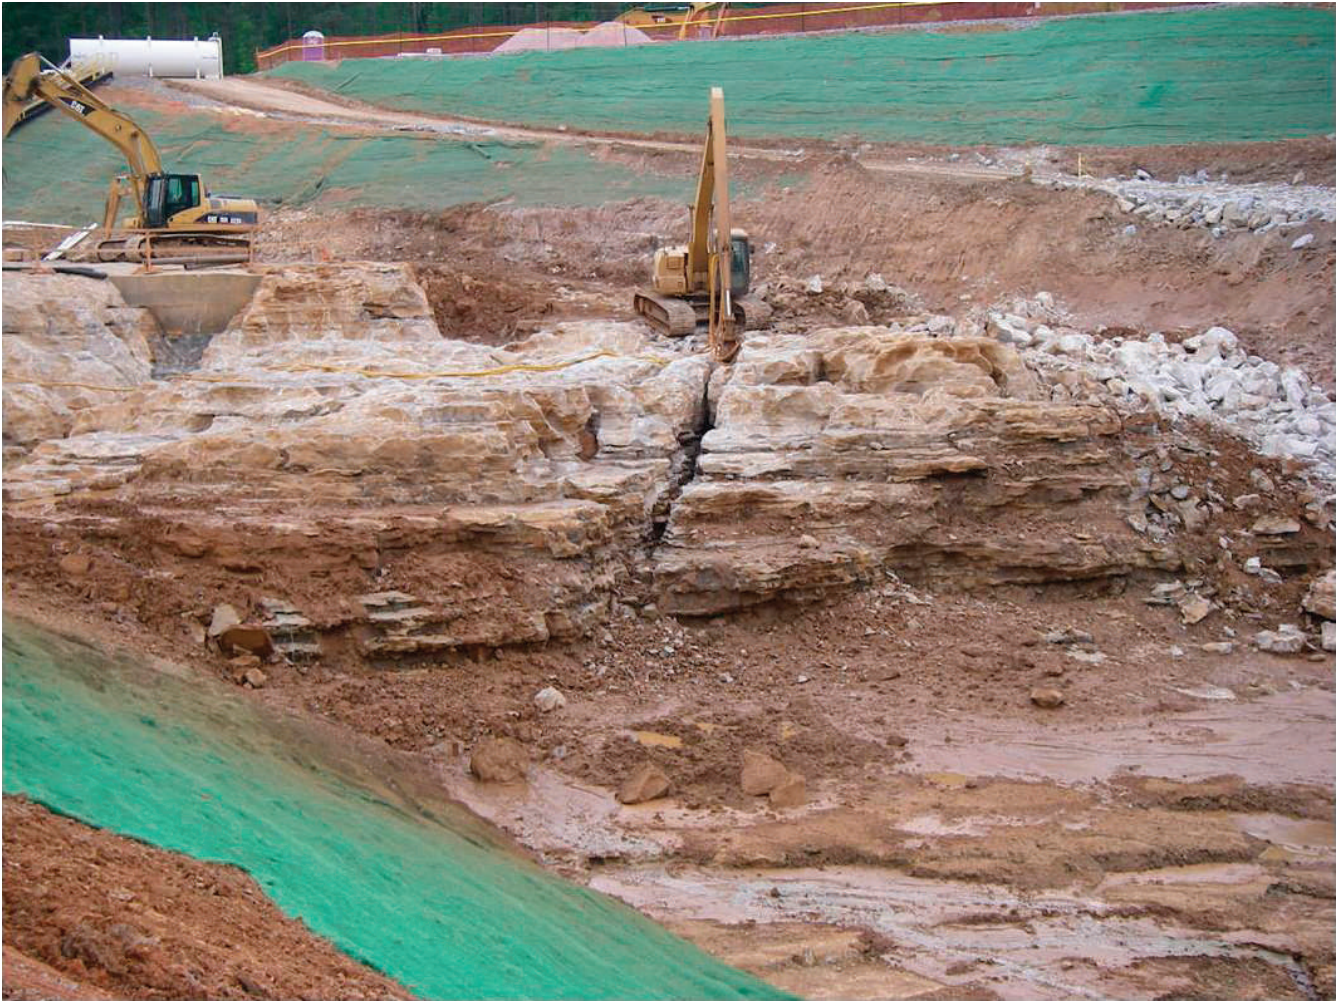
Figure 2. Irregular packstone surface detected in seismic refraction survey.

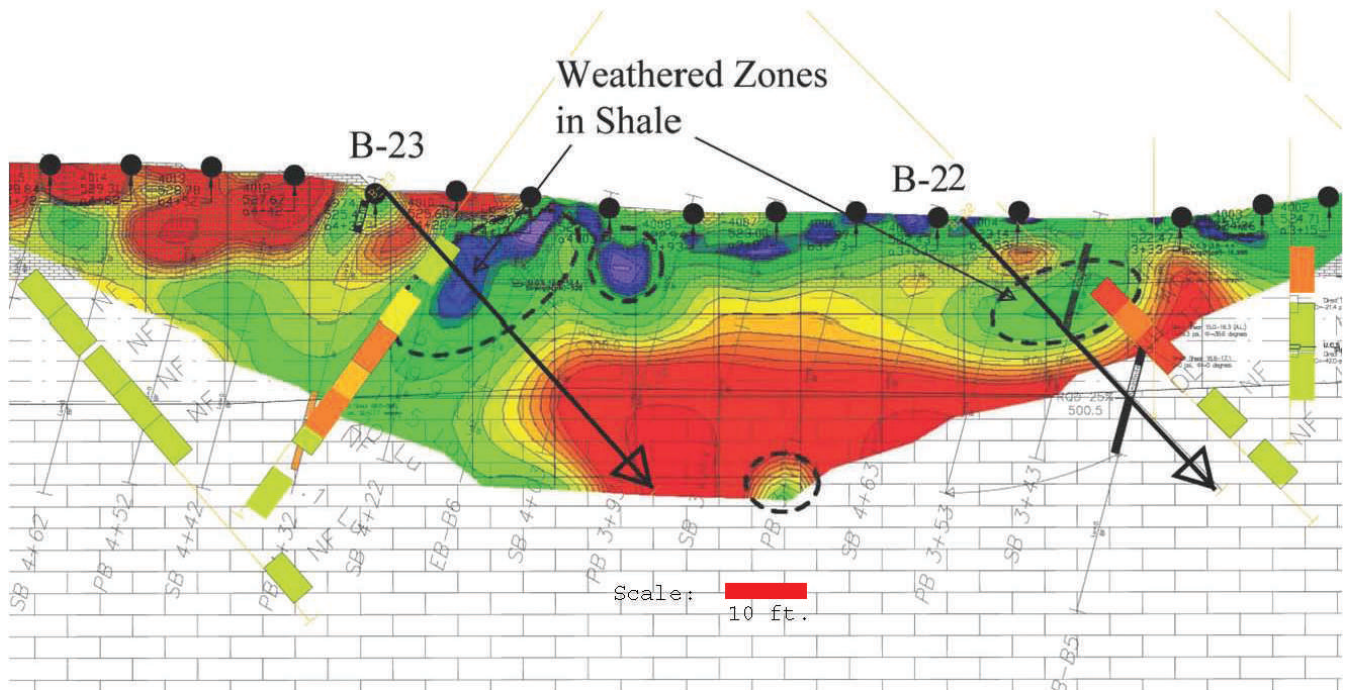
GPR, microgravity, and electrical resistivity surveys conducted in Phase III (within the historic Bear Creek channel) during June of 2008 were performed from the rock surface after excavation of up to 30 ft of alluvium, so comparing their performance with those identified during the 2007 surveys is not valid. The electrical resistivity survey proved fairly successful for the purpose of identifying weathered zones within the upper Bangor Limestone and Bangor Shale Unit C. The microgravity and GPR surveys did not prove as effective for this task. Resistivity successfully identified weathered zones within the Bangor Shale Unit C that were verified with two borings as well as mapping of cutoff panel walls during cutoff panel excavation. Figure 3 presents the

locations of the weathered zones identified by the resistivity surveys and the locations of the two borings, B22 and B23, and Figure 4 shows the actual zones of weathered shale encountered during excavation of Panel 3.

Figure 3. Resistivity profile showing weathered zones in Bangor Shale Unit C beneath historic Bear Creek channel.

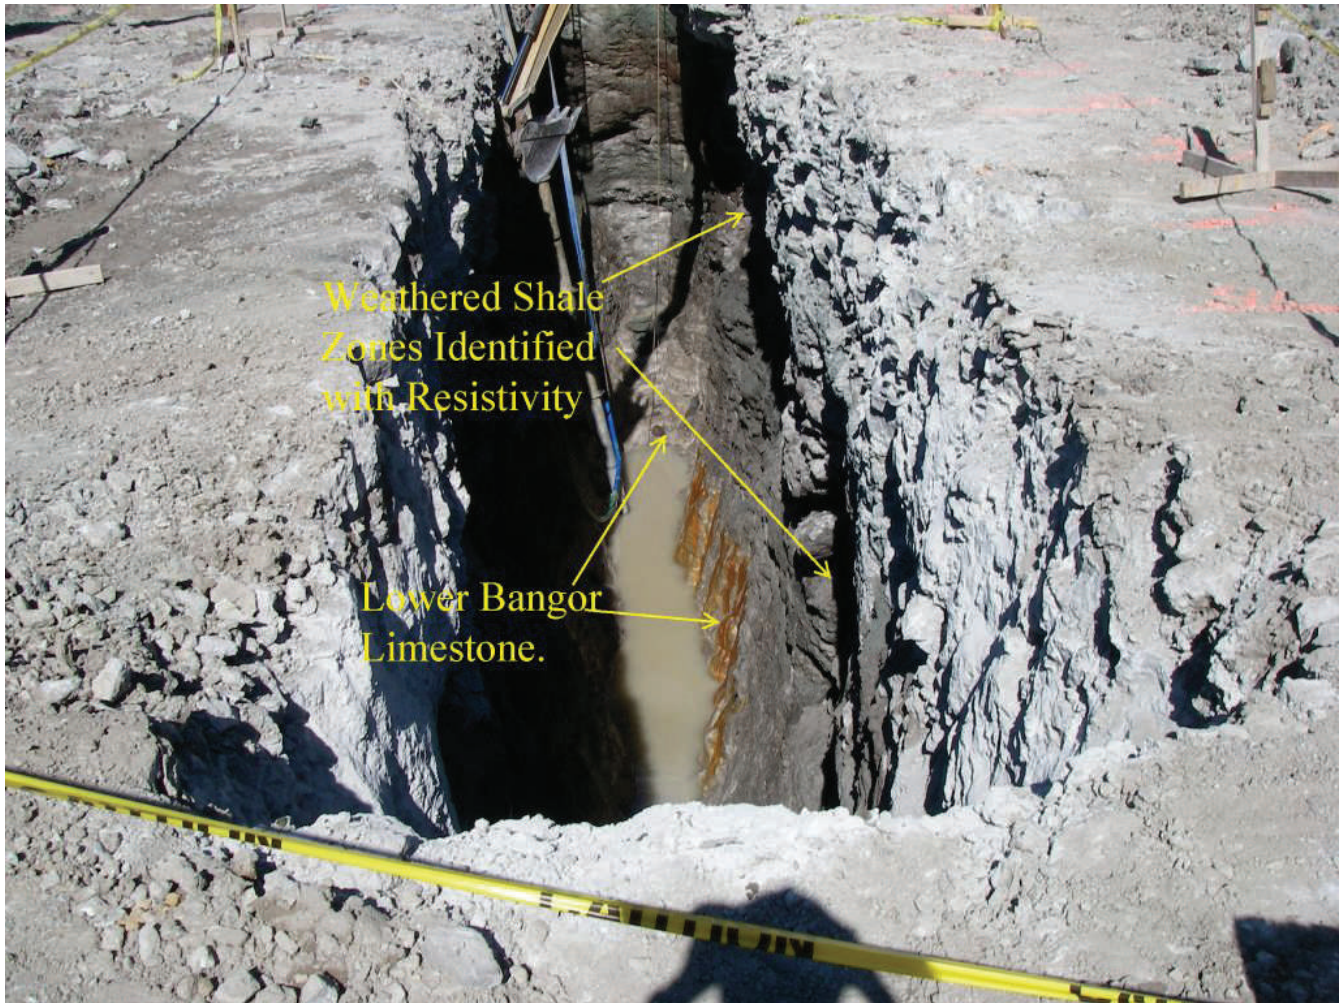
Figure 4. Weathered zones mapped in Bangor Shale Unit C beneath historic Bear Creek channel.

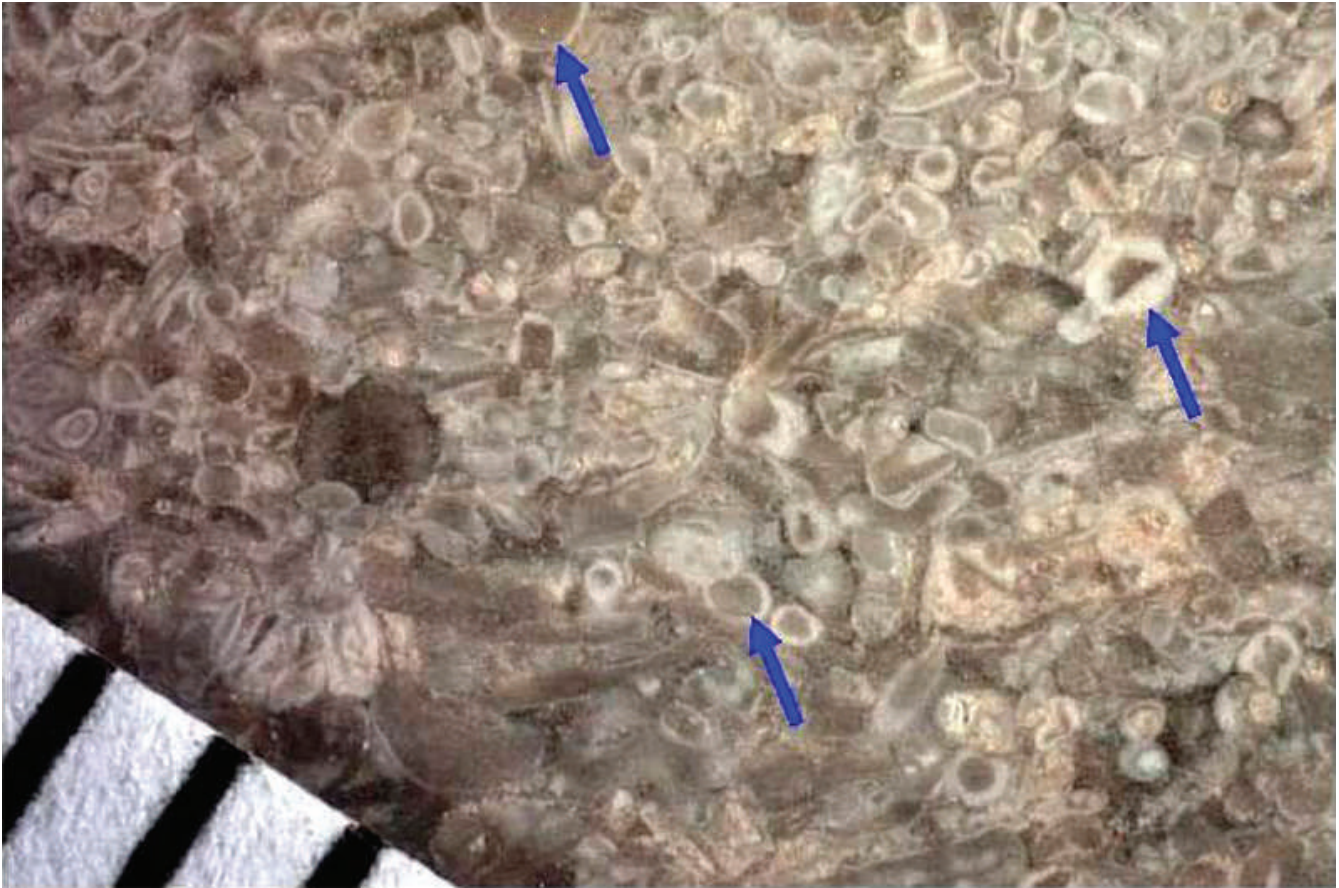
The configuration of the final rock surface was significantly controlled by stratigraphic and structural characteristics. Specifically, in laboratory analyses, a packstone layer containing up to 21 percent (by wt.)  $\text{SiO}_2$  and up to 53 percent (by wt.)  $\text{CaO}$ , bounded above and below by a cherty limestone containing 56 percent (by wt.)  $\text{SiO}_2$ , exhibited significant karst features. Figures 5 and 6 show magnified views of the packstone and overlying cherty limestone, respectively. Figure 7 shows the exposed contact of the packstone and overlying cherty limestone. The blue arrows in Figure 5 point out the oolitic grains in the packstone.

Figure 5. Packstone (scale is marked in millimeters).

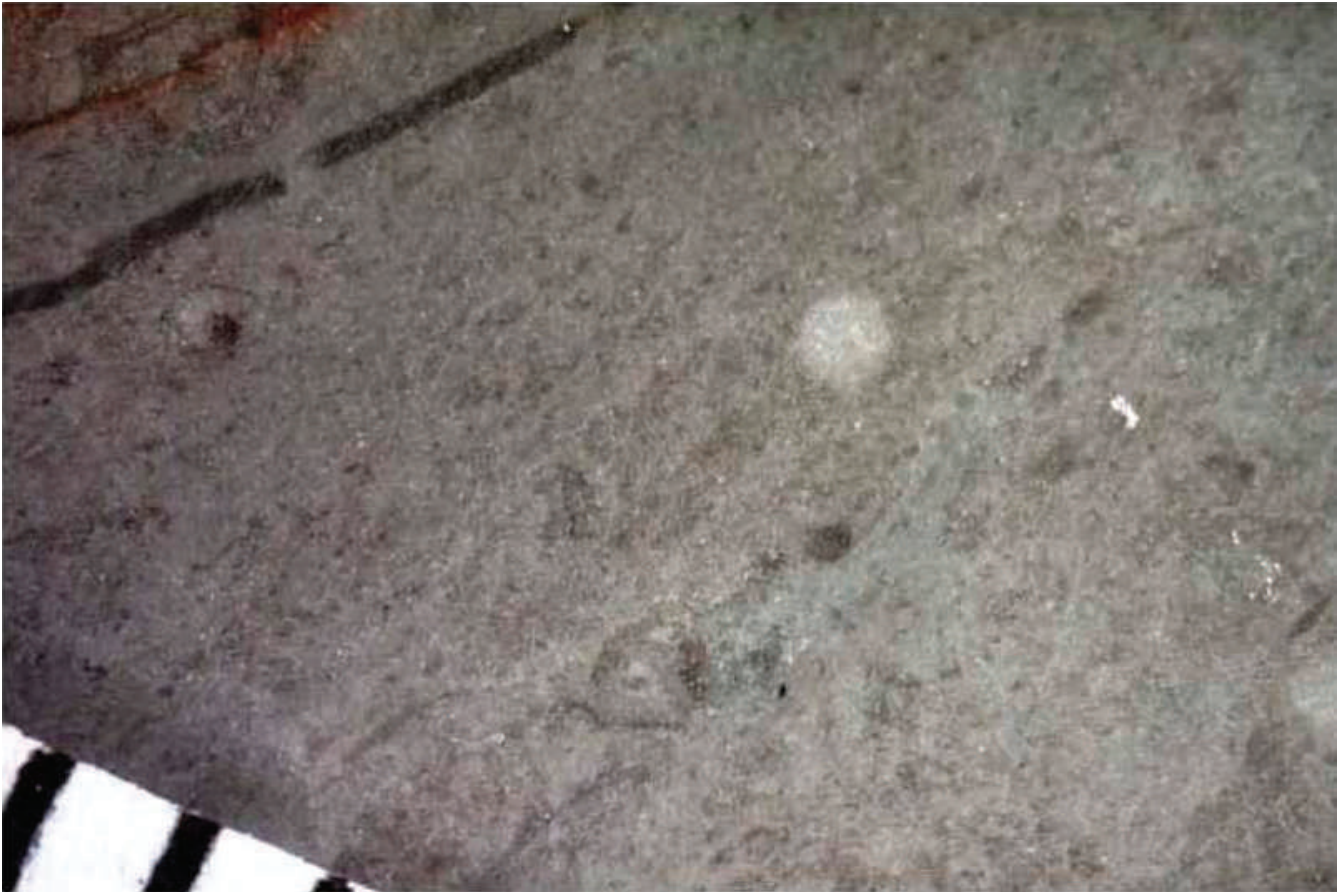
Figure 6. Cherty limestone (scale is marked in millimeters).

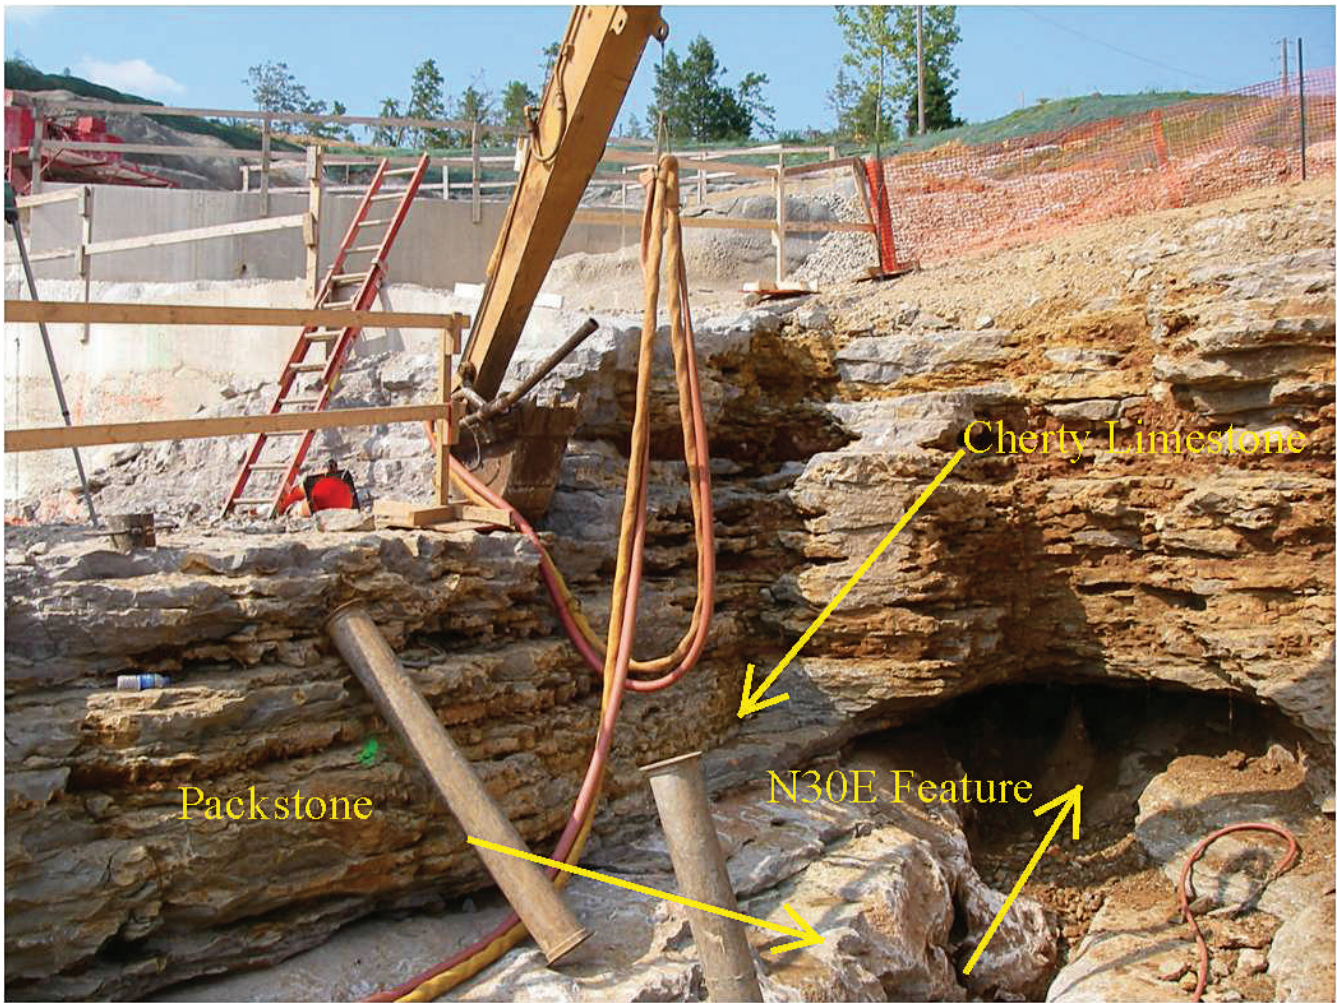
Figure 7. Cherty limestone and packstone contact.

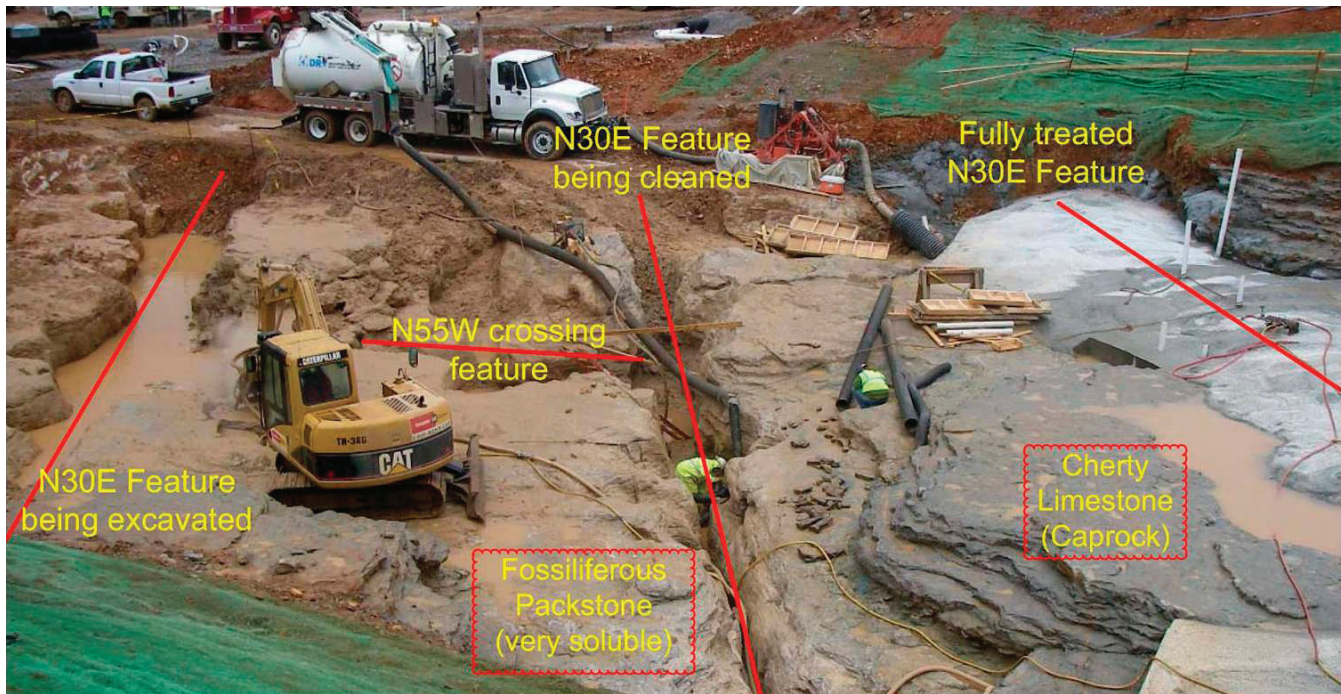
In addition, joints associated with bedding planes and two steeply dipping regional fracture sets striking roughly N30E and N55W acted as zones of accelerated weathering. Figures 8 and 9 show exposed N30E weathered zones and the intersection of N30E and N55W features, respectively (note the 3 in.-diameter yellow hose for scale in Figure 9). Depending on discontinuity orientations, these features sometimes resulted in horizontal surfaces, vertical surfaces, benches, deep depressions, or overhangs. Generally, the foundation surface was shaped adequately by conventional excavation using a track hoe and hoe ram. Over-excavation was appropriate in zones of weathered rock along the aforementioned discontinuities.

Figure 8. Cleaning of N30E features.

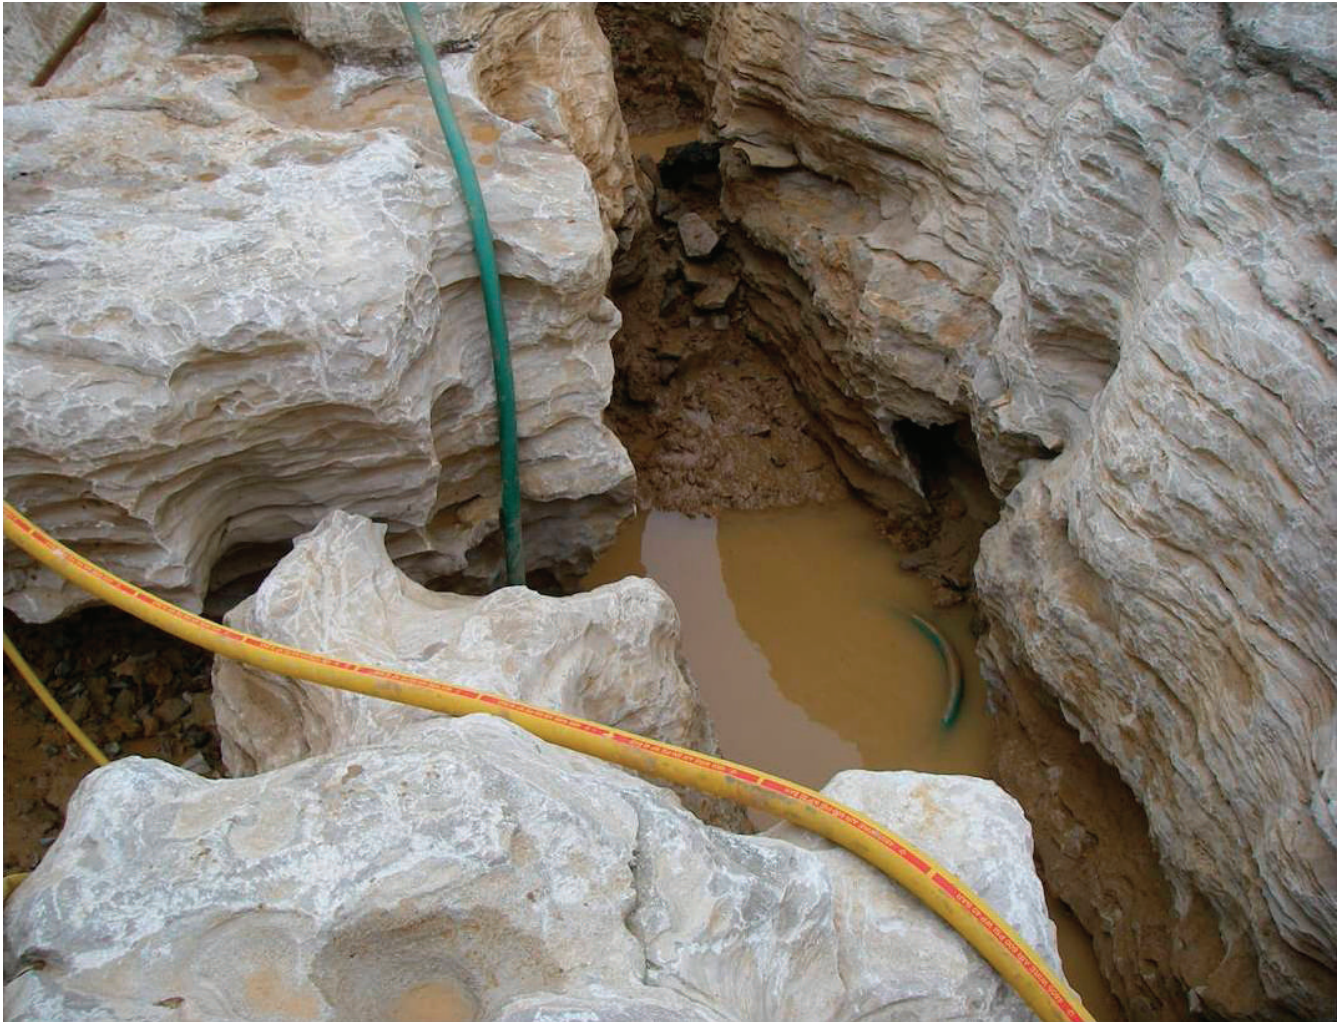
Figure 9. Intersection of N30E and N55W features.

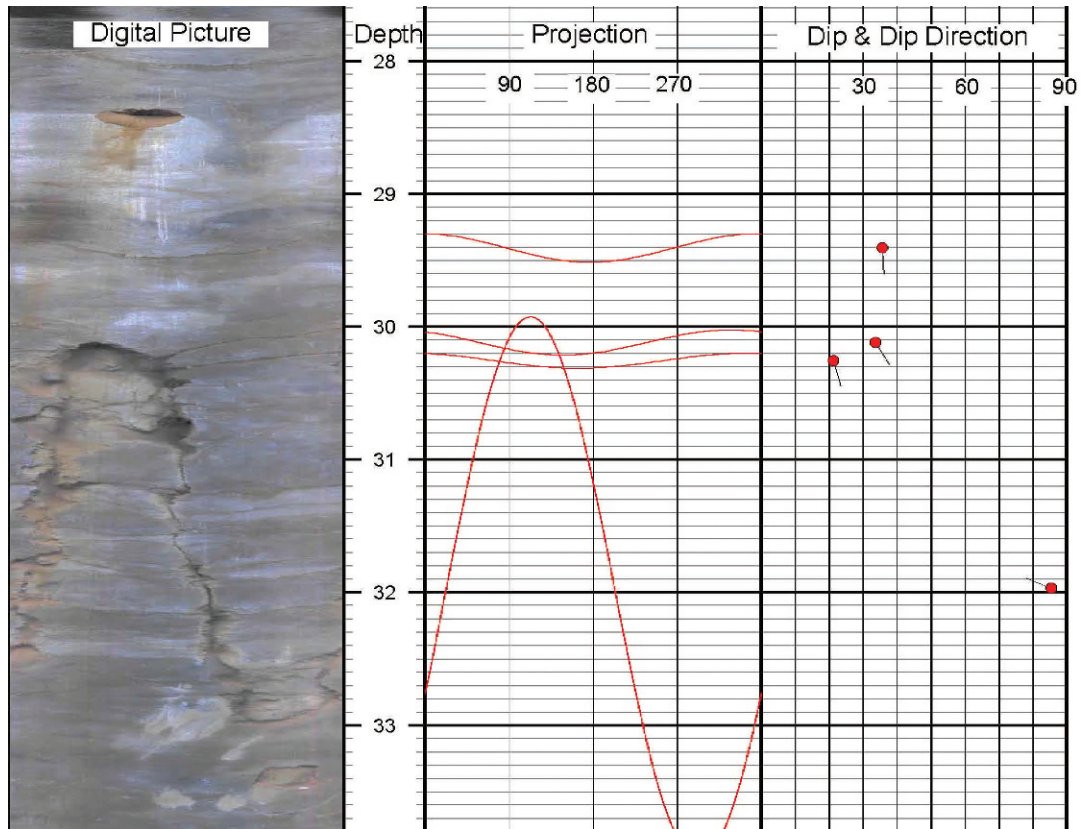
valuable to the generation of an accurate portrait of the site stratigraphy. Figure 11 is a portion of a log produced by the optical televiewer showing the camera shot of a vertical fracture encountered in the core hole within the cherty zone of the Bangor Limestone and the corresponding mapping data recorded by the televiewer.

Figure 11. Section of optical televiewer log showing mapped fracture. Depth in feet.
