FOUNDATION REMEDIATION USING MICROPILES AND LOW MOBILITY GROUTING (LMG) AT SANDY COVE CONDOMINIUM, BARBADOS

J.R. Wolosick, P.E., D.GE¹, J. P. Dittrich, Ph.D., P.Eng.², D.A. Bruce, Ph.D., MICE³

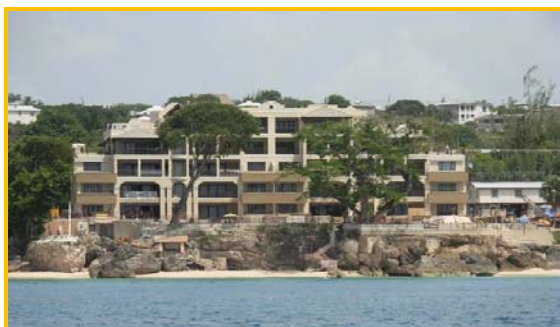
Figure 1: Sandy Cove Condominium

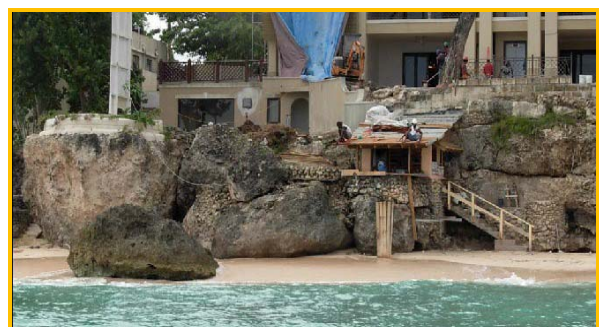
Figure 2: Coral Cliff at Condominium

mass near sea level along prominent sub-horizontal weaknesses combined with sub-vertical major fissures extending landward from the sea to below and beyond the building.

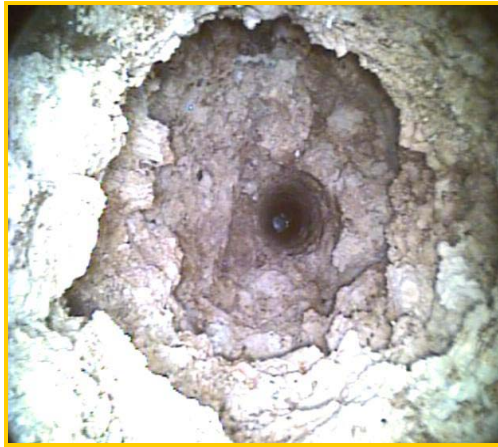
The results of the subsurface investigation revealed that the building was founded on a highly variable, vuggy, heterogeneous, weak coralline rockmass containing numerous voids, sub-horizontal and sub-vertical fissures and joints. Numerous voids were encountered in the stratum during the investigation, as evidenced by 'drops' in the drill-rods, typically ranging from about 4 inches (100 mm) to 3 feet (900 mm), however at one location, a drop of over 8 feet (2.4 m) was recorded. The boreholes also revealed the presence of a less friable, less voided and generally more competent zone of coralline rock at a depth of about 50 feet (15 m). Figures 3 and 4 show borehole camera images from beneath the structure. The investigation also found that a hardened coralline cap, up to about 10 feet thick, was present around parts of the site including on the remnant coral sea stacks immediately in front of the west side of the building (i.e. on the shore side). This more competent material likely existed over much, if not all, of the rockmass within the building footprint prior to construction. However, excavation for the basement had likely removed most of this cap in the northern half of the building. Mapping of the coral cliff faces adjacent to the building indicated that notching/jointing was present in the coral rock

Figure 3: Borehole Camera at 13 foot depth

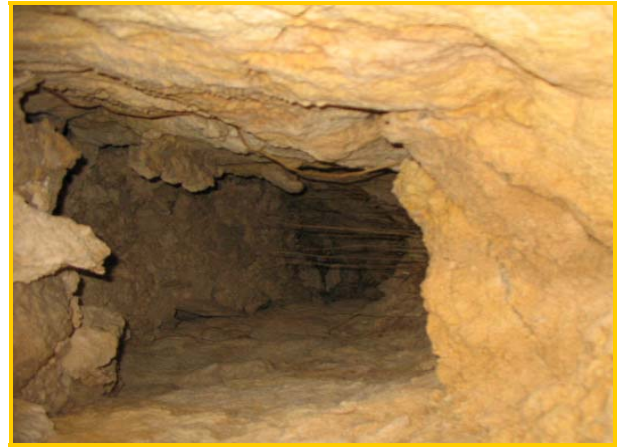
Figure 4: 1 meter high Cave discovered under Structure

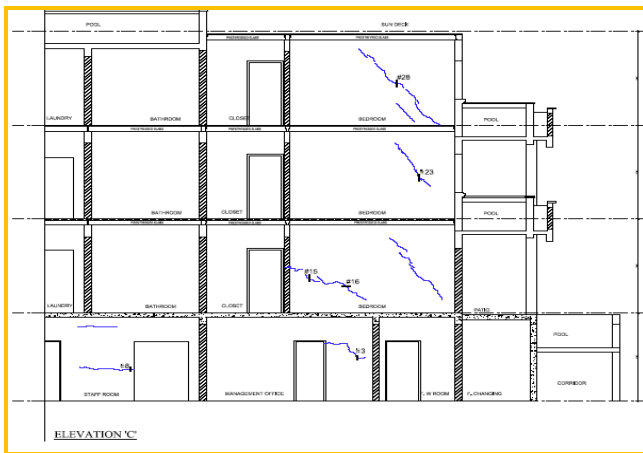
The distress cracking in the building appeared on all five levels of the main floors of the building (Level 1 to 5) and also in the basement (Level 0). The majority of the cracking was concentrated in the northwest corner of the building, principally in the basement and on the first three floors. However, cracking was also observed (albeit less severe) in the southwest corner and on the west central side and in the northeast corner of the building. In general the cracking typically comprised about 45° oriented flexural shear cracking on both east-west and north-south structural walls, however some sub-vertical (about 90°) tensile cracking was also observed. Figure 5 shows a map of some of the exterior cracks observed on the structure. Figure 6 is a photograph of typical interior cracking.

Figure 5: Cracking on Exterior of Building

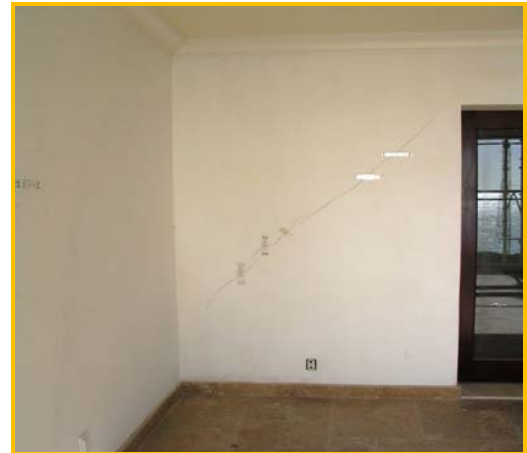
Figure 6: Interior Cracking

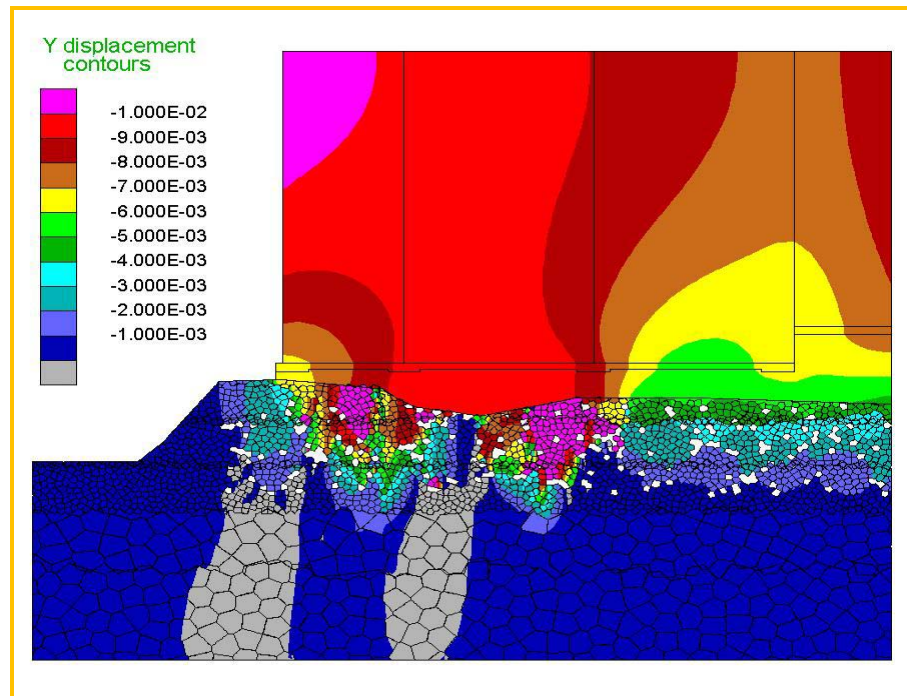
Figure 7: Model of Zones of Vertical Weakness with Displacements (meters)

Based on the modeling, void creation as well as undercutting of the cliff face (from wave action), in conjunction with a weakened rock mass along the sub-vertical jointing, showed the most convincing settlement and interpreted cracking patterns in the building structure. Foundation degradation (i.e. progressive undermining, loss of support and associated building movement) was likely exacerbated by migration of fines from natural fissures and void zones within the coralline rock mass during violent sea conditions. In addition, the fact that the northern half of the structure was constructed with a lower foundation (due to the inclusion of a basement level) was likely a key factor in the observed building behavior. It was concluded that the removal of the more competent coralline cap material in this area, higher foundation loads as a result of the additional level and a founding level in closer proximity to the weak subsurface conditions resulted in the observed building distress. These findings were the basis for the design of remediation approaches.

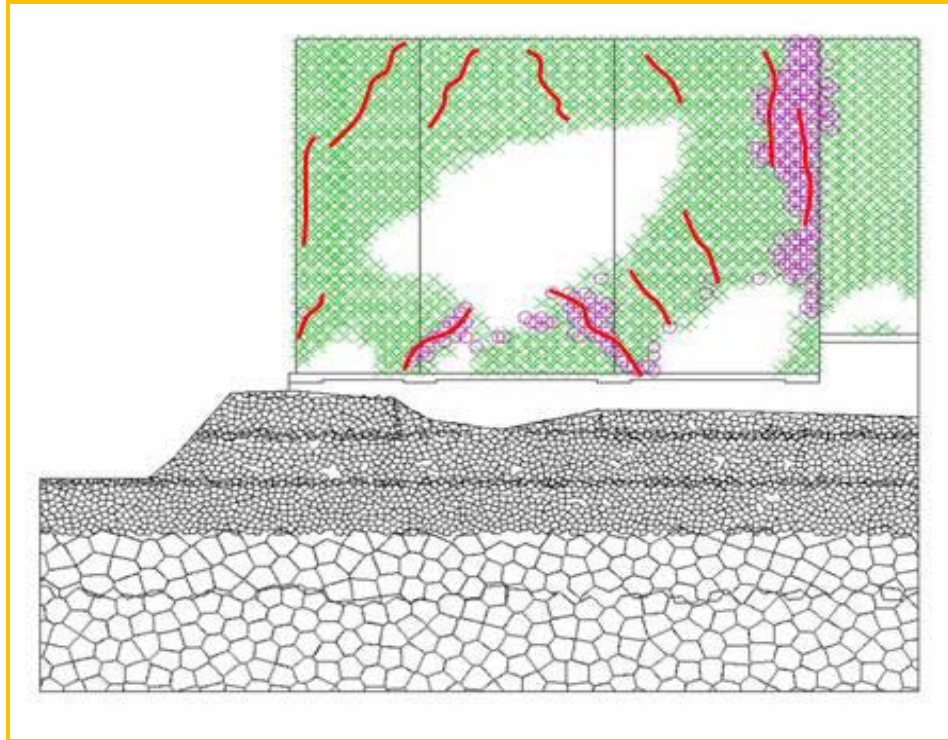
Figure 8: Interpreted Crack Patterns which Matched Observed Cracking

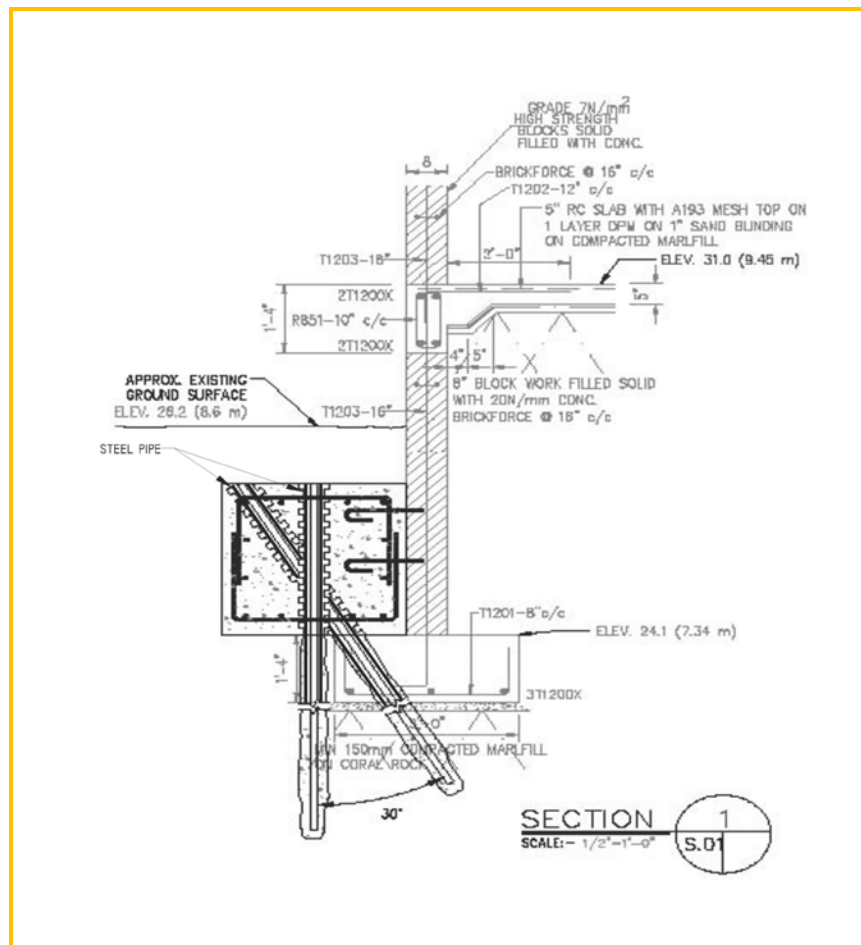
Figure 8: Typical Micropile Grade Beam Attachment

The subsurface seawall was designed to be comprised of two rows of 5 1/2 inch (140 mm) diameter micropiles. The outer row of near vertical micropiles was designed on a 15 degree inclination from the vertical, parallel to the sides of the building and extended down into the more competent coralline rock at a depth of 50 foot (15 m). The inner row of

battered micropiles was designed to be installed perpendicular to the sides of the building at inclinations alternating between 30° and 45° from the vertical and depths varying from 30 feet to 60 feet to extend below the existing building. The tops of the micropiles were designed to be formed into a concrete cap/grade beam that was structurally connected to the existing building footings and/or to the foundation wall (See Figures 8 and 9). The simultaneous grouting, carried out as part of the micropile installation and via supplemental grout-only holes, was laid out to essentially back-fill the washed out zones and any open and interconnected fissures and fractures to stiffen the in situ rockmass, reduce void porosity and hence minimize potential for future vertical settlement. In addition to the micropile wall on the exterior of the building, the design also included a number of near vertical micropiles to be installed within the interior of the building through the basement foundation slab in the areas of highest wall loads and largest measured vertical movement to date. These interior micropiles were supplemented by a series of grout-only holes to provide additional void filling and foundation stiffening at key locations on the interior to minimize future vertical differential settlements.

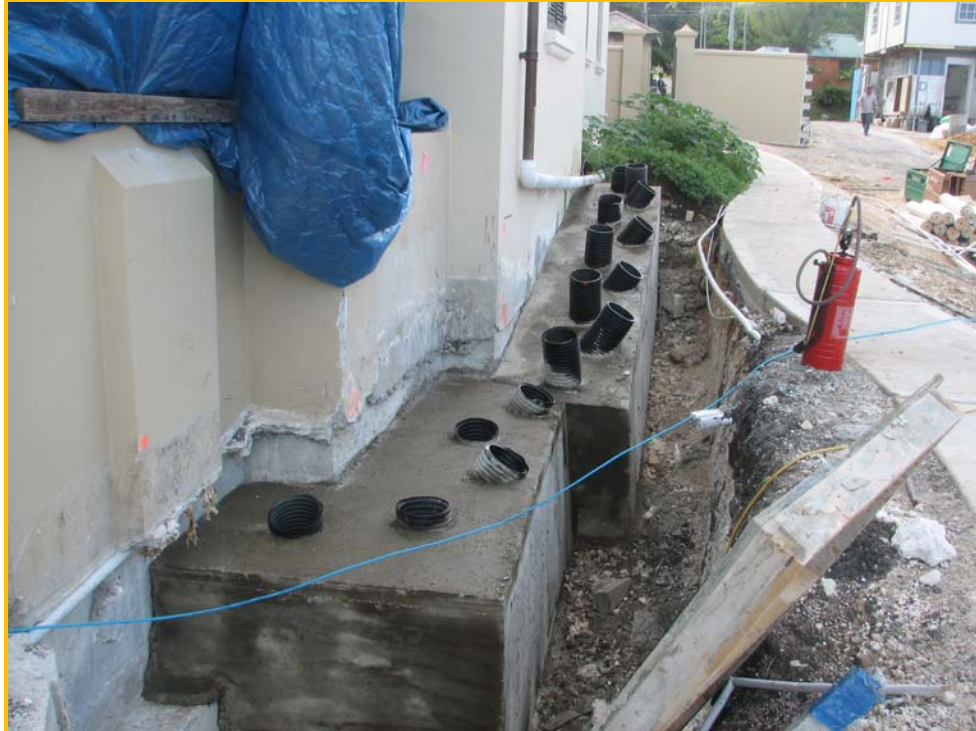
Figure 9: New Grade Beam around Foundation

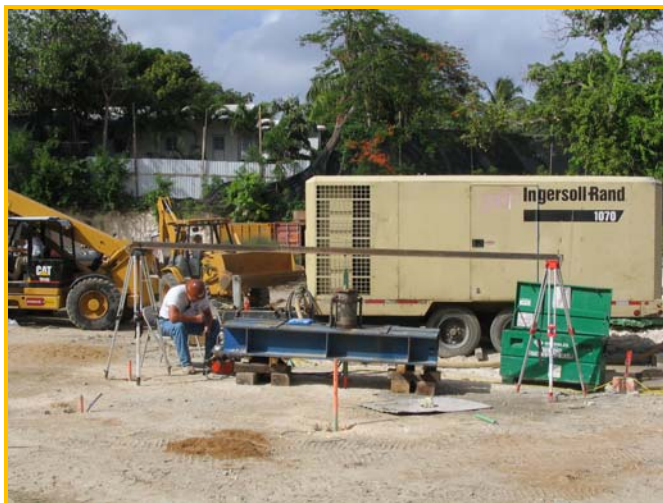
Figure 10: Micropile Tension Testing

The structural design of the micropiles was prepared by Golder and Hayward Baker and reviewed by Mueser Rutledge. The pile consisted of a full-length grade 75 ksi (517 MPa) all-thread bar from DSI and included a short steel pipe in the upper zone of the micropiles. A total of four tension load tests were performed on sacrificial piles near the building (Figure 10). Two tests were completed with LMG grout and two with High Mobility Grout (HMG) (Figure 11). A sample performance of an LMG test is shown on Figure 12.

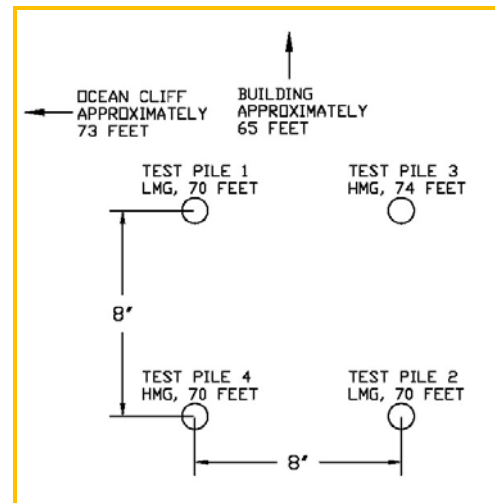
Figure 11: Test Pile Layout

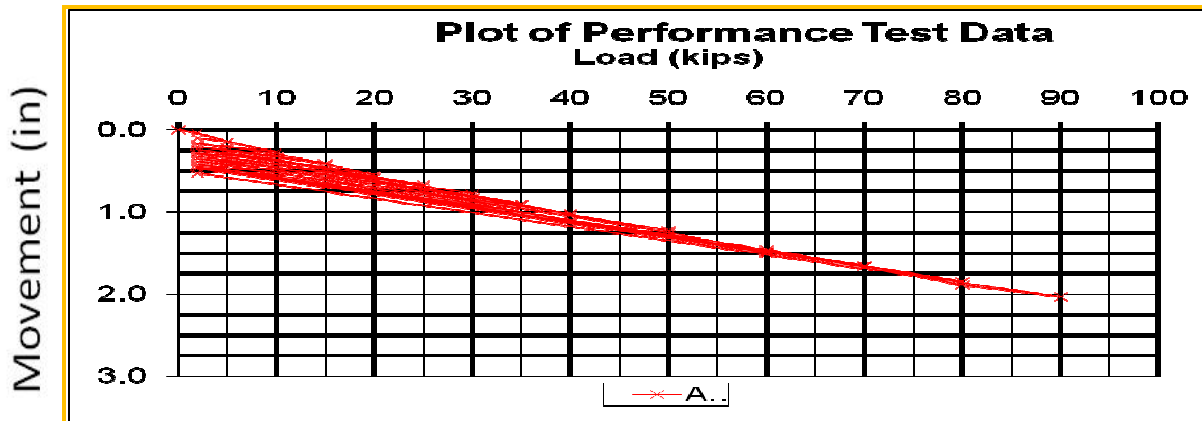
Figure 12: Tension Test Result from 74 foot long LMG Micropile (60 ft free length) Monitoring During and Following Construction

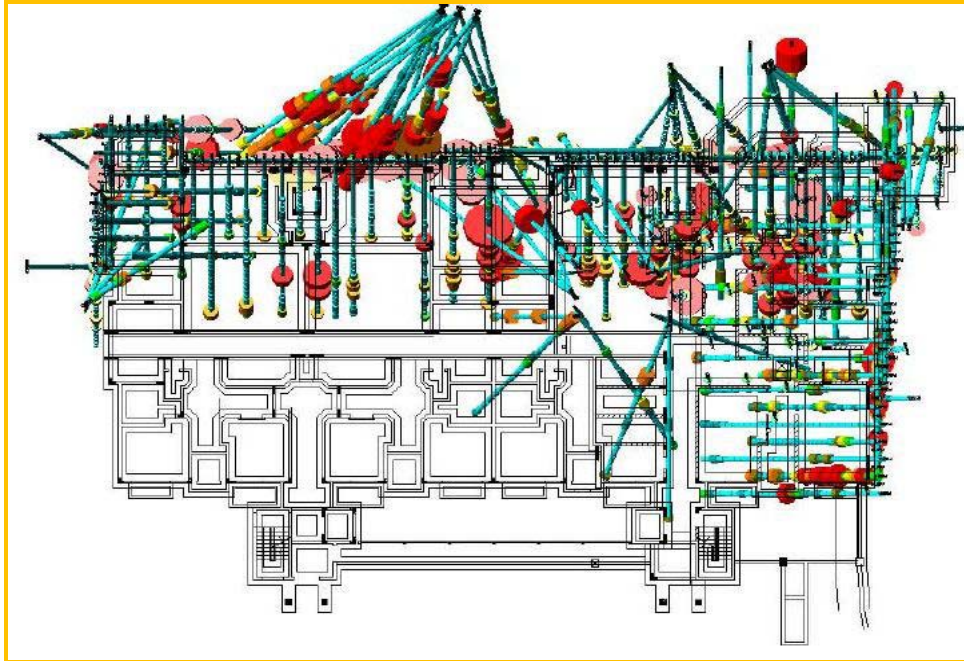
Figure 13: 3-Dimensional Illustration of Grout Locations and Quantities

During the course of the remediation work, the conditions encountered during drilling and the volume of grout injected (or 'take') at discrete depth intervals in each hole was carefully recorded. In this manner, the geological model developed as part of the design phase and formulated into the numerical modelling was adjusted and refined as construction proceeded. Refinements to the design and borehole layouts were undertaken in near real-time as additional subsurface information was obtained during the construction. Records were updated daily and the grout-take data was tracked using 2-D and 3-D graphical models so that the weakest conditions (i.e. most voided) in the subsurface could be readily identified. Figure 13 shows the 3-D model, where higher grout take volumes are shown with larger spheres. These areas were then targeted with additional grout-only holes during the course of the production work. At the completion of the works, data had been acquired from the drilling and grouting of 174 micropiles, during which 1000 yd³ (750 m³) of low-mobility grout was injected into the voided areas of the foundation around the perimeter and below the interior of the building.
