THE THIRD TIME'S A CHARM

Victor M. Vasquez, P.E.¹
John L. Rutledge, P.E.³
Donald A. Bruce, Ph.D., C.Eng.⁵

M. Leslie Boyd, P.E.²
Martin J. Cristofaro, P.E.⁴
Patrick Carr, P.E.⁶

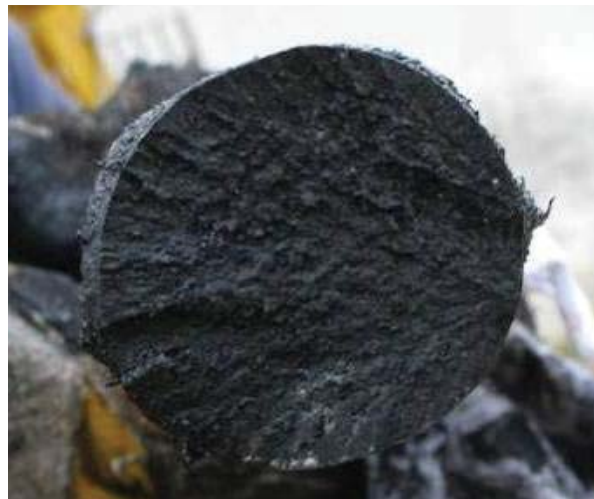
- three new broken bars (Figure 1),
- two bars still damaged as noted in the past,
- one bar broken during testing, and
- continued loss of load.

Figure 1. Typical Broken Bar

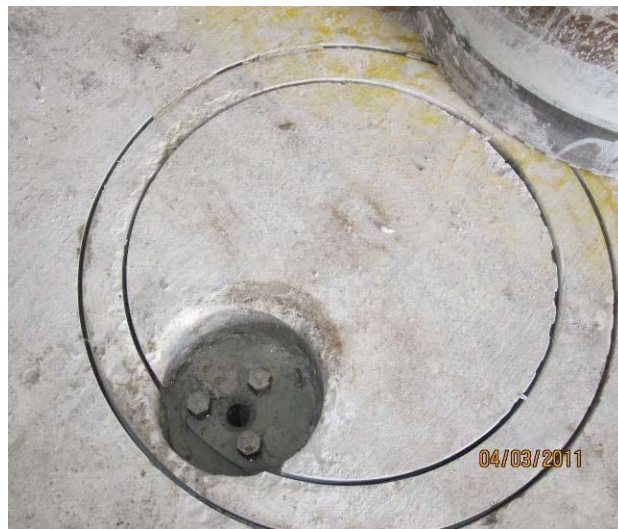
The outlet tower anchors proved to be the most challenging. The only available locations for the five anchors in the outlet tower were within the narrow splitter walls of the outlet conduits. Anchors had already been installed in this same location. Gate operating equipment prohibited locating the anchors upstream or downstream by any significant amount. Thus, FNI selected a location very near the original anchor and required that the existing bar anchors be de-stressed before drilling the new holes. The new pockets overlapped the bearing plate area of the old bar anchors, as shown in Figure 2.

Figure 2. Pocket Overlap with Existing Anchors

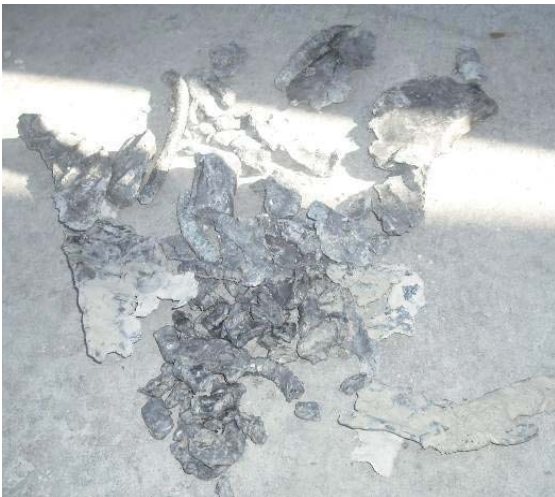
Environmental Controls. A down hole hammer was used for the anchor hole drilling in both concrete and rock. Significant amounts of steel as seen in Figure 10 were encountered in the concrete, particularly in the left abutment non-overflow section and the gatehouse. The rock was relatively soft and drilled easily. The site was environmentally sensitive making it necessary to collect all the drill cuttings as seen in Figure 11. This was accomplished using a deflector bolted to the concrete to divert the discharge into a roll off.

Figure 10. Steel Removed from One Hole

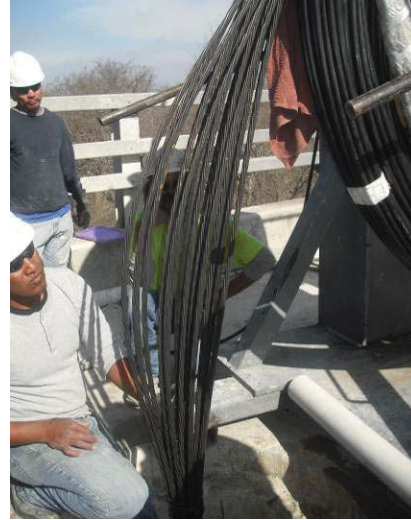
Difficulties were encountered while inserting the tendons. In some instances, the corrugation was damaged during insertion, and in some cases the tendon became wedged and could not be lowered into the hole. After several failed insertion attempts, one of the tendons was uncoiled on the surface. It was found that because of the difference in the inside and outside radius of the coils the extra length would accumulate making a large basket that would expand in the hole, as shown in Figure 15. It would damage the corrugation and wedge inside the hole. Once the problem was discovered, the bands used for assembly were cut as the tendon was inserted and the extra material worked to the top so the strands could even out. This was a slow and tedious process.

Figure 15. Strand Tendon Opening up During Uncoiling
