THIRD POST-TENSIONED ANCHORS STABILIZATION AT OLMOS DAM

Abstract

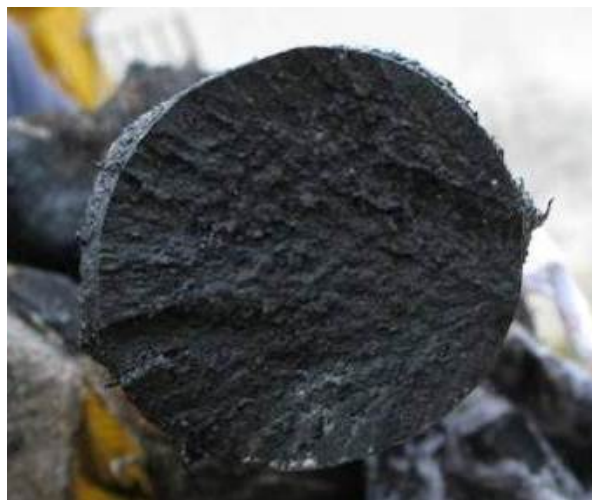
- three new broken bars (Figure 3),
- two bars still damaged as noted in the past,
- one bar broken during testing, and
- continued loss of load.

Figure 3. Typical Broken Bar

Since the previous lift-off tests and anchor re-stressing, the anchors were reported to have lost from 0.3% to 2.7% of their load every year with an average of 1.5% a year.

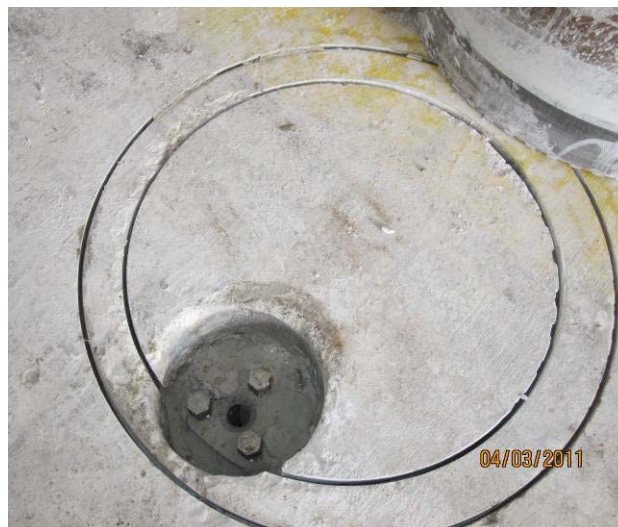
The outlet tower anchors proved to be the most challenging. The only available locations for the five anchors in the outlet tower were within the narrow splitter walls of the outlet conduits. Anchors had already been installed in this same location. Gate operating equipment prohibited locating the anchors upstream or downstream by any significant amount. Thus, FNI selected locations very near the original anchors and required that the existing bar anchors be de-stressed before drilling the new holes. The new pockets overlapped the bearing plate area of the old bar anchors, as shown in Figure 6.

Figure 6. Pocket Overlap with Existing Anchors

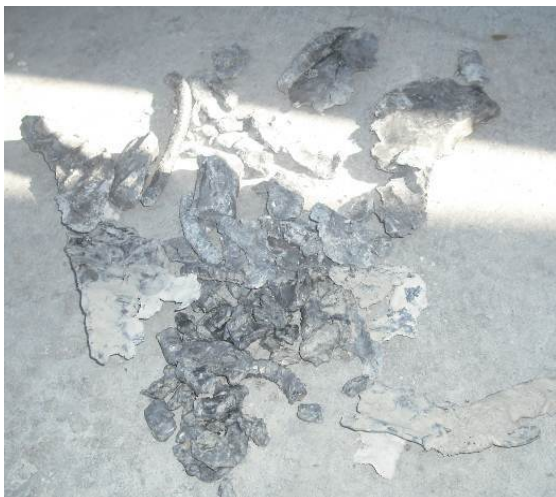
Environmental Controls. A down hole percussion hammer was used for the anchor hole drilling in both concrete and rock. Significant amounts of steel as seen in Figure 14 were encountered in the concrete, particularly in the left abutment non-overflow section and the gatehouse. The rock was relatively soft and drilled easily. The site was environmentally sensitive making it necessary to collect all the drill cuttings as seen in Figure 15. This was accomplished using a deflector bolted to the concrete to divert the discharge into a roll off.

Figure 14. Steel Removed from One Hole

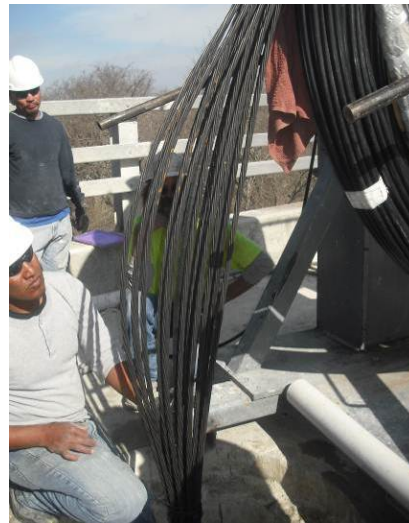
Difficulties were encountered while inserting the tendons. In some instances, the corrugation was damaged during insertion, and in some cases the tendon became wedged and could not be lowered into the hole. After several failed insertion attempts, one of the tendons was uncoiled on the surface. It was found that because of the difference in the inside and outside radius of the coils the extra length would accumulate making a large basket that would expand in the hole, as shown in Figure 19. It would damage the corrugation and wedge inside the hole. Once the problem was discovered, the bands used for assembly were cut as the tendon was inserted and the extra material worked to the top so the strands could even out. This was a slow and tedious process.

Figure 19. Strand Tendon Opening up During Uncoiling

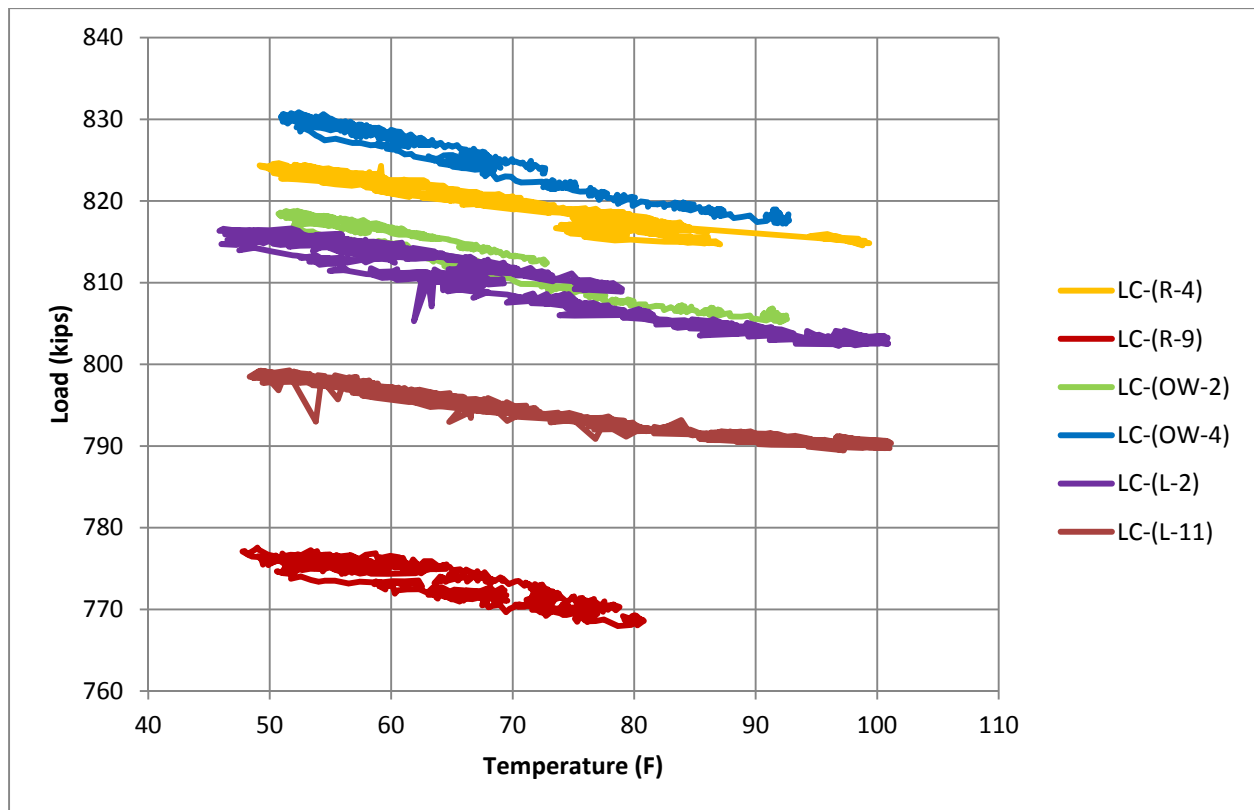
A review of the load cell data reveals that the load cell readings are clearly related to temperature. Figure 23 shows the 20-strand load cell readings versus temperature. The temperature effect may be due to the load cell or both real load changes caused by the expansion and contraction of anchor tendons, anchor head and dam concrete. In order to observe anchor performance independent of temperature, the linear trends observed in Figure 23 were used to adjust the remaining figures to 100°F.

Figure 23. 20-strand load cell readings related to temperature

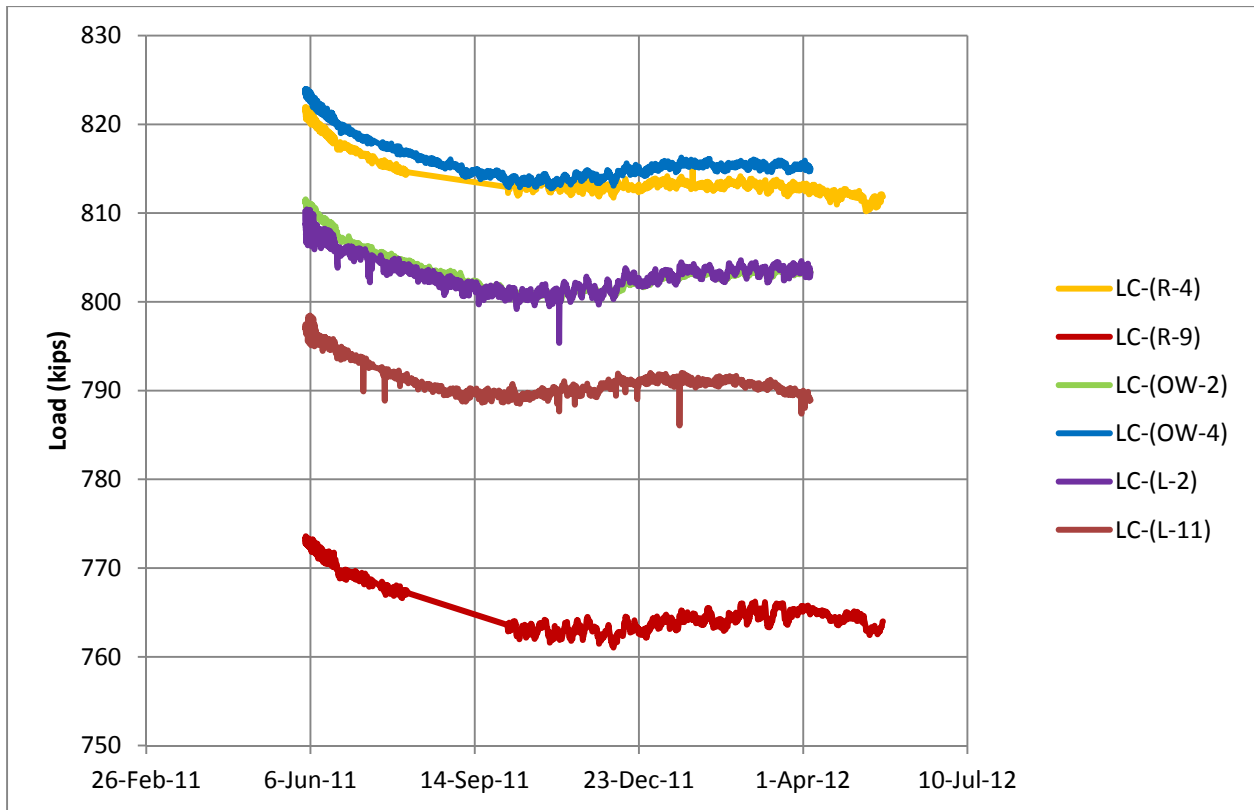
Figure 24 shows the temperature adjusted 20-strand load cell readings versus date and Figure 25 shows the same readings versus logarithmic installed time. The readings show an initial load loss and then relatively constant readings. The design line on Figure 25 shows the anticipated anchor load for the 50-year design life. The 20-strand anchors are reporting loads greater than design and the slope of the observed loads is less than the design slope, indicating that the anchors are holding the load better than design expectations.

Figure 24. Temperature adjusted 20-strand load cell readings versus date

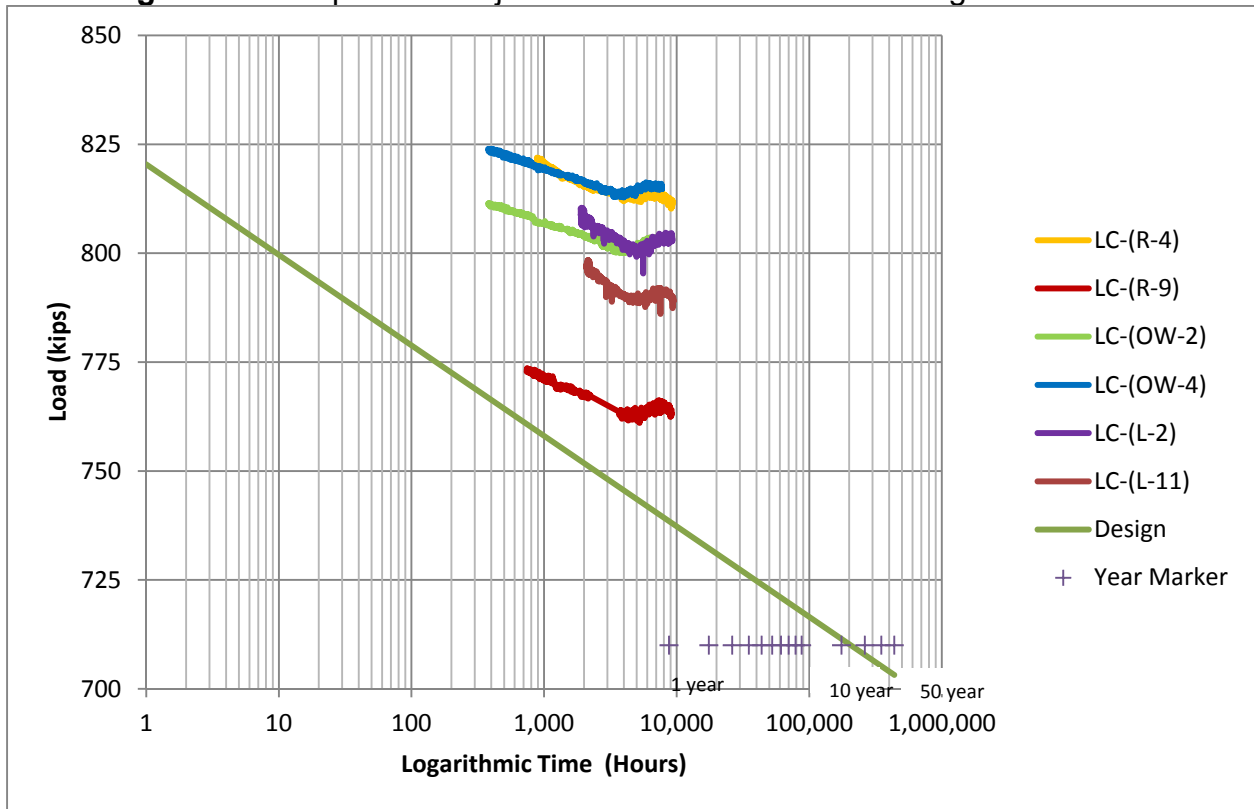
Figure 25. Temperature adjusted 20-strand load cell readings versus installed time.

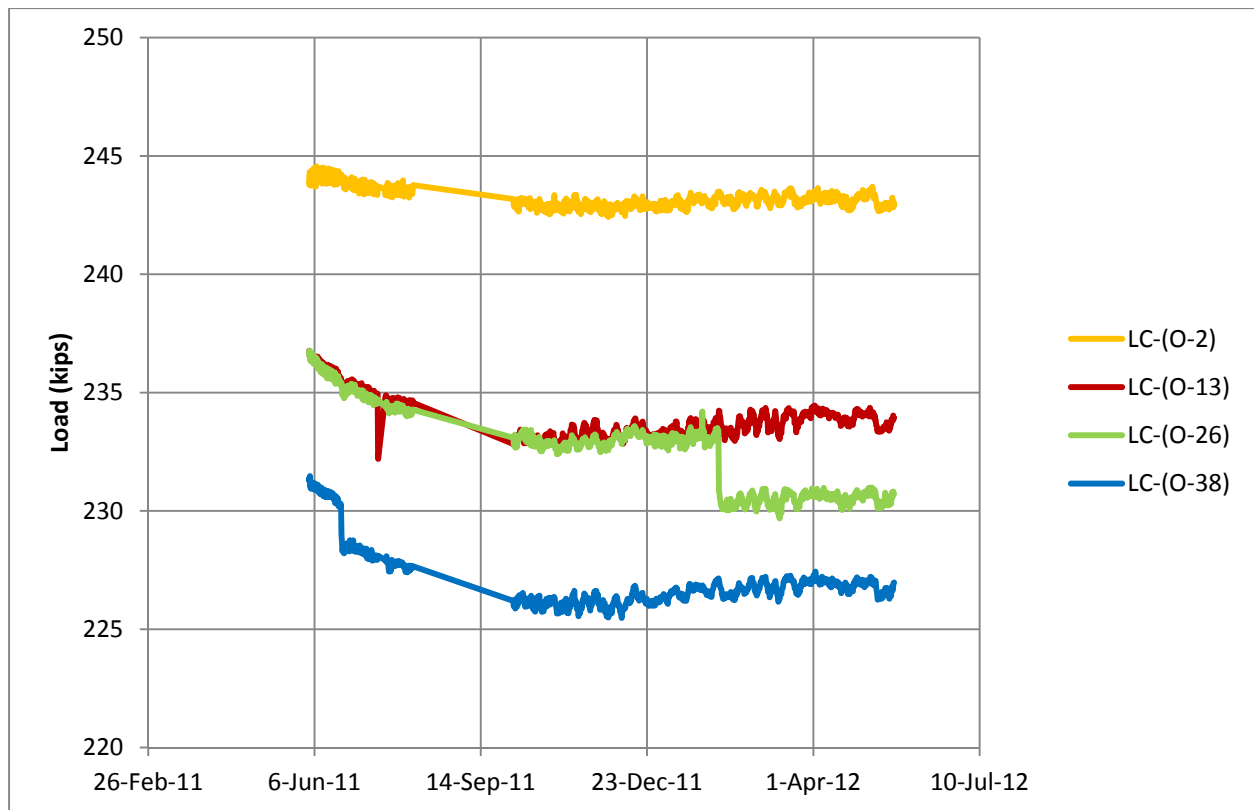
The temperature adjusted readings for the 6-strand load cells are shown in Figure 26 and Figure 27. The readings are similar to the 20-strand readings in that there is some initial load loss during the first few months after installation and then the readings become relatively constant. Of interest are sudden load reductions of approximately two kips in load cells O-26 and O-38. The readings indicate that the anchors are providing the design load and that if the current trend continues, they will have more than the design load at the end of 50 years. Future readings will be monitored to verify that the trend continues. No correlations have been observed between lake level and load cell reading to date.

Figure 26. Temperature adjusted 6-strand load cell readings versus date

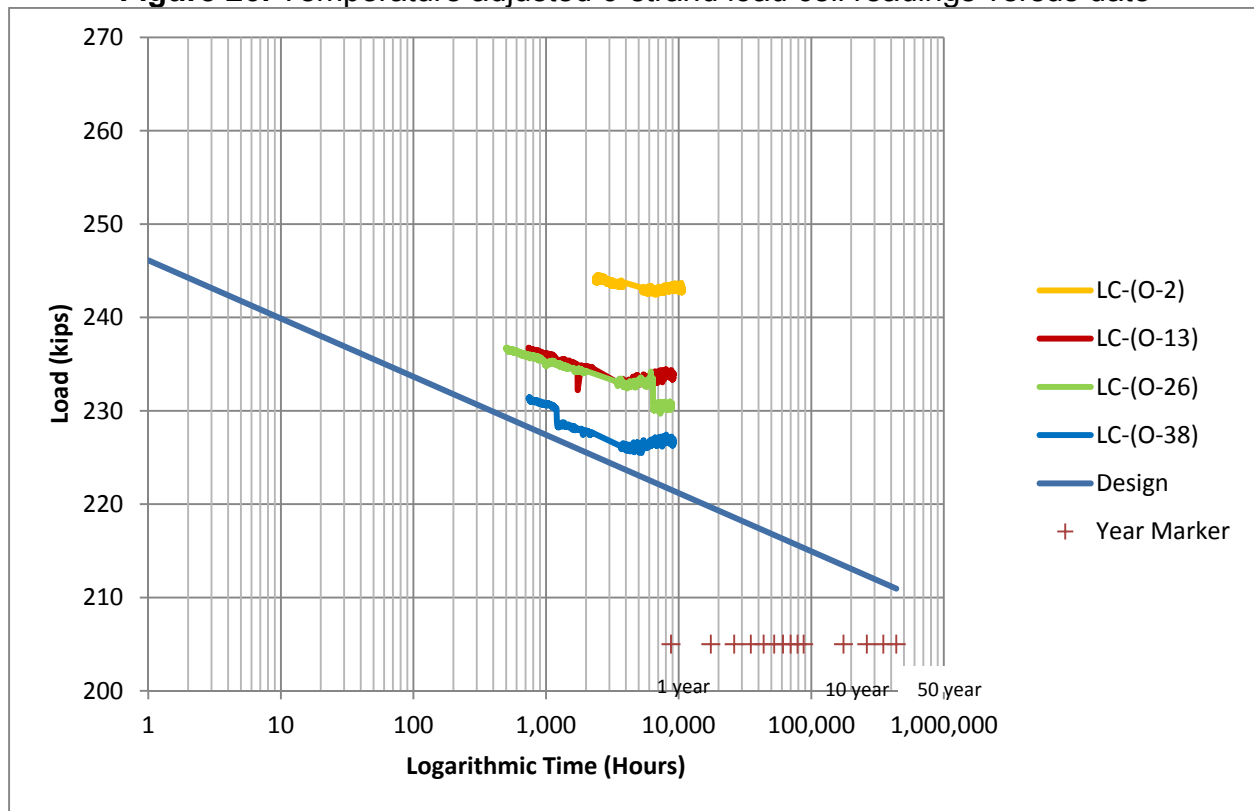
Figure 27. Temperature adjusted 6-strand load cell readings versus installed time

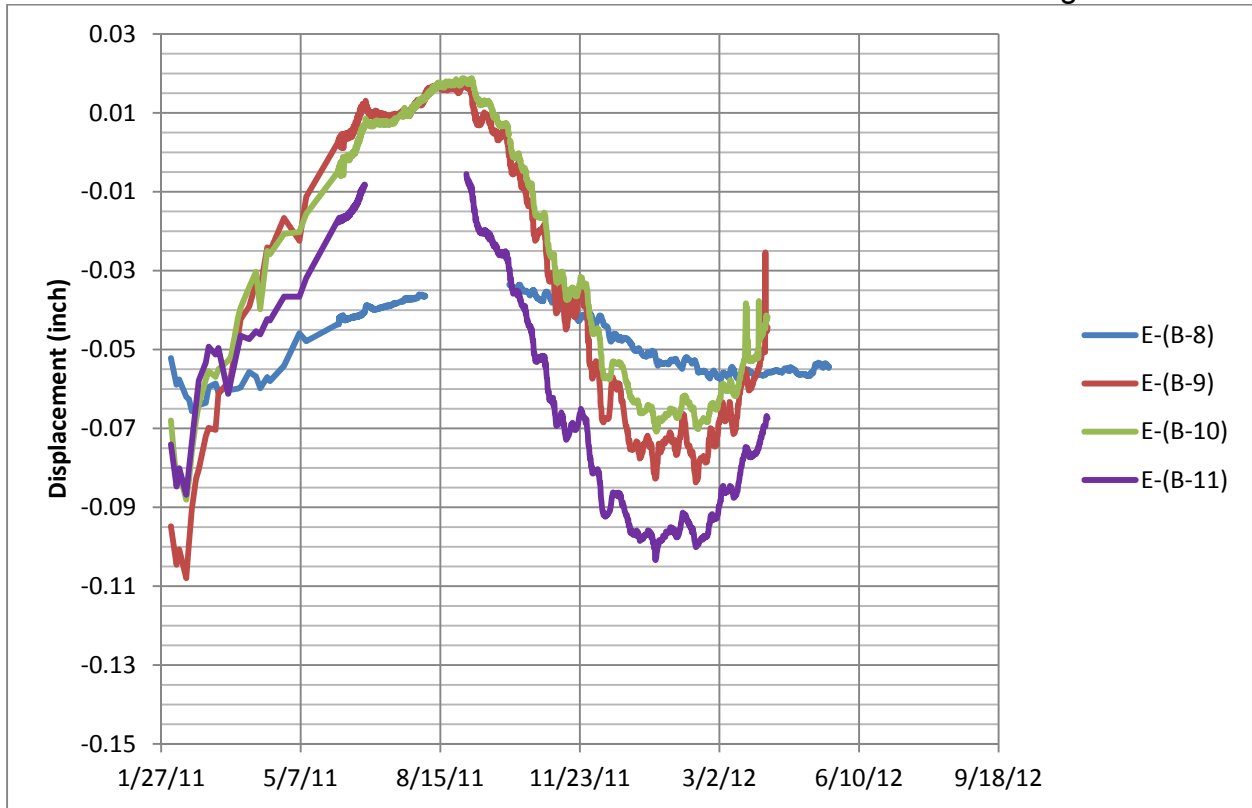
Four extensometers were installed to monitor movement of the dam crest relative to the foundation. Movements of approximately 0.1 inch have been observed. Similar to the load cells, the readings in the left non-overflow are correlated to temperature. As the weather cooled, the extensometers reported contraction between the foundation and the crest and as the weather warmed, the displacement grew. The extensometer in the right non-over flow has reported minimal movement. Figure 28 and Figure 29 show the observed movement. No correlations have been observed between lake level and extensometer reading to date.

Figure 28. Extensometer readings versus date

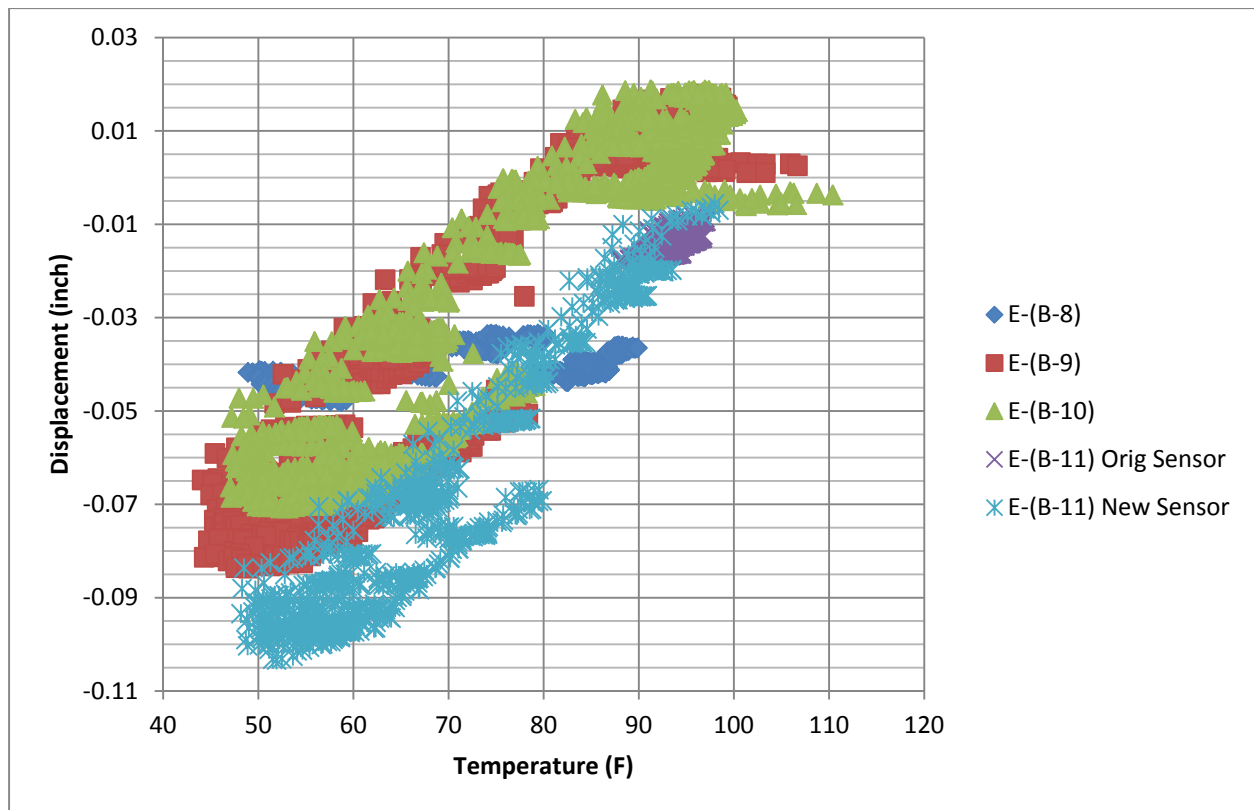
Figure 29. Extensometer readings versus temperature
