EVOLUTION OF GROUTING IN KARST AT LOGAN MARTIN DAM, ALABAMA

DONALD A. BRUCE

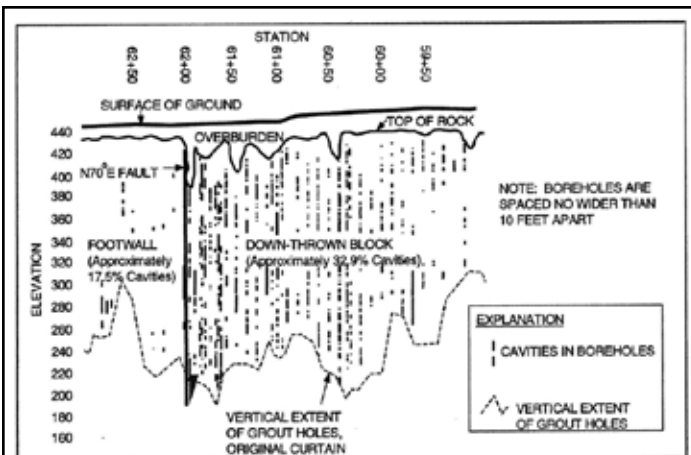
FIGURE 2. GEOLOGIC CROSS-SECTION DEPICTING A MAJOR NORMAL FAULT AND IMPACTS ON KARST CONDITIONS AT LOGAN MARTIN DAM (REDWINE, 1999).

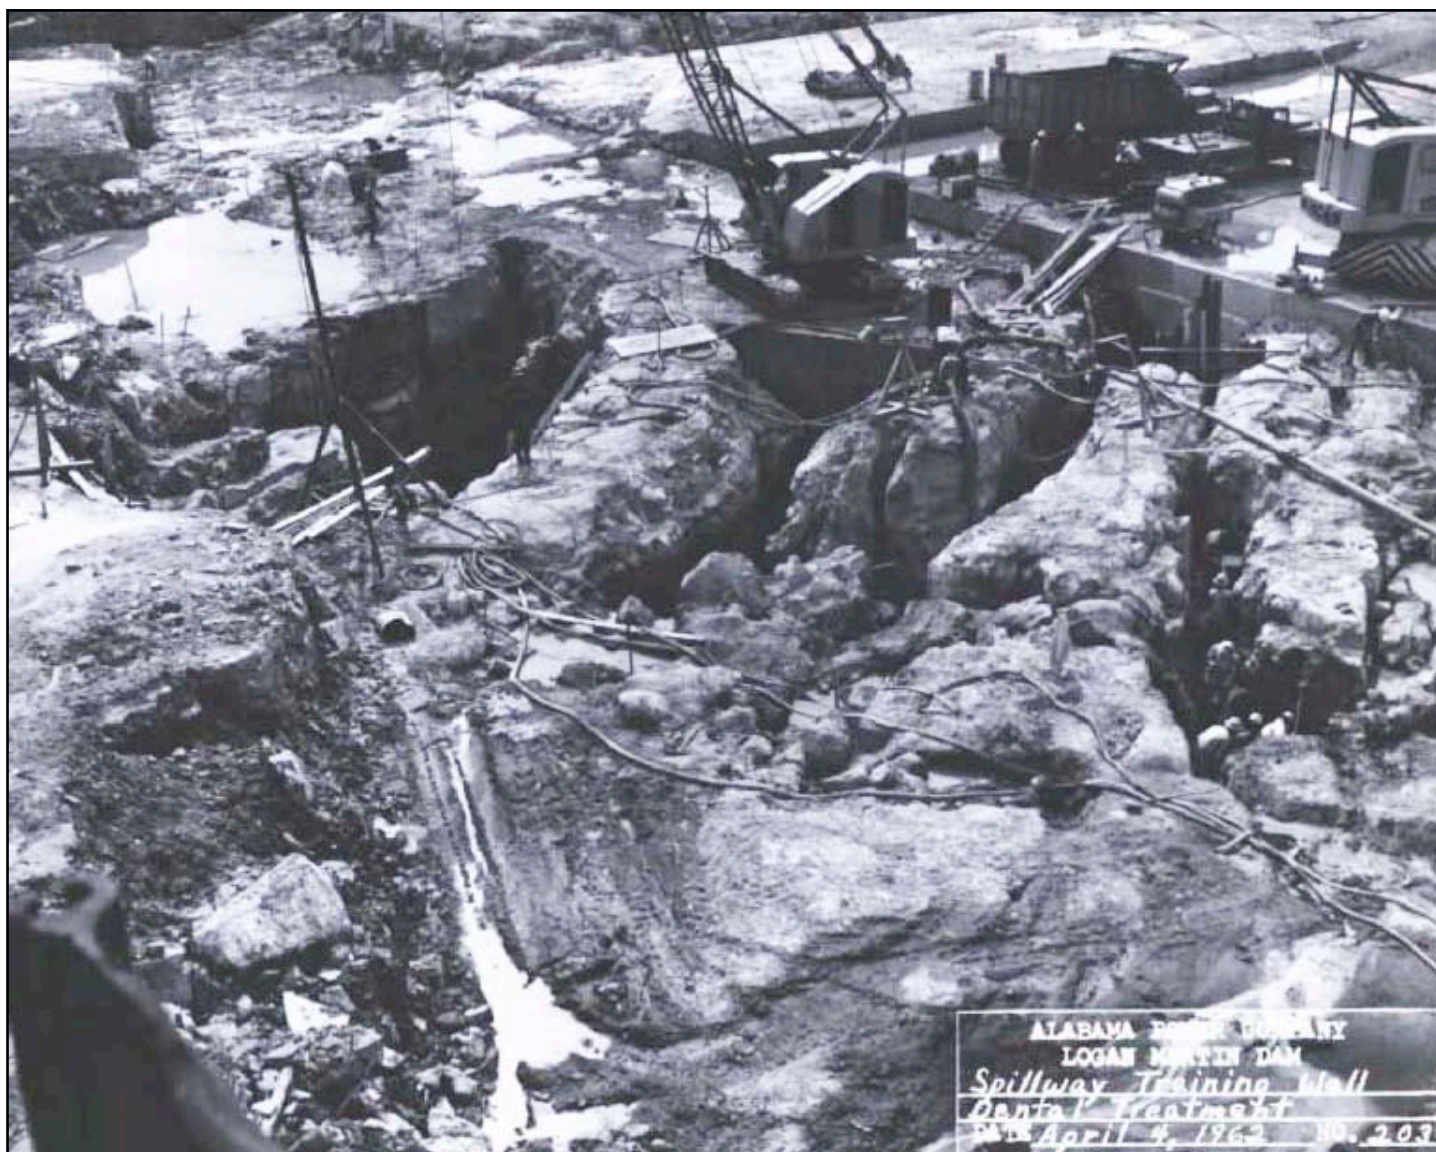
Construction at the site began in 1960. The embankments were constructed as homogeneous earth fills consisting of a cherty clay residuum with a maximum height of 100 ft (30 m). The first stage of construction consisted of installing coffer cells for the west embankment closure for the powerhouse and spillway excavations. As the excavation proceeded, large cavities were exposed in the underlying bedrock (Figure 3). These cavities were cleaned and

FIGURE 3. PHOTOGRAPH OF OPENED FOUNDATION DURING CONSTRUCTION SHOWING PRONOUNCED KARSTIC SOLUTIONING ALONG STRUCTURAL GEOLOGIC FEATURES.

treated with dental concrete. The west embankment construction was completed in 1963. The coffer cells were removed and water diverted through the spillway at this point. The second stage of construction proceeded on the east embankment. Two dumped rock cofferdams were constructed that eventually became the upper and downstream toes of the dam through the original river section. A clay blanket was placed along both the upstream and downstream slopes. Similar to the west embankment, once the foundation bedrock on the east side was exposed, larger and more numerous cavities than expected were encountered. Due to the size of the embankment as well as the number of cavities present, it was decided that a reinforced concrete slab would be constructed beneath the upstream slope of the east embankment through the original river section. The slab was approximately 89 feet (27 m) wide and ranged in thickness from 3 to 7 ft (1 to 2 m). Prior to the slab construction, any cavities exposed were cleaned by hand and filled with crushed rock. A 4 ft (1.2 m) thick blanket drain was installed beneath the downstream portion of the dam.

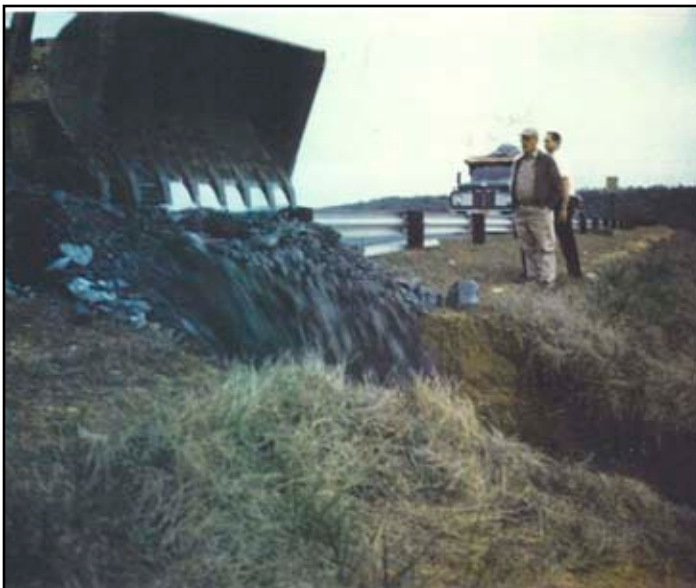
Immediately upon initial filling of the reservoir in 1964, mud flows were noticed downstream of the earthen portion of the eastern embankment. Boils also began forming in the tailrace area. In June of 1966, seepage was noted at the toe of the east embankment. Weir 27 was built to monitor flow at that point. On February 23, 1968 the weir began discharging mud. For a period of 40 days these mud flows were observed. On April 9, 1968 a sinkhole approximately 20 ft (6 m) in diameter and 16 ft (5 m) deep opened just downstream of the east embankment crest and was referred to as the “chimney sink.” Immediate action by site personnel to shut down the roadway across the dam with backfilling (Figure 4). This sinkhole was a clear manifestation of the karstic subsurface conditions at the site and had the clear potential to fundamentally threaten dam safety. Numerous holes were drilled surrounding the sink to determine its extent. In addition, piezometers were installed across the site to further monitor water levels and temperatures. The sinkhole event also highlighted the need for further grouting programs.

FIGURE 4. BACKFILLING OF THE CHIMNEY SINKHOLE ON THE EAST EMBANKMENT IN 1968.

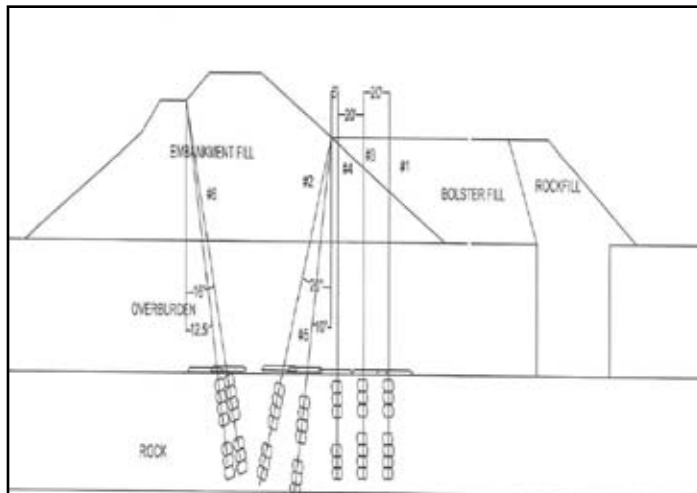
Difficulties in setting casing to the rock surface, communications of pressure and drilling fluid between drill holes and other instrumentation prompted further investigation into the condition of the upper 50 ft (15 m) of rock beneath the lower half of the east embankment of the dam. A review of historic drill log data, framed in reference to the recent drilling data and the communication anomalies, led APC/SCS to the conclusion that additional protection was needed to prevent the formation of sinkholes along this section of the dam.

FIGURE 6. CROSS-SECTION DEPICTING LMG COLUMNS EMPLACED IN THE TREATMENT AREA BENEATH THE EAST EMBANKMENT TOE.

The board of consultants recommended a corrective measure utilizing LMG grouting techniques to construct discreet grout columns to partially fill the voids while providing support of a thin “roof” of competent rock. Since the grouting would be performed on the downstream side of the dam, the grout injection process had to be conducted in such a manner as to not change the piezometric levels or potential flow directions of any shallow leakage within the upper fifteen meters of rock so as not to increase pore pressure and affect embankment stability. Therefore, a test program was conducted to develop the grouting plan and ensure that the required outcome could be achieved.

The initial test section consisted of four grout holes per row. With the exception of the angle holes, each hole was spaced 20 ft (6 m) apart. The grout holes were drilled to a depth of 150 ft (46 m) using the WDTM method. Using an LMG grout supplied by a local ready mix company, the 50 ft (15 m) of rock at each grout hole location were grouted in 4 ft (1.5 m) stages. Refusal criteria was either a maximum pressure (gage pressure minus line pressure) of 250 psi (1.7 kPa) or 5 yd³ (3.8 m³) of grout per stage. The objective was to form approximately 4 ft (1.5 m) diameter columns. At the interface of the overburden and the top of rock, the grout mix was adjusted to a higher slump and injected to form a cap along the top of rock wider than the grout columns. The wider cap formed at the top of each grout column was placed to provide support to the base of the embankment.

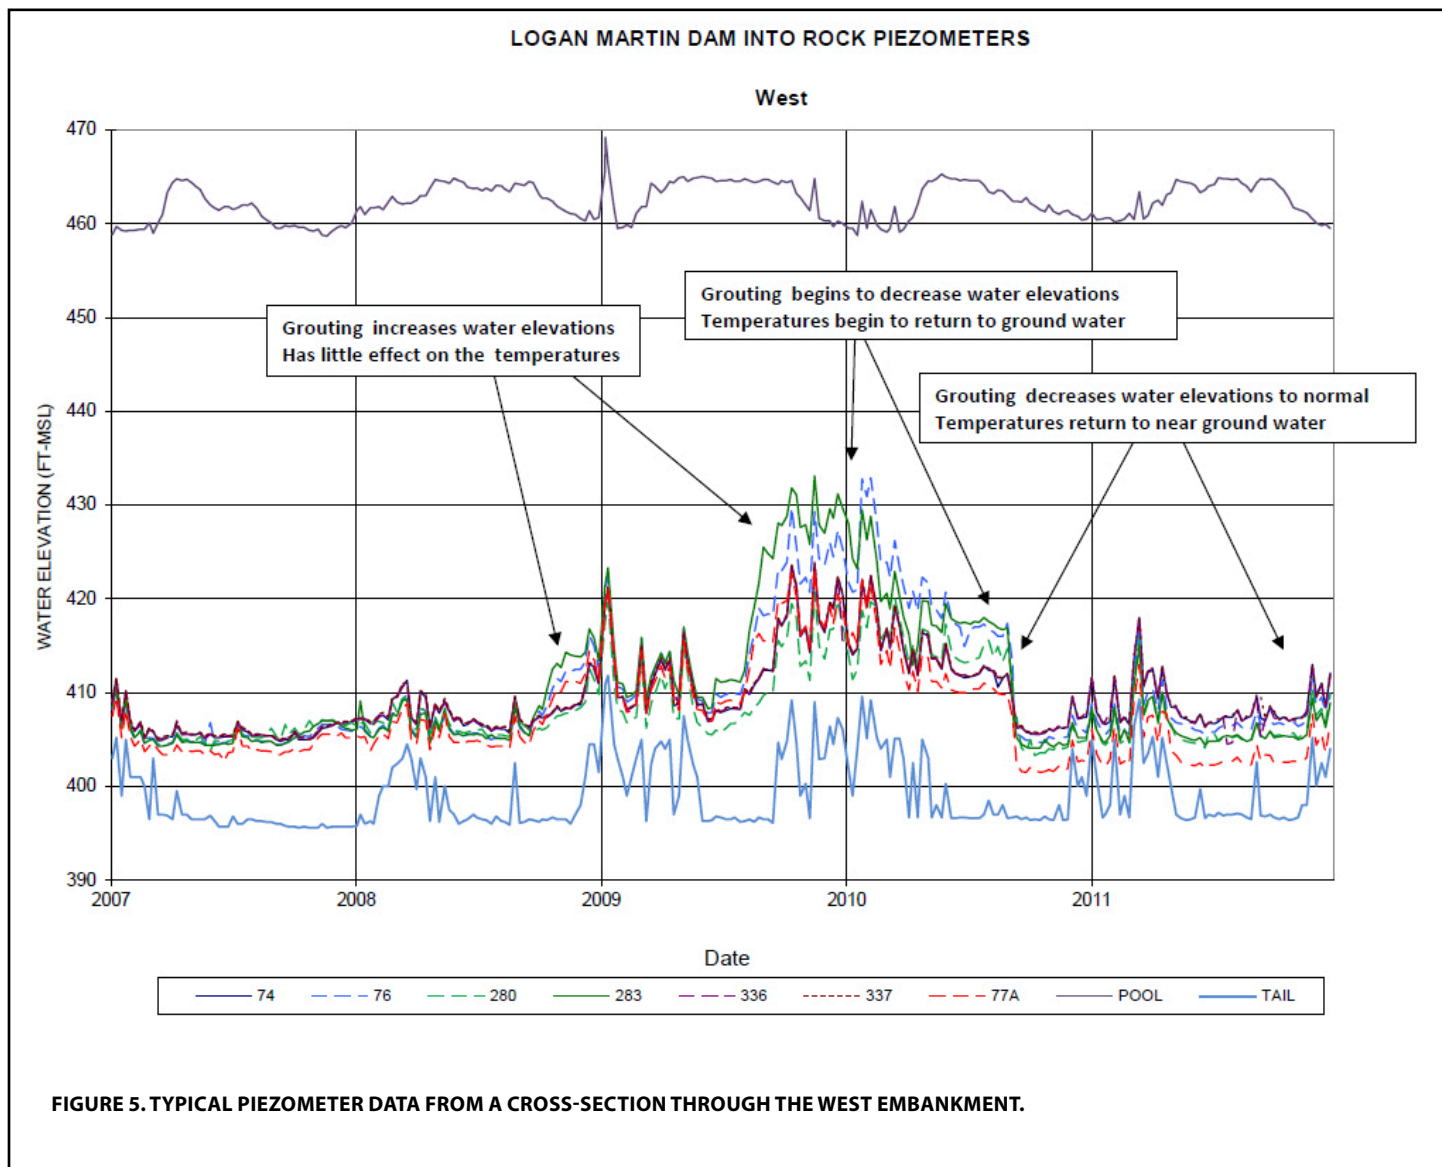
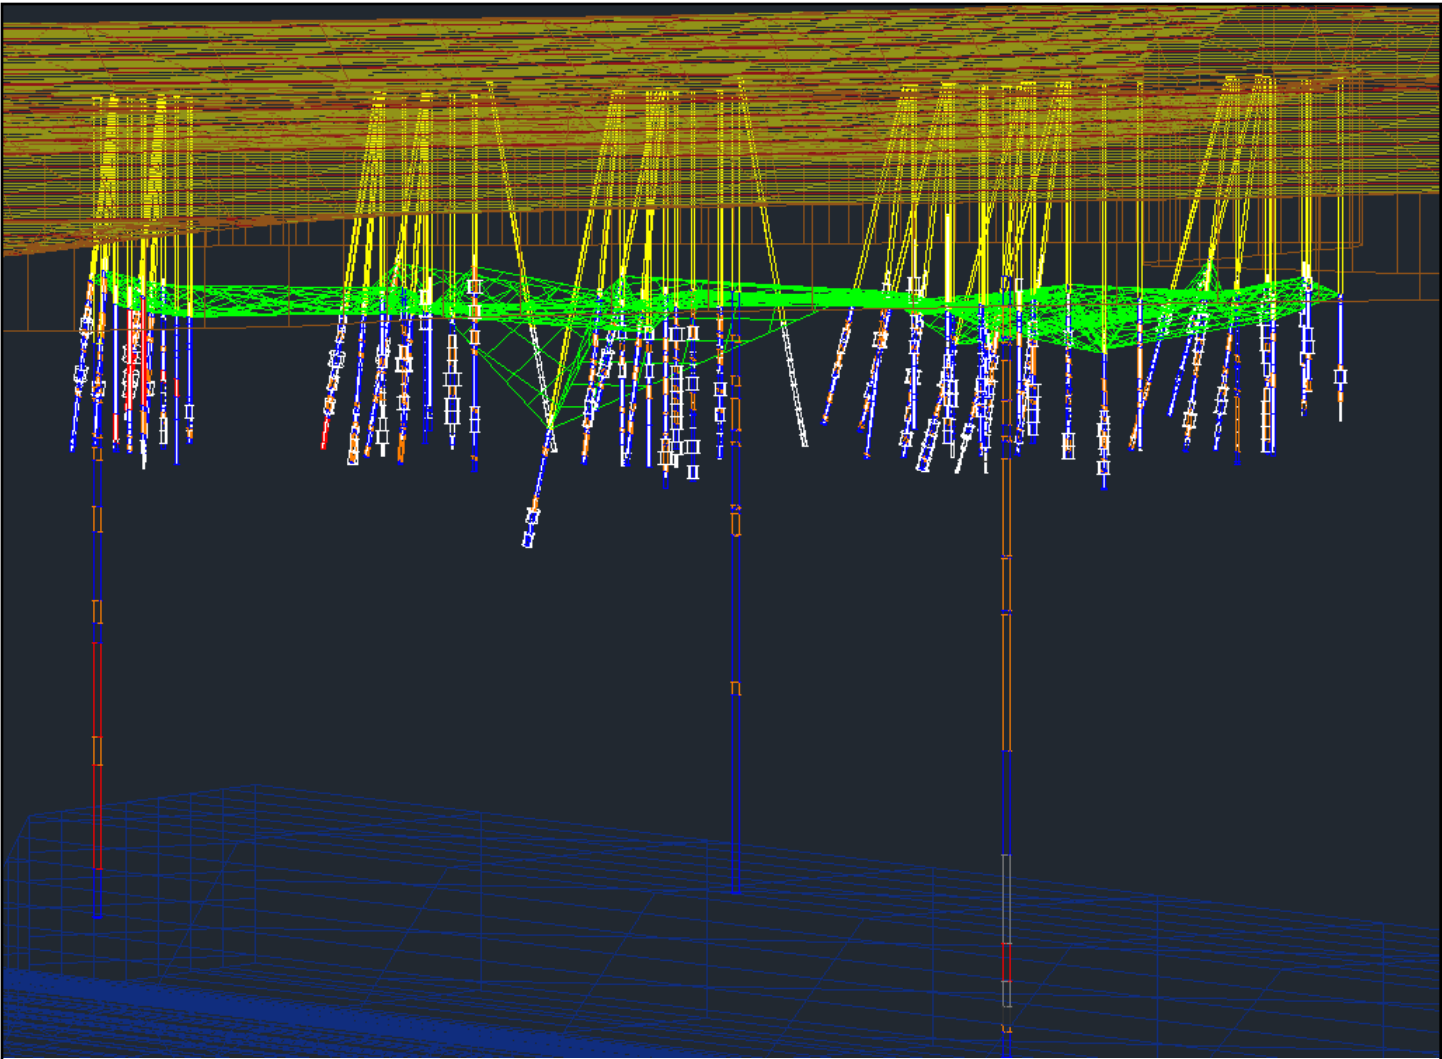
FIGURE 7. 3-D GEOLOGIC MODEL IMAGE BASED ON COMPLETED DRILLING AND GROUTING BENEATH THE EAST EMBANKMENT TOE. (NOTE TOP OF ROCK DEPICTED IN BRIGHT GREEN.)
