# Unique Use of Grout Column Support of Karst Features below Logan Martin Dam, AL

Findlay, R.C., Findlay Engineering; Greene, B.H., Consultant; Bruce, D.A., Geosystems, L.P.;  
Williams, B.E., Southern Company Services; Williams, J.H., Southern Company Services;  
Mickwee, R.L., Southern Company Services.

## I. PROJECT DESCRIPTION AND GEOLOGY

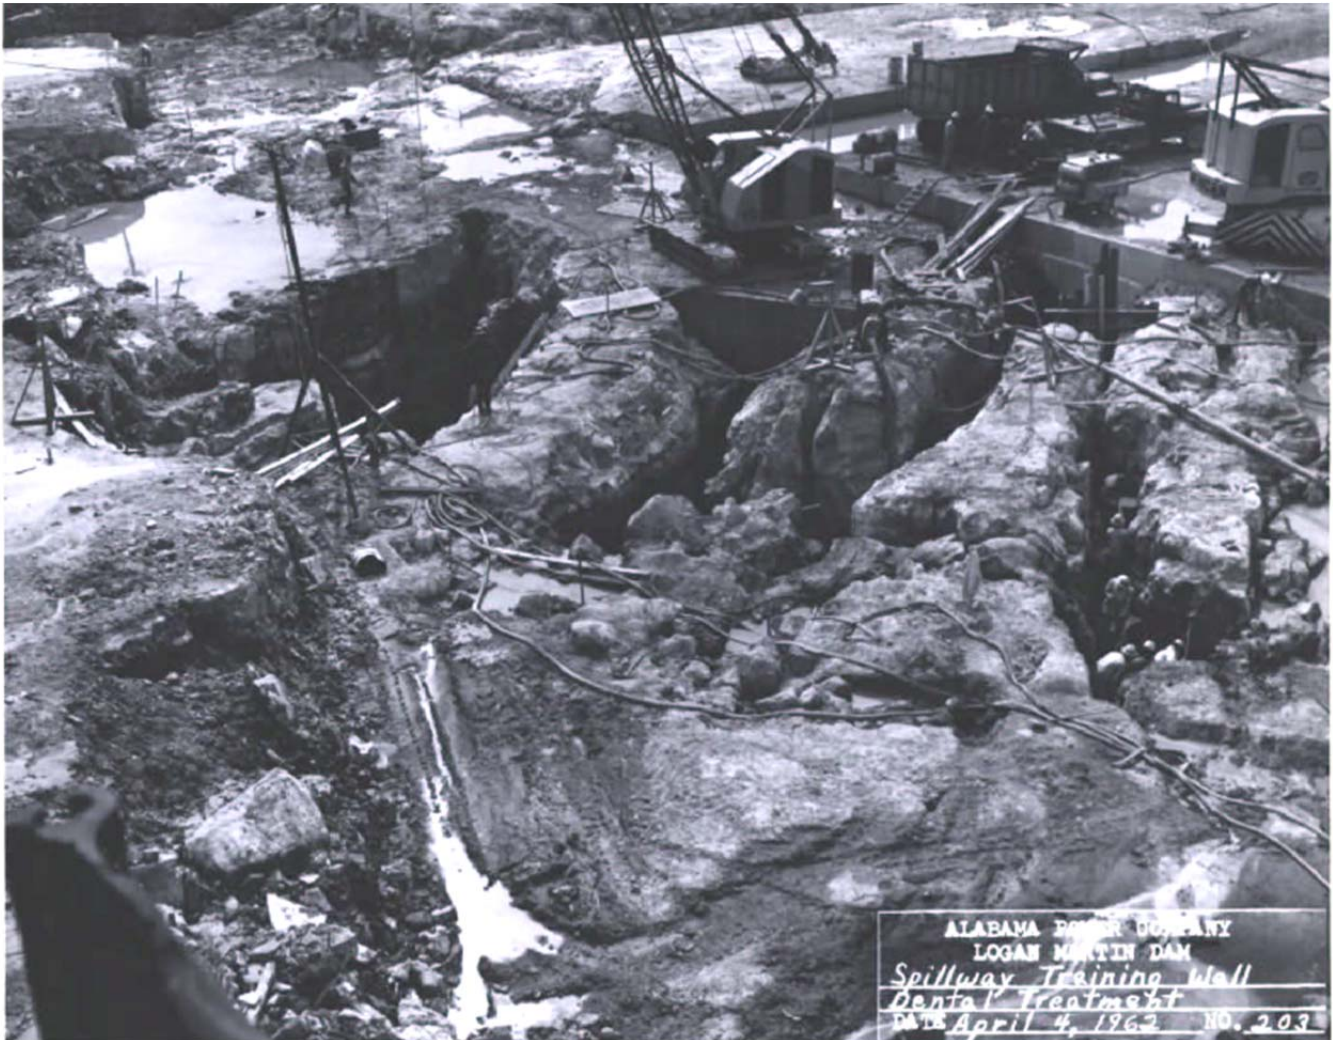
In the tailrace of the dam is a tight, doubly plunging syncline that can be observed at low outflow conditions. The foundation beneath the dam and reservoir is part of a large fault block that overlies a prominent thrust fault. Three thrust faults and a series of near vertical normal faults have been identified at the dam site. The most prominent of these faults has been termed locally as the "target zone fault" which strikes N72°E and crosses the east embankment of the dam (Robinson and Williams, 1997). Locally the faults often serve as structural boundaries that affect the flow of water under the dam. Overprinted on the rock structure is a series of joints. A N85°E to 75°W vertical joint set is linked with the formation of conduits and this joint orientation closely parallels vertical faults at the site. The presence of well-developed solution weathering along these joints presents clear evidence that they are preferred hydraulic flow paths for water, especially where they intersect highly permeable limestone layers (Robinson and Williams, 1997). A photograph of showing well-developed solution features that were revealed during construction is presented as Figure 3.

Figure 3. Well Developed Solution Features Revealed During Construction

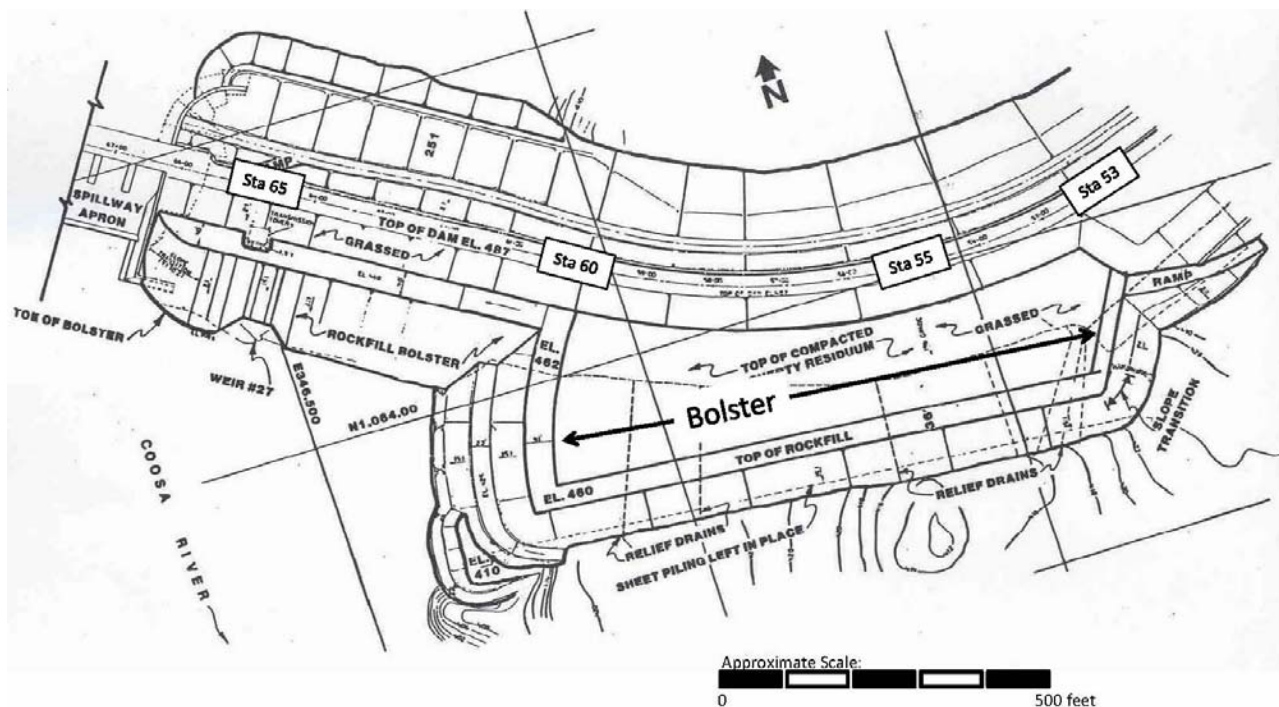
Figure 4. Plan of Bolster Area with Stationing

In 2012, Alabama Power Company/Southern Company Services (APC/SCS) was conducting a grouting program at what was referred to as the E-line, in the dam and foundation upstream of the bolster area. The Weir 15 section of the E-line grouting had progressed to a point where further definition of the rock at depths greater than 328 feet (100 m), mapping of geology downstream of the dam, and identification of potential flow conduits was desired. Additional deep into-rock piezometers were drilled downstream of the dam on the bolster to provide additional information and future grout monitoring instrumentation. Difficulties in setting casing into the rock surface, communications of pressure and drilling fluid between drill holes and other instrumentation prompted further investigation into the condition of the upper bedrock beneath the downstream half of the dam. The interval of drilling difficulties coincided with a zone of ongoing crest settlement between dam Stations 53+00 and 60+00 (Figure 4) that had been noted in deformation monitoring, adding to the concern of this newly identified area. A review of historic drill log data, framed in reference to the recent drilling data and the communication anomalies, led APC/SCS to reach the conclusion that additional protection was needed to mitigate the potential of sinkholes developing along this section of the downstream shell of the dam. This interval of concern coincides with the interval referenced above as the bolster, and was estimated to be approximately 700 feet (212 m) along the axis of the dam and about 150 feet (46 m) wide. The initial borings through the untreated upper bedrock zone found it to be about 50 feet (15 m) thick, consist of about 30% voids (filled and unfilled), and that it seemed underlie a relatively thin "roof" of competent rock.

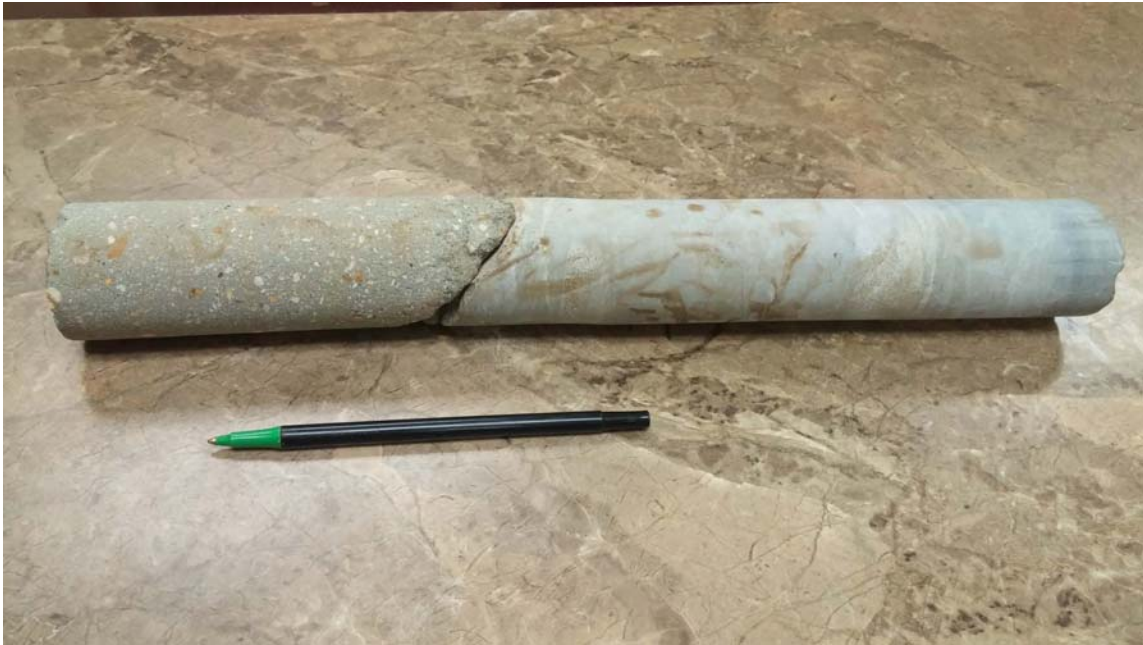
The cores from the exploratory holes were observed by the BOC. The grout could clearly be seen to fill the extensive void areas, and a significant amount of intact rock core was retrieved (see Figure 7). A couple of intervals of apparent void (one three feet or 0.9 m thick) were encountered. The BOC believed these "voids" were likely filled with soil material that was washed out during the core drilling process. If these were truly empty voids, the grouting would have been expected to have filled them. The reduction in column strength represented by such a void is believed to be made up for by the higher strength of rock making up the walls surrounding or adjacent to the void. Based on the information presented at the meeting, the BOC concluded that discrete columns of LMG/rock are being built in the ground, since there are no systematic reduction ratios between the successive phases of holes, and there is no evidence from the piezometers that this extremely permeable horizon is being systematically sealed.

Figure 7. Photo of Rock Core and Grout Encountered in Drilling through Column Locations

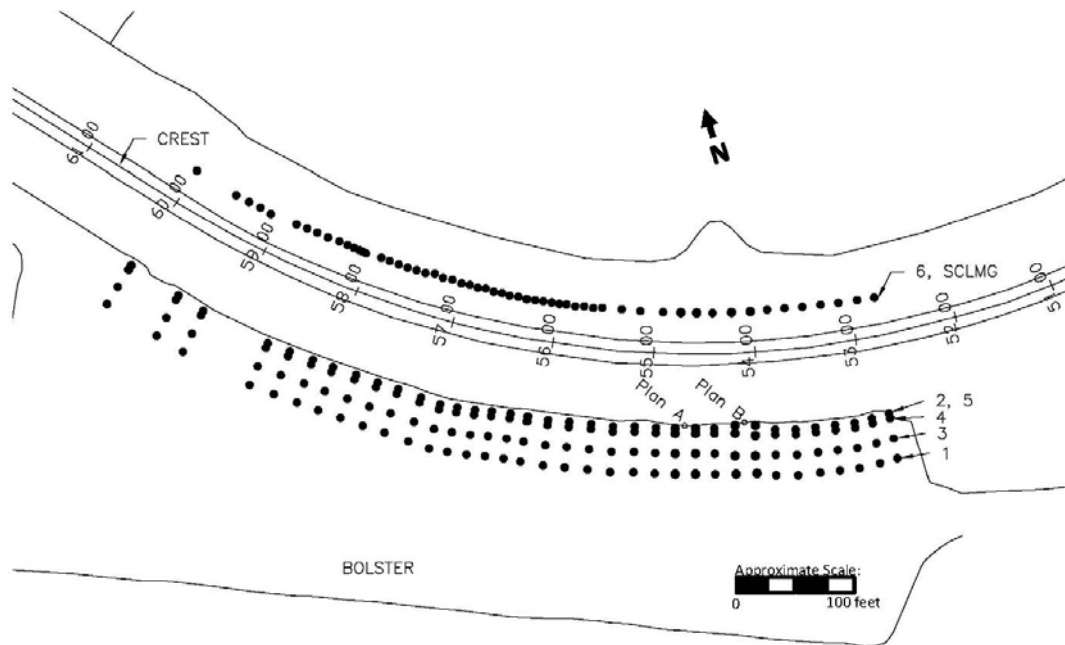
Figure 9. Final Plan of LMG Column Locations at Ground Surface as Constructed (Black Dots)

The production work proceeded without significant incident, since most of the bugs were worked out during the test section phase of work. At the completion of the work, 263 column locations were grouted. Prior to grouting, each hole was evaluated based upon available data such as the location and number of cavities (whether or not the cavities were open or mud filled) void ratio, and number of stages. A total of 2,156 cubic yards (1,648 cu m) of low mobility grout has been injected into the formation. The average grout take at each column location was 8.2 cubic yards (6.3 cu m). A total of 36 stations were treated along the downstream bolster. Each station was spaced on twenty foot (6.1 m) centers spanning from Station 52+70 to Station 60+00. In general, each station consisted of 5 holes; 2 angle holes and 3 vertical holes. The number of holes per station varied inside the batch plant due to existing structures. There were a total of 185 holes treated downstream with a total of 1,791 cubic yards (1,369 cu m) of grout.

In addition, there were 78 grout holes drilled from the upstream work berm. As noted above, these holes were angled downstream 16 and 12.5 degrees. Few split spacing holes were needed since grout takes were small. The total amount of grout injected along the upstream work berm was 365 cubic yards (279 cu m), significantly less than the downstream side of the crest. The most likely reason for the reduction was the influence of the previous grouting along a previously installed line of grout holes, referred to as the E-line. A complete layout of the LMG columns is shown on Figure 8.
