Long-Term Grouting of a Karst Foundation at Logan Martin Dam, Alabama

Donald A. Bruce¹, Brian H. Greene², R. Craig Findlay³,
Bobby E. Williams⁴, John H. Williams⁵ and Richard L. Mickwee⁶

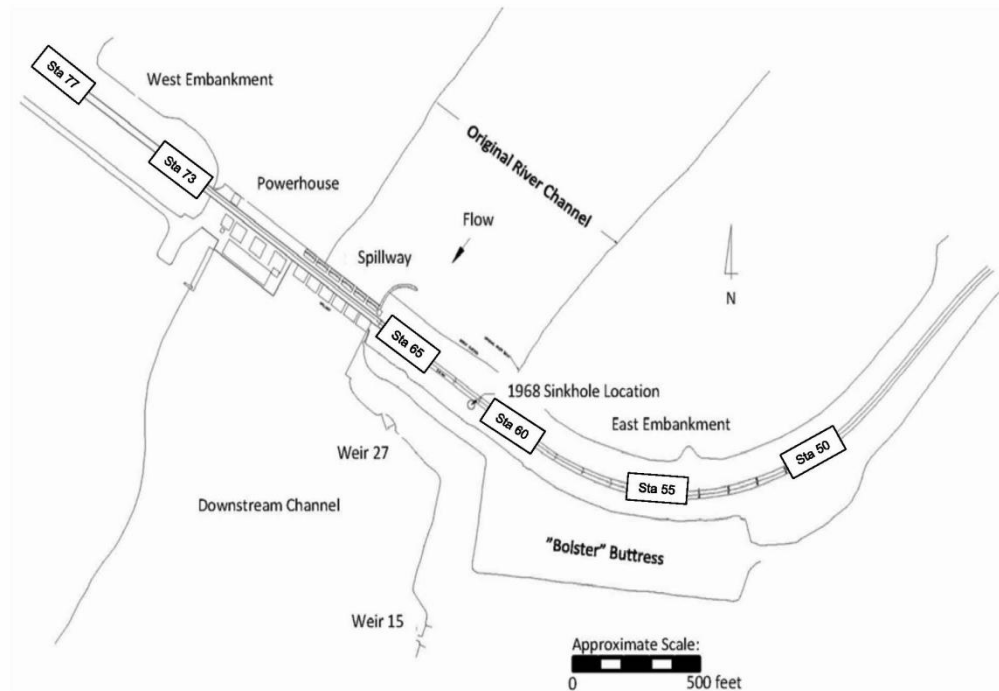
Figure 1. Project Layout Plan View (not to scale), showing stationing, and the locations of Weirs 15 and 27, the 1968 sinkhole, and the “bolster” buttress.

Immediately upon initial filling of the reservoir in 1964, mud flows were noticed downstream of the eastern embankment. Boils also began forming in the tailrace area. In June of 1966, seepage was noted at the toe of the east embankment. Weir 27 was built to monitor flow at that point. On February 23, 1968 the weir began discharging mud. For a period of 40 days mud flows were observed. On April 9, 1968 a sinkhole approximately 6 m in diameter and 16 feet deep opened just downstream of the east embankment crest and was referred to as the “chimney sink.” Immediate action was taken by site personnel to shut down the roadway across the dam and backfill the sinkhole. This sinkhole was a clear manifestation of the karstic conditions at the site and had the clear potential to fundamentally threaten dam safety. Numerous holes were drilled surrounding the sinkhole to determine its extent. In addition, piezometers were installed across the site to further monitor water levels and temperatures. The sinkhole event also highlighted the need for further grouting programs.

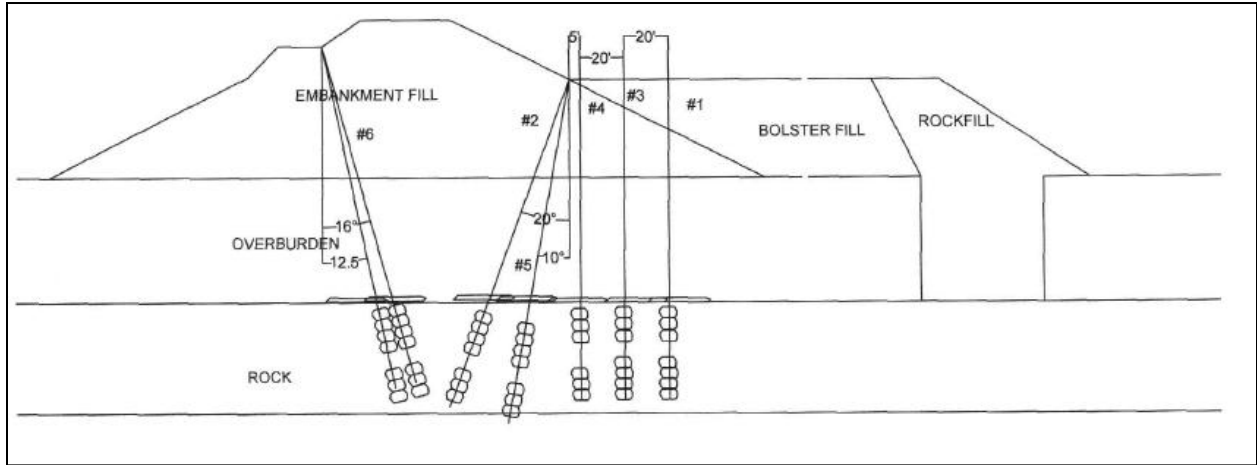
Difficulties in setting casing at the rock surface, communications of pressure and drilling fluid between drill holes and other instrumentation data prompted further investigation into the condition of the upper 15 m of rock beneath the downstream section of the east embankment (Figure 1). A review of historic drill log data, framed in reference to the recent drilling data and the communication anomalies, led APC/SCS to the conclusion that additional protection was needed to prevent the formation of sinkholes along this section of the dam.

Figure 2. Final Configuration of LMG Column Layout at Each Station (not to scale).

The Board of Consultants recommended a corrective measure utilizing LMG grouting techniques to construct discrete grout columns to partially fill the voids while providing structural support of a thin “roof” of competent rock. Since the grouting would be performed on the downstream side of the dam, the grout injection process had to be conducted in such a manner as to not change the piezometric levels or potential flow directions of any shallow leakage within the upper 15 m of rock so as not to increase pore pressure and affect embankment stability. Therefore, a test program was conducted to develop the grouting plan and ensure that the required outcome could be achieved.

The initial test section consisted of four grout holes per row. With the exception of the angle holes, each hole was spaced 6.1 m apart. The grout holes were drilled to a depth of 46 m using Wassara water-powered down-the-hole hammer (WDTH) drilling methods. Using a low mobility grout (LMG) supplied by a local ready mix company, the upper 15 m of rock at each grout hole location was grouted in 1.5 m stages. Refusal criteria were either a maximum pressure (gage pressure minus line pressure) of 1,724 kPa or 3.8 m³ of grout per stage. The objective was to form approximately 1.5 m diameter columns. At the interface of the overburden and the top of rock, the grout mix was adjusted to a higher slump to form a “mushroomed” cap along the top of rock wider than the grout columns. The wider cap formed at the top of each grout column was placed to provide support to the base of the embankment.

Based upon the information gathered during the initial test section, the test program was extended to include rows of grout holes spaced on 6.7 m centers along the area of concern. Two additional angle holes were added from the upstream berm at each location to improve the treatment under the dam crest. A total of 1,648 m³ of LMG has been injected into the formation into 263 columns. Typically the take at each column location has been 7 to 8 m³ which correlates to a 27 percent void ratio within the treatment zone. The as-built configuration is shown in Figures 2 and 3.

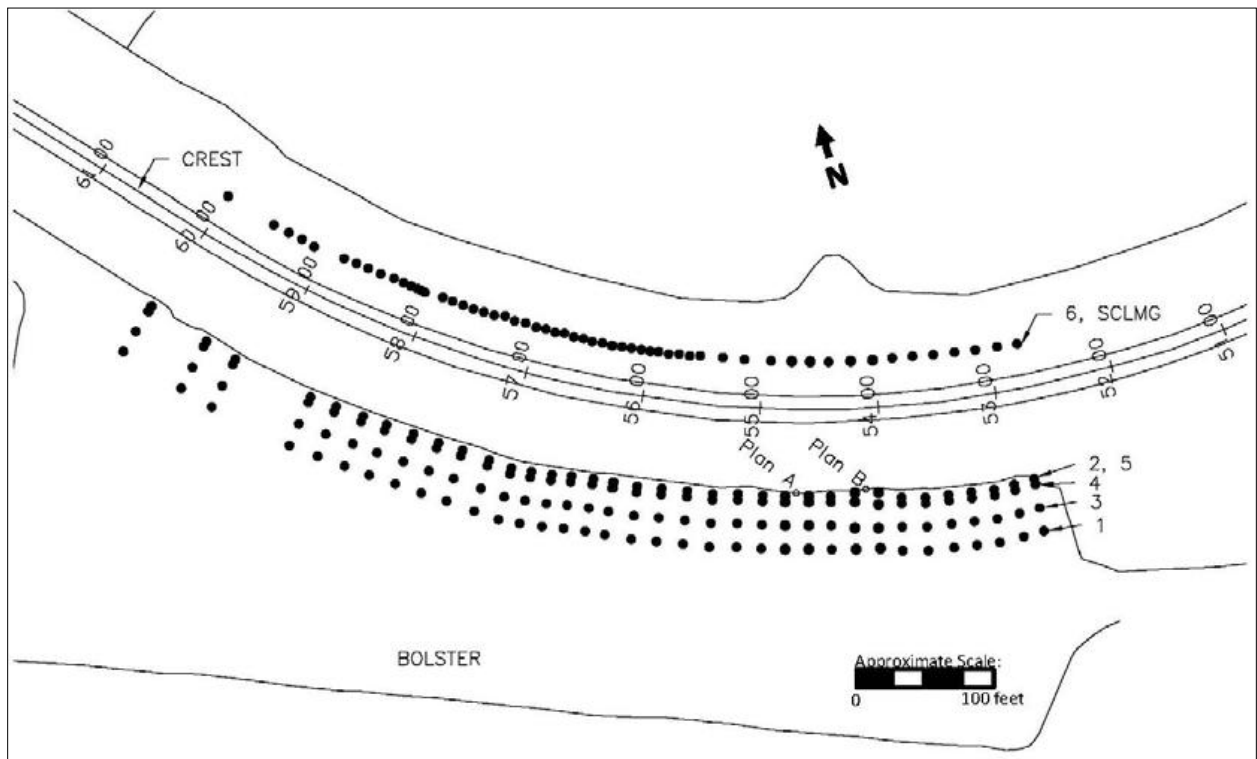
Figure 3. Final Plan of LMG Column Locations at Ground Surface as Constructed (black dots).
