**21ST CONGRÈS
DES GRANDS BARRAGES
Montreal, 2003**

SEEPAGE EVALUATION AND REMEDIATION UNDER EXISTING DAMS

2. SETTING OF ARAPUNI DAM, NEW ZEALAND

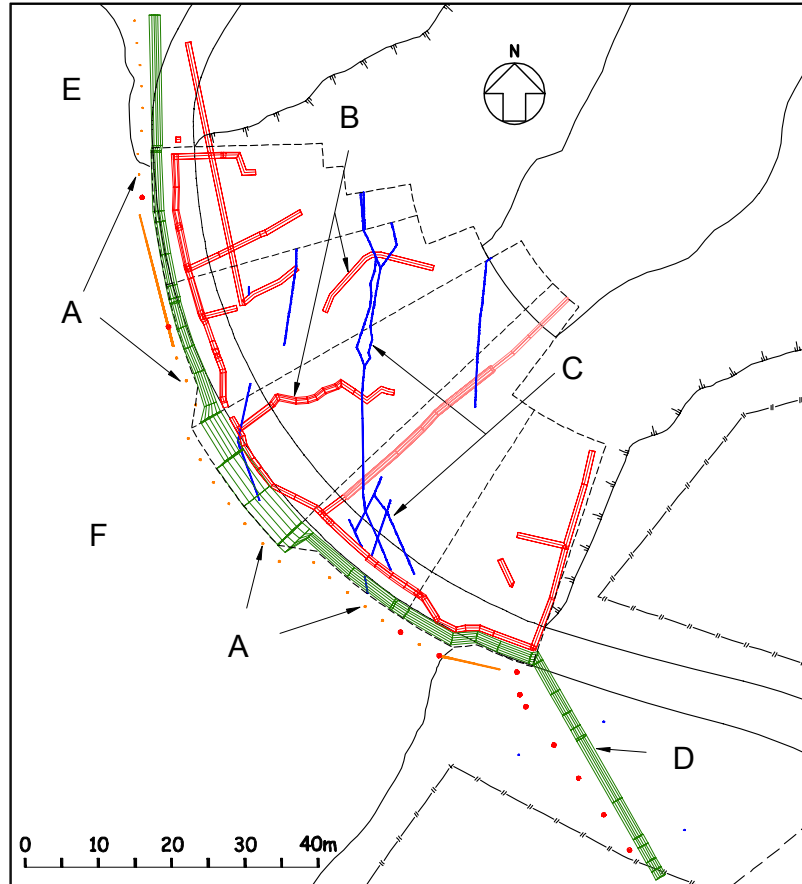
Figure 1. Plan view of Arapuni Dam, New Zealand. The position of the foundation defects (“the feature”) as determined during construction is shown. The diversion tunnel curves to the south of the cut off wall.

There was no blanket grouting, curtain grouting or drainage curtain in the dam foundation as originally constructed. The grout curtain constructed during the 1929-1932 lake lowering was a vertical single row curtain with holes at 3m centers. It was constructed just upstream from the dam and cutoff walls, and was not structurally connected to them (Figures 1, 2, and 3). In the valley

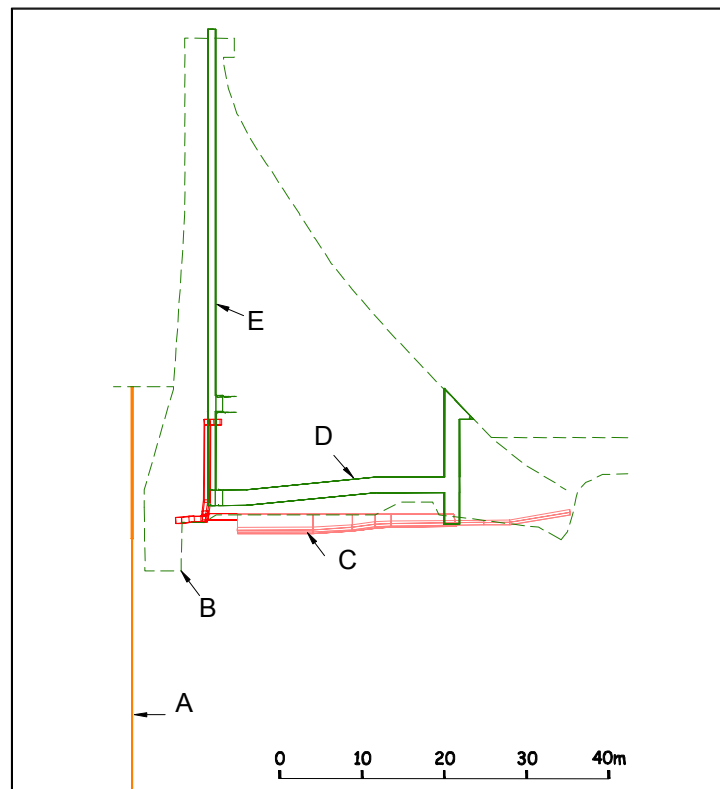
The dam is founded directly on the Ongatiti Ignimbrite with a cutoff trench located at the upstream face of the dam and a circumferential porous concrete drain located downstream from the cutoff. Some additional, similar contact drains are located along or across the fissures. A series of radial drains conduct drainage flows to the downstream face of the dam where the flows are monitored by weirs (Figure 3).

Figure 3. Cross section of Arapuni Dam, New Zealand.

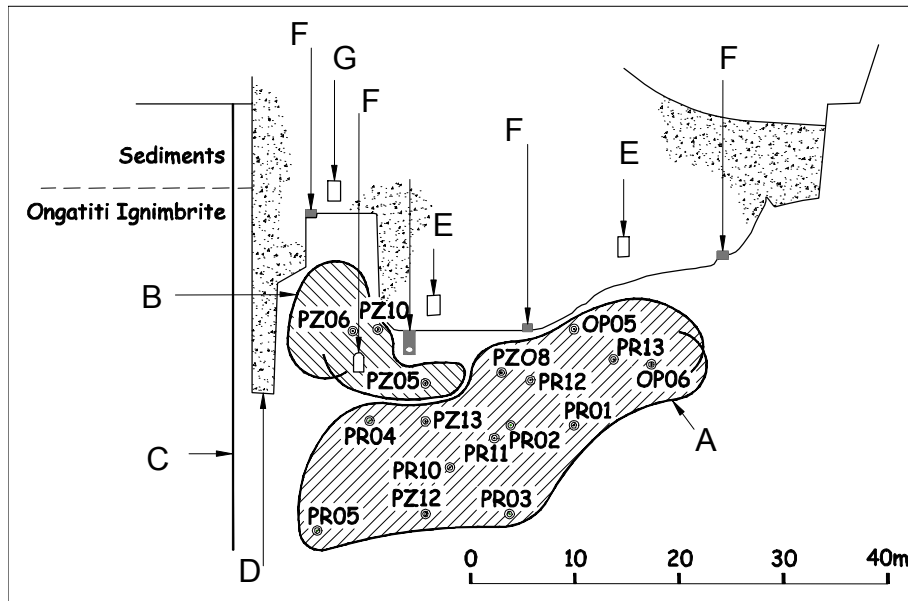
Figure 4. Elevation of defect showing intersections by investigation and grout holes drilled from the galleries and the downstream face.

- High piezometric pressures were only observed in some parts of the feature (Figure 4) and had little effect on the adjacent foundation. They were not present in the other mapped foundation cracks.
- OP06 flows were carrying bitumen fragments, clay fragments from the fissure, snails (small), and lake biota.
- Dye traces were observed in drainage flows from releases in the lake, the headrace channel, right abutment boreholes and the diversion tunnel. Average dye velocities in the rock foundation were typically between 0.8 and 2.0 m/minute. Special attention was devoted to analyzing and rationalizing

- The high pressure area of the defect averaged about 80 mm in width.
- The hydraulic connection between the dam drains and the feature was probably limited to a porous drain contact near OP05 (Figure 4).

Grouting was planned and initiated once the primary seepage investigations were complete and additional relief wells and grouting holes were drilled into the high pressure area of the fissure (Figure 4). The grouting plan required that upstream relief wells would be used during the grouting operation to lower fissure water pressures such that the added pressure of the grout injection would not exceed previously observed pressures in the fissure. This minimized the risk of infill blowout and increased downstream leakage.

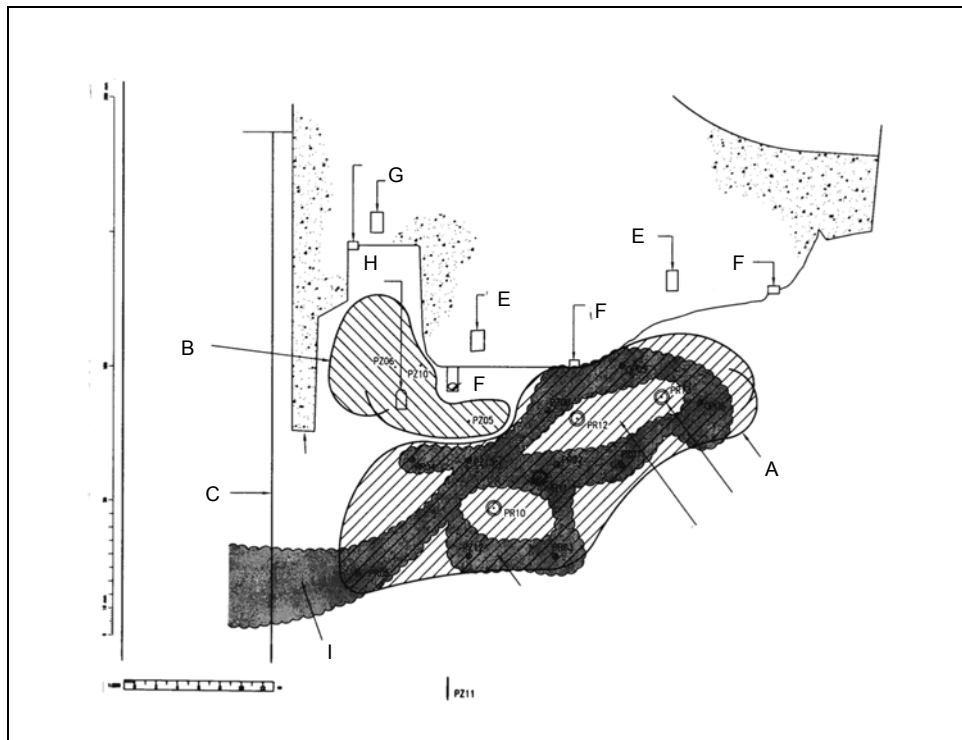
Four holes drilled into the grouted area retrieved drill core showing three natural infill zones and one grouted zone. The grouted zone had good quality grout across the fissure with only minor surface traces of clay infill against the fissure sides. This drilling, combined with the other data and observations, led to the development of a model for envisioning the treated feature (Figure 5).

Figure 5. Conceptual interpretation of the grouted feature conditions after treatment.
