# **HIGH PRESSURE SEEPAGE AT ARAPUNI DAM, NEW ZEALAND A CASE HISTORY OF MONITORING, EXPLORATION AND REMEDIATION**

## **ABSTRACT**

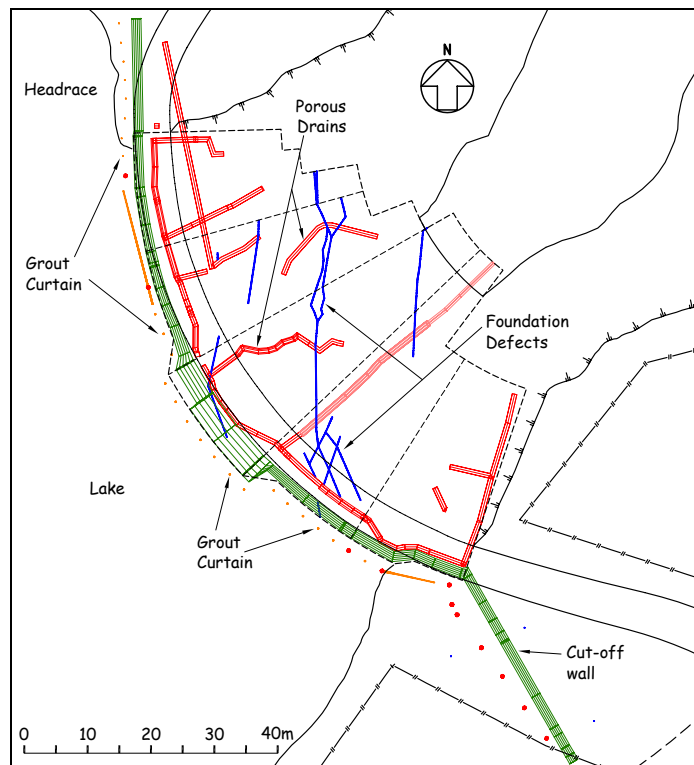
Figure 1. Plan view of Arapuni Dam, New Zealand. The position of the foundation defects (“the feature”) as determined during construction is shown. The diversion tunnel curves to the south of the cut off wall.

The Ongatiti Ignimbrite in the dam foundation is a very weak, coarse pumice breccia with an unconfined compressive strength of between 1 and 5 MPa. Joints are rare, subvertical where present, and spaced at greater than 6m. A set of three sub-parallel cracks or fissures (Figure 1) were recorded on the dam foundation as-built drawings forming a feature that runs obliquely across the foundation from the upstream right abutment to the downstream left abutment.

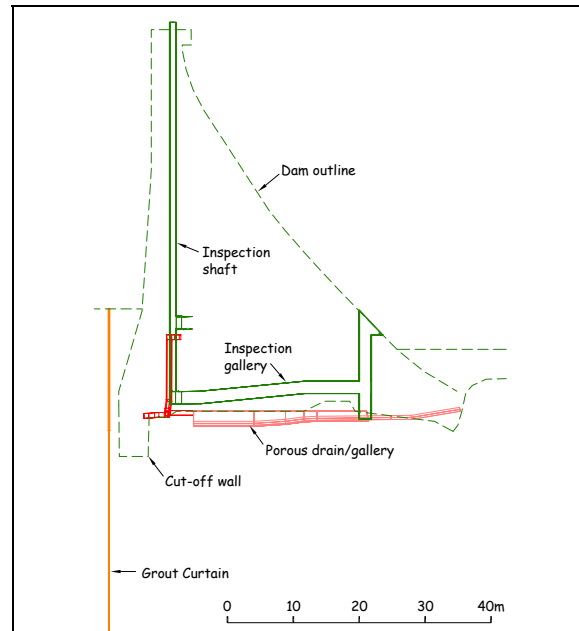
Figure 3. Cross section of Arapuni Dam, New Zealand. (Note the spatial separation of the original grout curtain from the dam or its concrete cutoff.)

There was no blanket grouting, curtain grouting or drainage curtain in the dam foundation as originally constructed. The grout curtain constructed during the 1929-1932 lake lowering was a vertical single row curtain with holes at 3m centers. It was constructed just upstream from the dam and cutoff walls, and was not structurally connected to them (Figures 1, 2, and 3). In the valley bottom, a fill platform for drilling was constructed above the river level and the grout curtain was constructed through the fill. In the steep gorge walls a bitumen plug was constructed between the dam and the gorge wall interface. Grouting was by descending stages with grout injection undertaken at points of lost drill water return. Injection pressures and grout takes were modest with an average

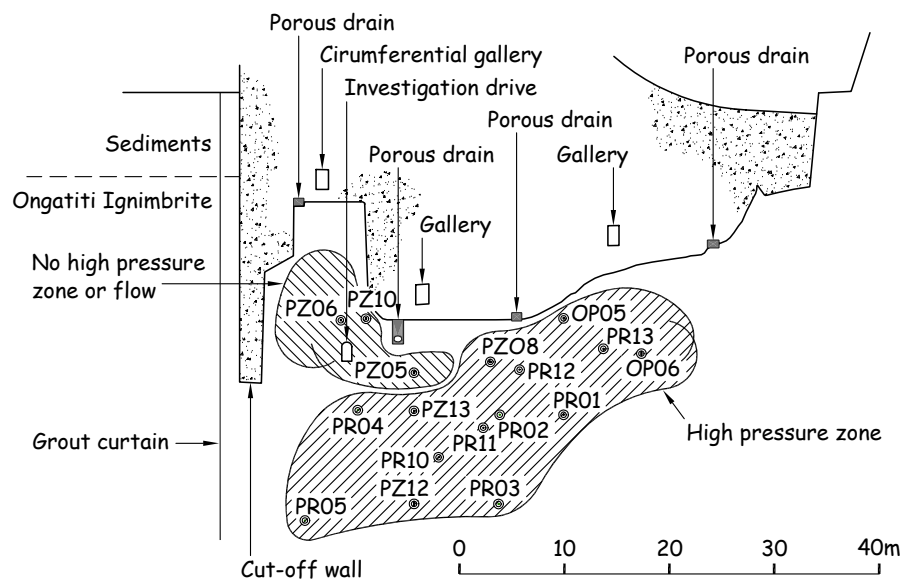
Figure 4. Elevation on defect showing intersections by investigation and grout holes drilled from the galleries and the downstream face.

- High piezometric pressures were only observed in some parts of the feature (Figure 4) and had little effect on the adjacent foundation. They were not present in the other mapped foundation cracks.
- OP06 flows were carrying bitumen fragments, clay fragments from the fissure, snails (small), and lake biota.
- Dye traces were observed in drainage flows from releases in the lake, the headrace channel, right abutment boreholes and the diversion tunnel. Average dye velocities in

- The high pressure area of the defect averaged about 80 mm in width.
- The hydraulic connection between the dam drains and the feature was probably limited to a porous drain contact near OP05 (Figure 4).

Grouting was planned and initiated once the primary seepage investigations were complete and additional relief wells and grouting holes were drilled into the high pressure area of the fissure (Figure 4). The grouting plan required that upstream relief wells would be used during the grouting operation to lower fissure water pressures such that the added pressure of the grout injection would not exceed previously observed pressures in the fissure. This minimized the risk of infill blowout and increased downstream leakage.

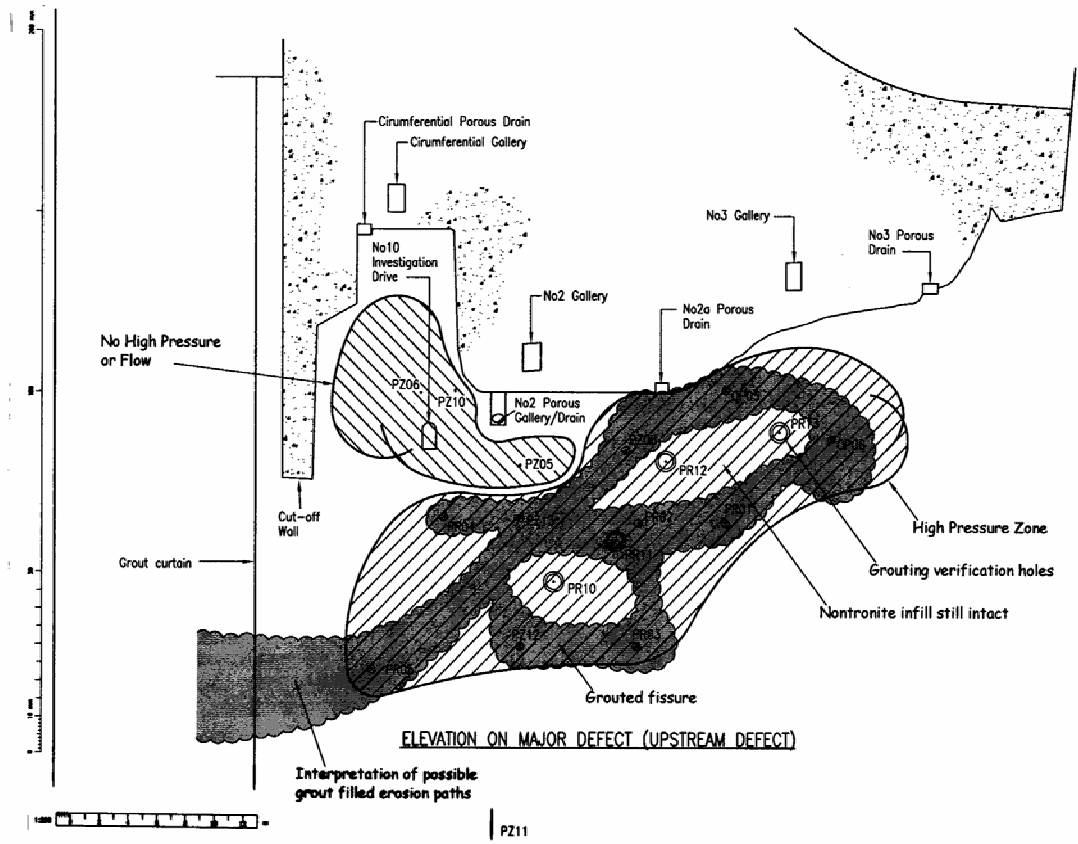
Four holes drilled into the grouted area retrieved drill core showing three natural infill zones and one grouted zone. The grouted zone had good quality grout across the fissure with only minor surface traces of clay infill against the fissure sides. This drilling, combined with the other data and observations, led to the development of a model for envisioning treated feature (Figure 5).

Figure 5. Conceptual interpretation of the grouted feature conditions after treatment.
