Quality Assurance Issues Related to the Installation of High Capacity Micropiles, Richmond-San Rafael Bridge Seismic Retrofit Project, California

Abstract

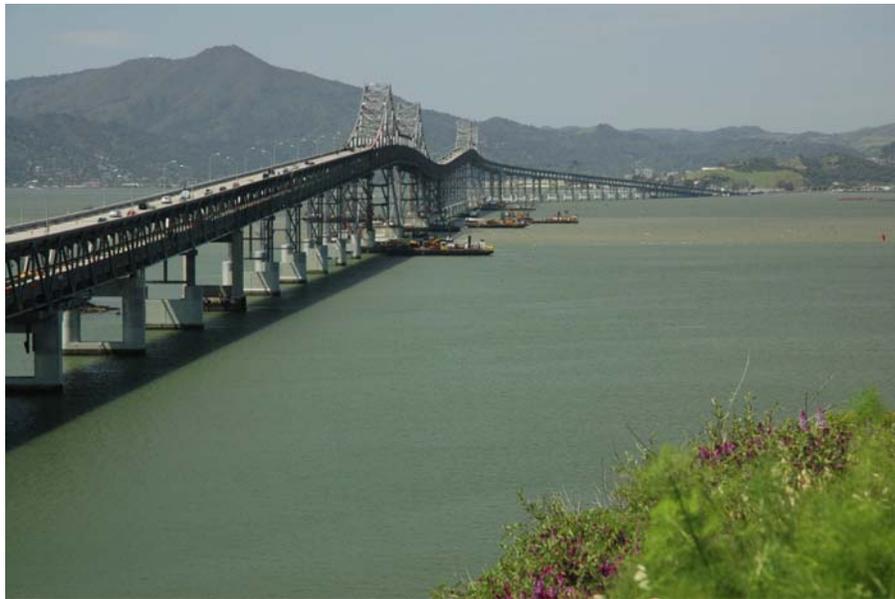
Figure 1. Richmond-San Rafael Bridge looking west across the San Francisco Bay toward Marine County, California.

The Richmond-San Rafael (RSR) Bridge is one of seven State owned and operated toll bridges in Northern California undergoing a major seismic retrofit ([Figure 1](#)). The bridge is a 5.5-mile-long cantilever and truss structure that spans the northern end of San Francisco Bay between Contra Costa and Marin Counties on California Interstate I-580. It opened in September 1956 and currently is used by about 56,000 motorists a day. The bridge was selected for retrofitting because of its high volume of use and close proximity to the San Andreas and Hayward faults. Both faults are within 10 miles of the RSR Bridge alignment and are believed to be capable of generating earthquakes of magnitude 7.5 or greater. In 1999, the original budget for retrofitting all seven Bay Area toll bridges was \$2.6 billion of which \$484 million was assigned to the RSR Bridge. The budget for the RSR Bridge has almost doubled since that time to an estimated \$914 million in August 2004.

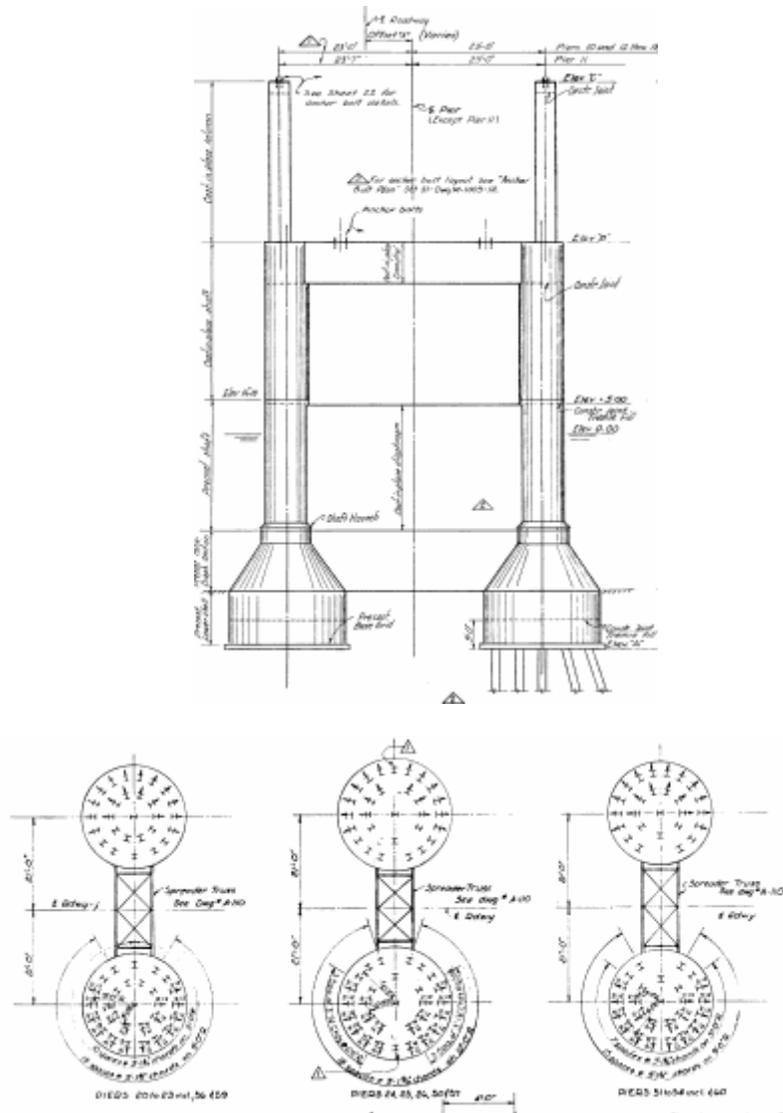
Figure 2. Typical profile view of two column pier with belled foundation and typical plan view of H-pile layout in driving template at base of bell (source: Caltrans, 1953 Richmond-San Rafael Bridge as-built drawings).

The bridge’s west approach is a concrete trestle supported on 37 bents. Moving east along the bridge, the trestle transitions to a double decked steel truss which constitutes the majority of the bridge alignment which is supported on 78 piers. Each pier is comprised of either two or four columns that are connected by concrete spandrel beams and diaphragm walls ([Figure 2](#)). Each column is founded on a precast concrete bell that is supported by driven HP 14x89 steel piles. The number of

steel piles supporting each precast bell ranges from 9 to 33 (typically two rows of H-piles per bell, both battered and vertical) with lengths ranging from 13 feet to 160 feet. The tops of the H-piles extend about 3 to 6 feet up inside the precast bells and the piles tip-out in Franciscan Formation bedrock. The prescribed micropile design required that micropiles be installed between the existing H-piles and that no existing H-piles be encountered either above or below the concrete bell during concrete coring or micropile drilling activities in order to maintain the integrity the original bridge foundation support. Only piers of two column construction were retrofitted with micropiles. The four column piers were retrofitted with 66 inch diameter cast-in-drilled-hole (CIDH) and 150 inch diameter cast-in-steel-shell (CISS) piles.

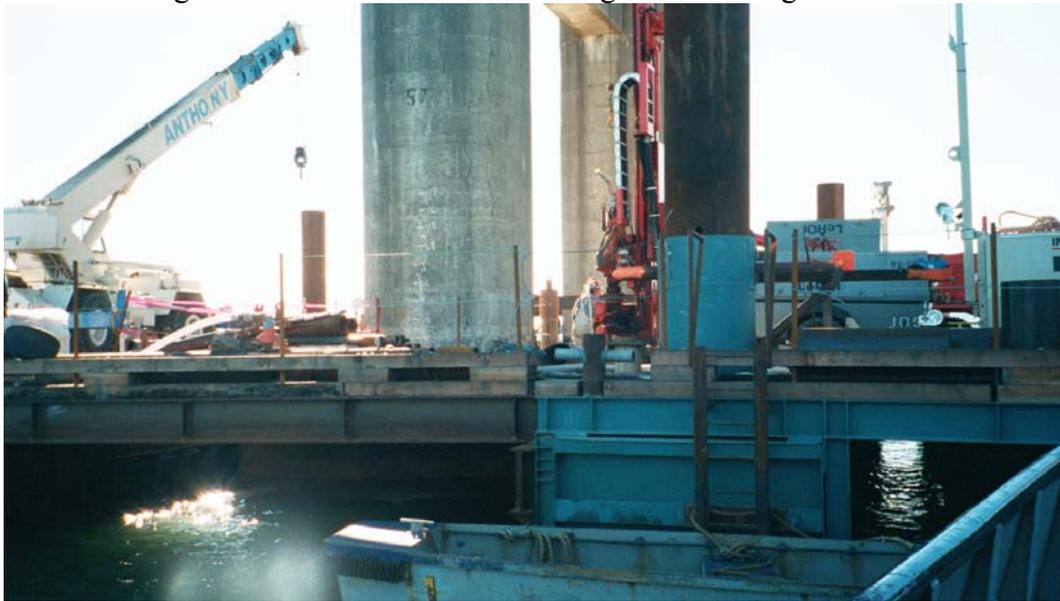
Figure 3. Pier 57 Production Pile work platform. The boat in foreground is docked in front of the metal frame with buoyancy tank that made up the majority of the work platform structure. The work platforms were pinned-off to 24 inch diameter driven pipe piles (shown in the background) at the highest tide to minimize the influence of tidal changes on platform motion. The pier's concrete columns are shown at the center of the picture.

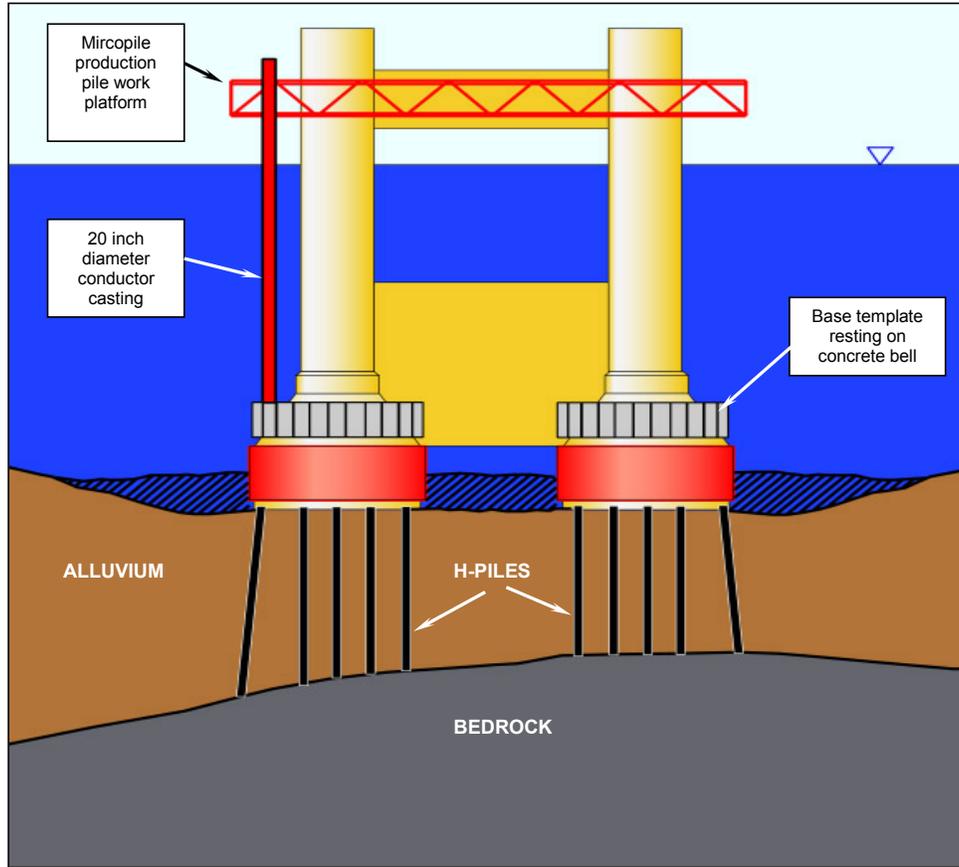
Figure 4. Schematic of micropile template resting on top of concrete bell with 20 inch diameter conductor casings extending up to deck level on the Production Pile work platform.

rest upon the upper inclined surface of the concrete bells but because of bells/column/diaphragm misalignment at most of the piers, it was more effective to hang the templates from the concrete columns at the work platform level. In either instance, the templates were positioned via an engineering survey that tied the template location to an underwater H-pile survey performed at the bottom of the bell. The theoretical horizontal clearance between the H-piles and coring equipment was about 3 inches horizontal distance as measured from the perimeter of the corehole. Roughly 40% of the micropiles were installed between existing vertical H-piles. Installations between vertical piles was of importance to the Owner in that undermining of existing H-pile tips (and foundation support) was to be avoided. Thus, the 12 inch diameter micropile casing tips between vertical H-piles were seated 10 feet below H-pile tips. These were referred to as “type B” micropiles in the Contract Documents. The remaining 60% of the piles were installed between battered piles. The Contract required shallower casing seatings for these piles, specifically a minimum of "zero feet and zero inch" embedment into the Franciscan Formation. These were referred to as “type A” micropiles in the Contract Documents.

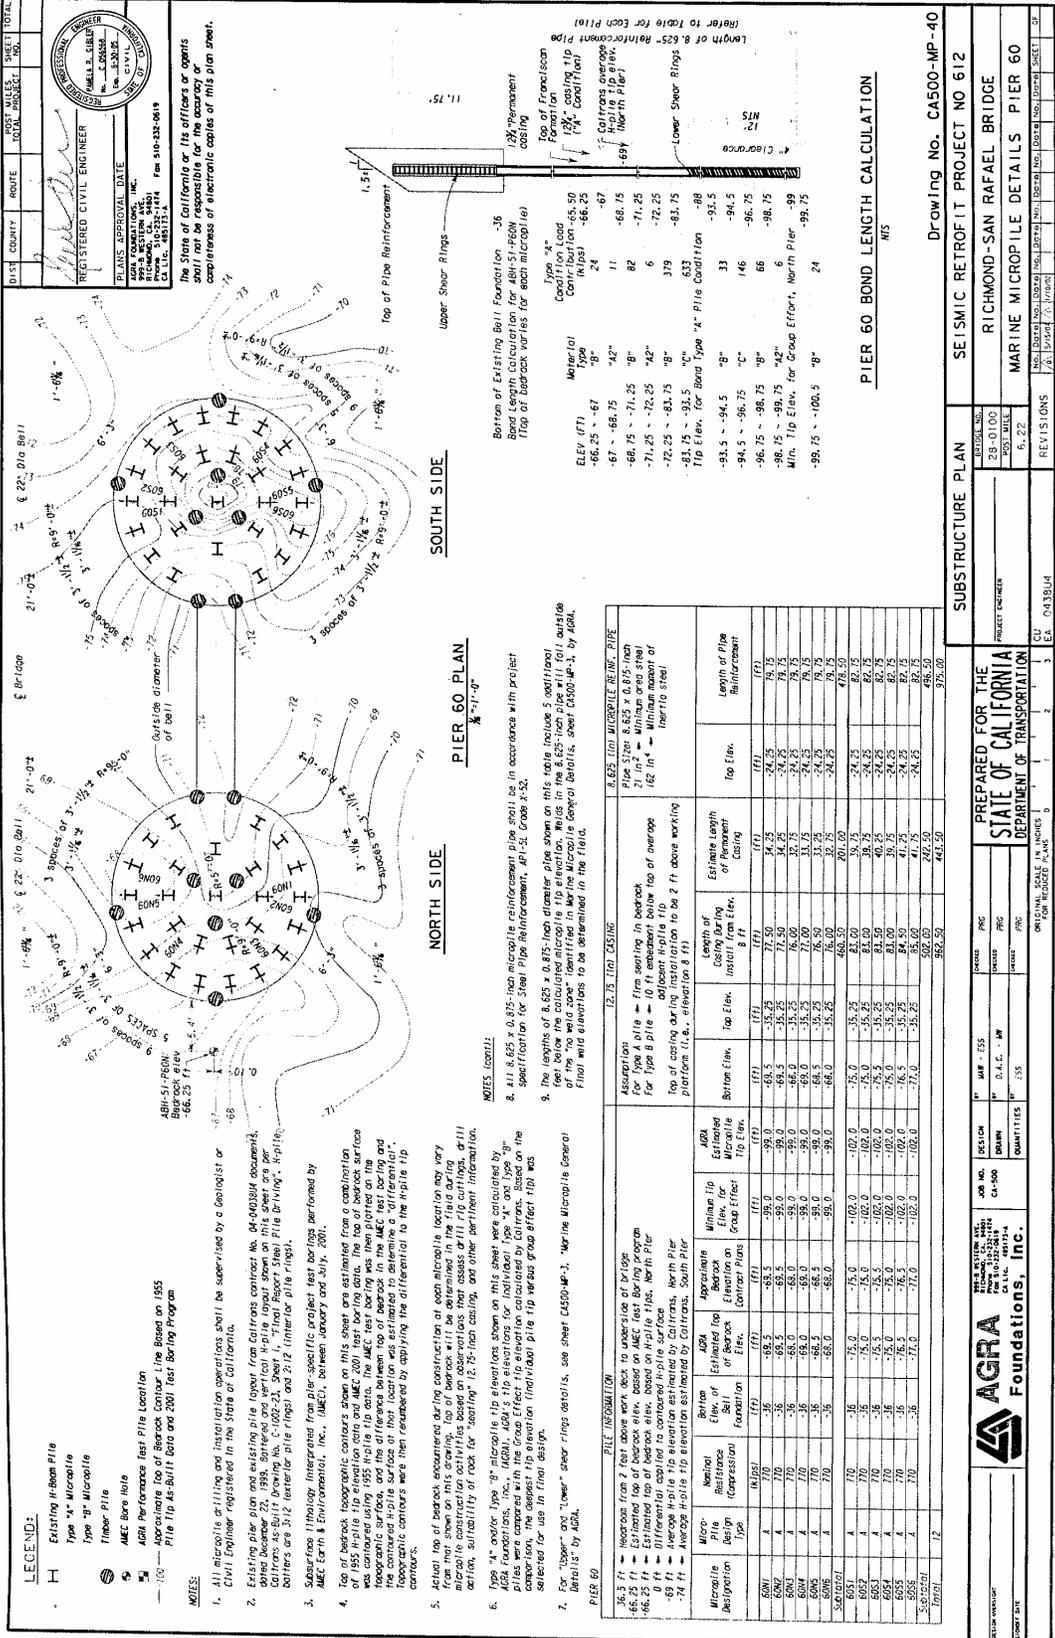
Figure 5. Typical Working Drawing: Pier 60.

The Working Drawings for micropiling construction procedures covered drilling, spoils and slurry containment, grouting, Performance Pile platforms and load frames, Proof Pile testing, production piling work platforms, and micropiling templates. The Drawings provided tabulated elevations for top and bottom of existing concrete bell, steel reinforcement, 12 inch casing, and rock socket. Figure 5 illustrates the complexity and detail involved in a typical pier. In addition, the Drawings showed top of bedrock topographic contours based on H-pile tip data, a schematic of subsurface conditions based on the post-contract Log of Test Boring, and a plan view of the north and south bells with the location and identification number of each micropile. A separate piling drawing was done for each pier. Because of variations in bedrock topography beneath each bell, essentially every micropile had a unique geometry in terms of elevations of steel reinforcement and rock socket tip. In the

field, the Micropiling Contractor used the approved Working Drawings as an estimate of micropile geometry. However, the actual subsurface conditions encountered ultimately dictated the as-built geometry of each micropile. For example, variations in where competent bedrock was encountered influenced where the 12 inch casing was seated while variations in rock quality influenced the length of the rock socket and also the length of the 8 inch or ATB reinforcement. The Working Drawings were useful in providing fairly accurate target elevations for anticipated construction. At the same time, the Micropiling Contractor had the latitude to modify the Working Drawing design for any of the micropiles based on actual subsurface conditions encountered.

To complete the Drilling Logs, the Micropiling Contractor assigned a field engineer or field geologist to each platform. Because the Micropiling Contractor was installing micropiles on up to three piers 24 hour per day, a total of six geologists/engineers were employed to document construction activities. The Drilling Logs documented lithology encounters, drill rates, drill action, quality of Franciscan Formation, and encounters of H-piles, wood piles, tree logs, and scour protection. The Logs included elevations of the top, bottom, and thickness of lithologic layers, top of Franciscan Formation, top of rock suitable for seating the 12 inch casing so as to effect both seat and seal, working shear load per layer, and cumulative shear load with depth. Cuttings were described typically on 0.5 to 10 foot intervals (depending on drill rate) and included percent sand/silt/gravel, grain size, color, Unified Soil Classification symbol, rock type, degree of weathering, and degree of fracturing. This information was assessed in real time to determine where rock suitable for seating and sealing the 12 inch casing was encountered and assign shear strength values to variable quality lithology encountered in the rock socket, as shown in Figure 5.

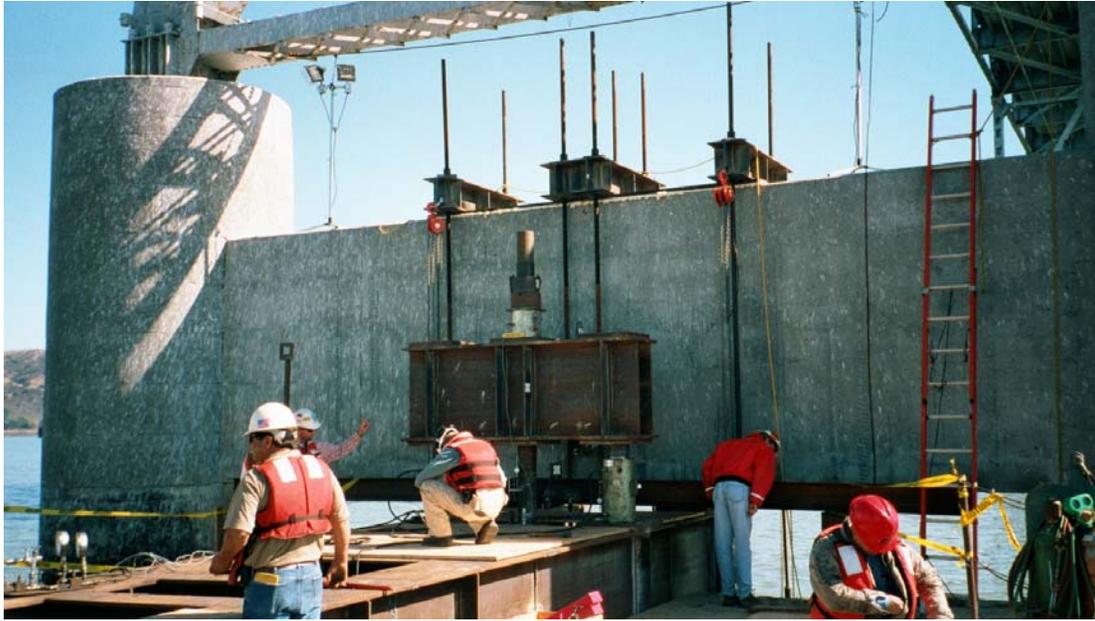
Figure 6. Performance Pile Load Test Setup

The load test system used for Performance load tests (as well as Proof load tests) on the RSR project consisted of a frame equipped with a horizontal reaction beam and two 600 kip jacks at each end of the beam ([Figure 6](#)). The reaction beam had a vertical port at its center through which the pull collar on the micropile was positioned. A load cell was secured at the top of the pull collar so that the base of the load cell was flush with the top of the reaction beam. Initially, one extensometer was installed to measure total vertical movement of the micropile. Later in the testing program, an additional extensometer was included in each load test so that a total of two extensometers recorded elongation data. In addition, between 4 and 8 dial gauges were installed on the test frame, jacks, micropile, and reaction beam. The calibrated load cell and extensometers were provided by the Owner. The load test frame and setup, calibrated jacks, pressure gauges, and dial gauges were provided by the Micropiling Contractor.

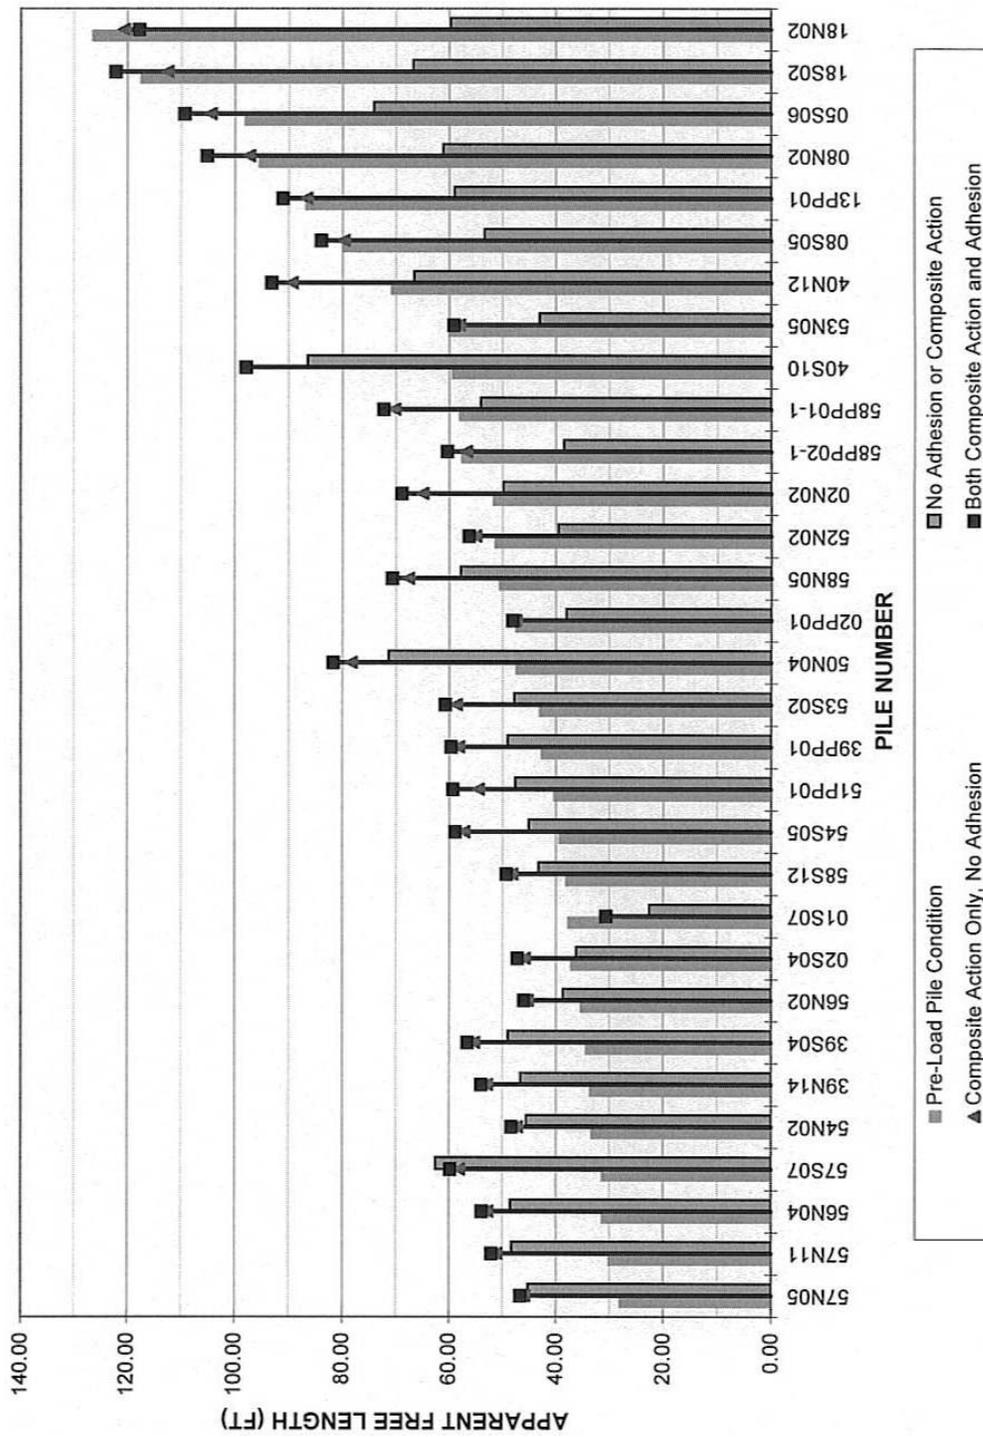
Figure 7. Micropile Apparent Free Length Based on Pressure Jack and Dial Gauge Data

Using elastic elongation measured in the field at peak loading, L3 was solved for with Bay Mud adhesion (using 250 psf and 500 psf) and without Bay Mud adhesion (0 psf) by iterating to find the point of fixity. The compilation of 31 load test analyses show that the calculated rock socket debonded length increases when composite action and adhesion are taken into consideration (Table 3 and Figure 7). Using the jack/dial gauge data, the average rock socket debonding is 7% when adhesion and composite action are ignored. With composite action only, rock socket debonding increases to 29%. With composite action and 250 psf adhesion on the 12 inch casing, debonding increases further to 37%. Note that the maximum load values used to calculate the debond values in Table 3 represent "overloading" conditions of up to 20% and the debond lengths at maximum Contract load measured using jack pressure would be correspondingly less. Rock socket debonding of 50% is considered by the industry to likely represent pile failure, confirmation of which should be made in conjunction of review of creep rates, maximum elongation, and a graph of the load-elongation curves for incremental and decremental loading. However, since the Owner used only total vertical movement as the pass/fail criterion for the tested piles, the magnitude of rock socket debond length was not a factor in the Owner's evaluation of pile performance. With the exception of the P58PP01 Performance Pile, no Performance Pile or Proof Pile was failed by the State and no production piles required remediation based on load test results. This occurred even though some piles technically did not satisfy the Owner's pass/fail elongation criterion. At piers where load test data indicated exceedence of the elongation criterion, Production Pile rock sockets were extended five feet deeper and/or a #20 steel ATB was added down the center of the 8 inch diameter reinforcement steel.
