## Embankment Dams on Karstic Limestone, Soluble and Erodible Foundations: Challenges and Solutions

Donald A. Bruce, Geosystems, L.P. Keith Ferguson, Kleinfelder, Inc.

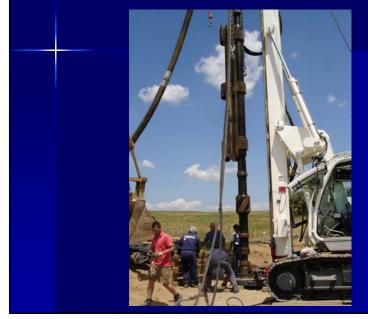
## Secant Pile Method "Arapuni"

Field Trial, Rome, Italy

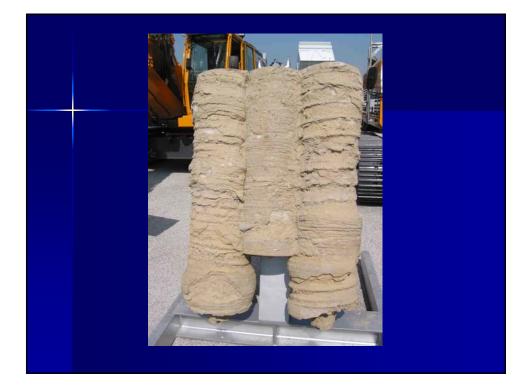
Deep mixing methods as they are known involve the use of a variety of cutting and mixing tools, mounted to one or more vertical shafts, that are driven into the ground to produce **columns** of treated soil.

Some of the better known methods of deep mixing are summarized in the following chart:

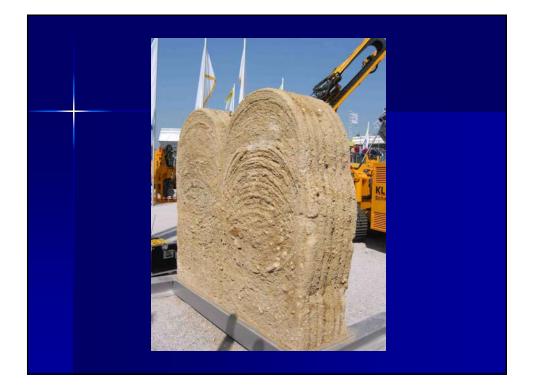
## Cutter Soil Mixing (CSM)

In 2004 Bauer developed a new method to carry out Deep Soil Mixing. The method is based on the use of diaphragm wall cutters mounted to a special frame that is driven into the ground by a Kelly bar to produce rectangular panels of treated soil.

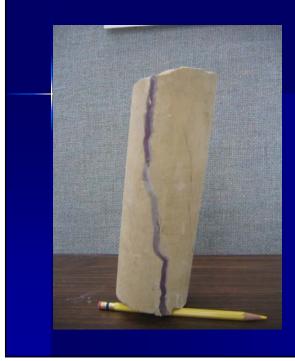
Clear example of equivalent performance of grouting to concrete cut-off wall construction.

Modern grouting can provide a high quality durable treatment in rock masses with clean fissures.
