SAVING INSTITUTIONAL MEMORY AND THE EXTRAORDINARY COST-EFFECTIVENESS OF PROJECT DATABASES

Dr. Donald A. Bruce, C.Eng., D.GE¹

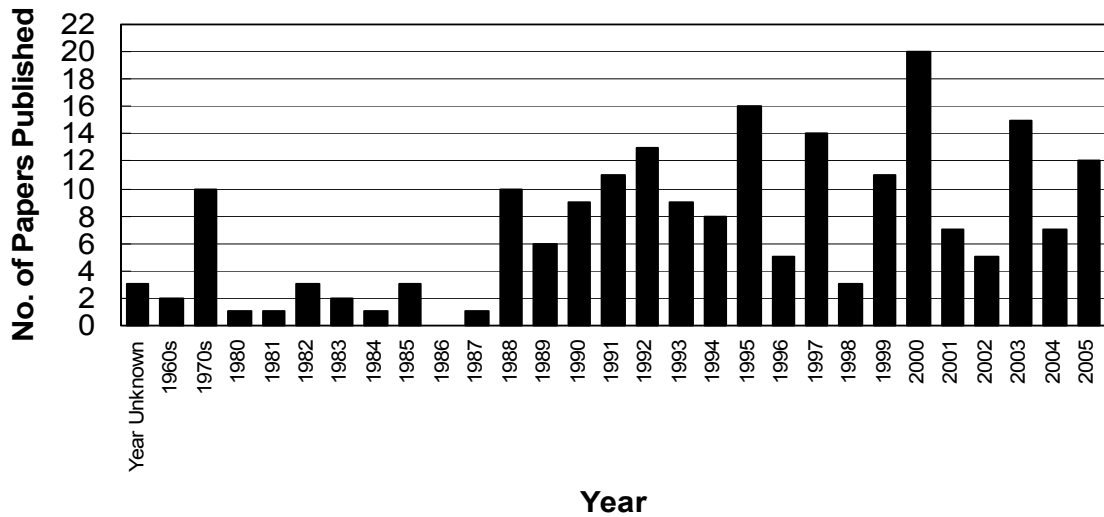
Figure 1. Numbers of technical papers on dam anchoring published per year (Bruce and Wolfhope, 2007).

- A database of over 230 technical papers published on the subject between the early 1960’s and 2005, as shown in [Figure 1](#).
- A compilation of all the successive Post Tensioning Institute (PTI) / Prestressed Concrete Institute (PCI) “Recommendation” documents governing design, construction and testing. As shown in [Table 1](#), this proved particularly useful in illustrating the development of concepts and attitudes with time, especially with regard to the critical issues of corrosion protection, and stressing and testing.
- A database of over 400 separate anchor projects completed in North America between 1962 and 2004 of which about 70% could be regarded as very comprehensive records and a further 12% labeled as “partial” ([Figure 2](#)).

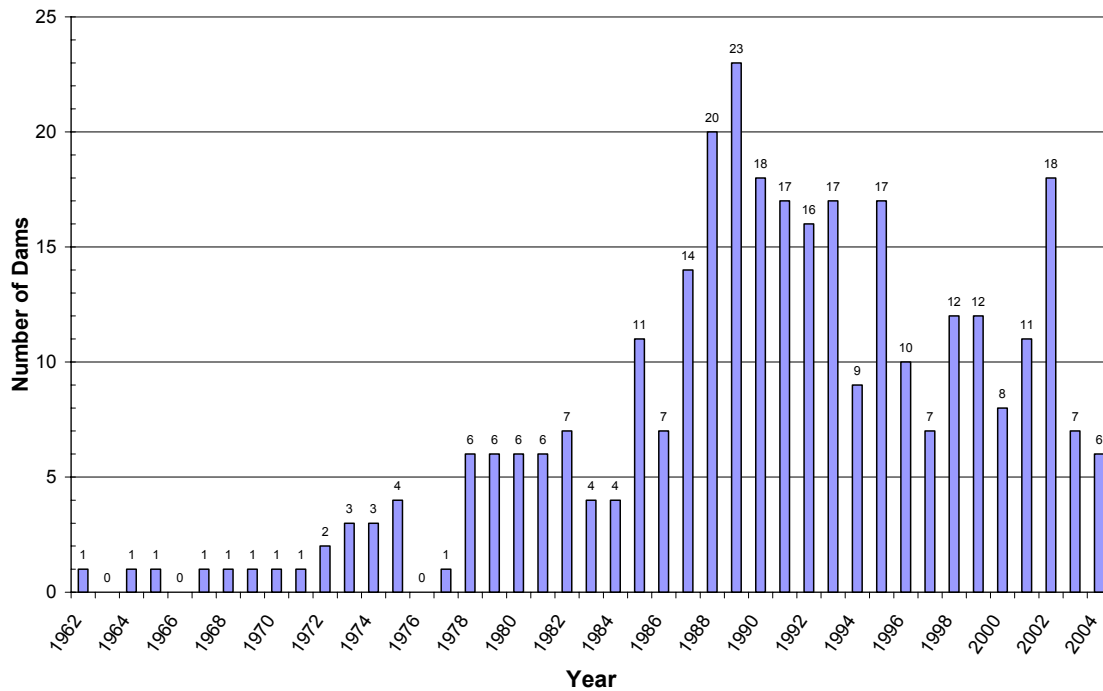
Histogram of Dams Anchored - North America (1962-2004)

Notes: 1) Total Number of Dams Shown = 323

2) Does not include 70 anchor case studies where year anchored not reported or as yet ascertained.

**Figure 2. Histogram of dams anchored by year (1962-2004)
(Bruce and Wolfhope, 2007).**

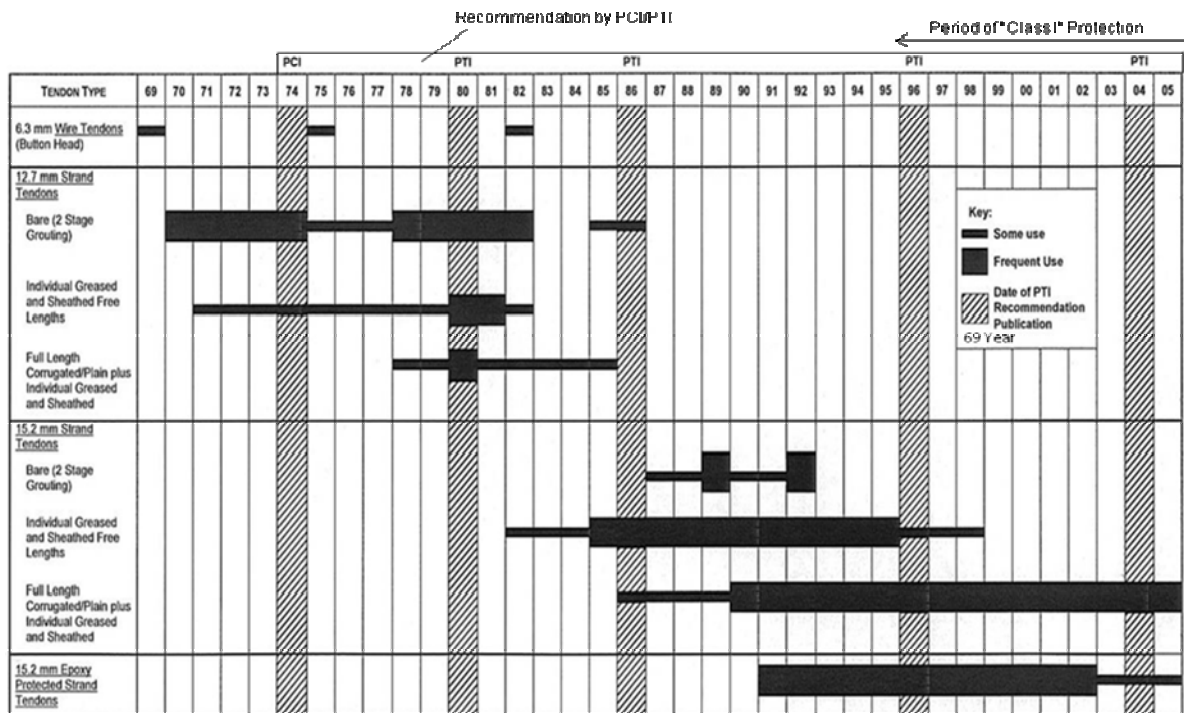
Figure 3. Illustrating how the types of corrosion protection have evolved (Bruce and Wolfhope, 2007).

- A basis for owners to access the probable status of the current functionality of their anchors. In other words, the reliability of the 60-70% of all known dam anchors installed before Type 1 corrosion protection (“double corrosion protection”) was first defined in the 1996 “Recommendations” document of PTI, the de facto equivalent of a national standard. This issue is illustrated in [Figure 3](#).

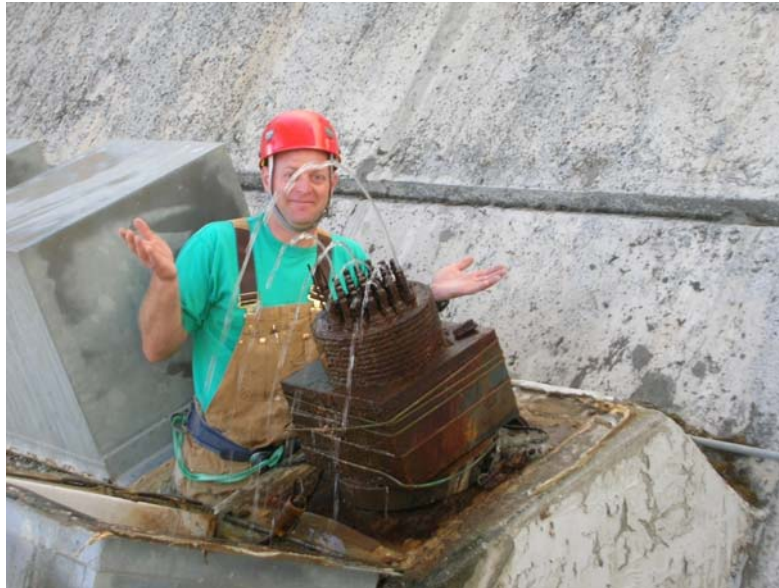
Photograph 1. Water emerging from the free length of an improperly protected tendon subject to excess hydrostatic head (Heslin et al., 2009).

This is obviously not a comprehensive list of benefits but, for dam owners, it is ironic that arguably the most significant of the benefits of the study may in fact be the one which has greatest dam safety implications. The issue of the reliability of the majority of anchors installed before 1996 is absolutely critical, especially for those anchors installed in the 1960's and 1970's when the free length was commonly not protected by a sheathing (bond breaker) and was therefore fully bonded by secondary grout following stressing. Such anchors cannot be lift-off tested to determine the residual load, even assuming they could still have physically accessible anchor heads. Even when a residual free length was incorporated, unacceptable levels of corrosion protection still occurred on occasions (Heslin et al., 2009) leading to corrosion occurring from the onset with progressively more severe loss of load (Photograph 1).

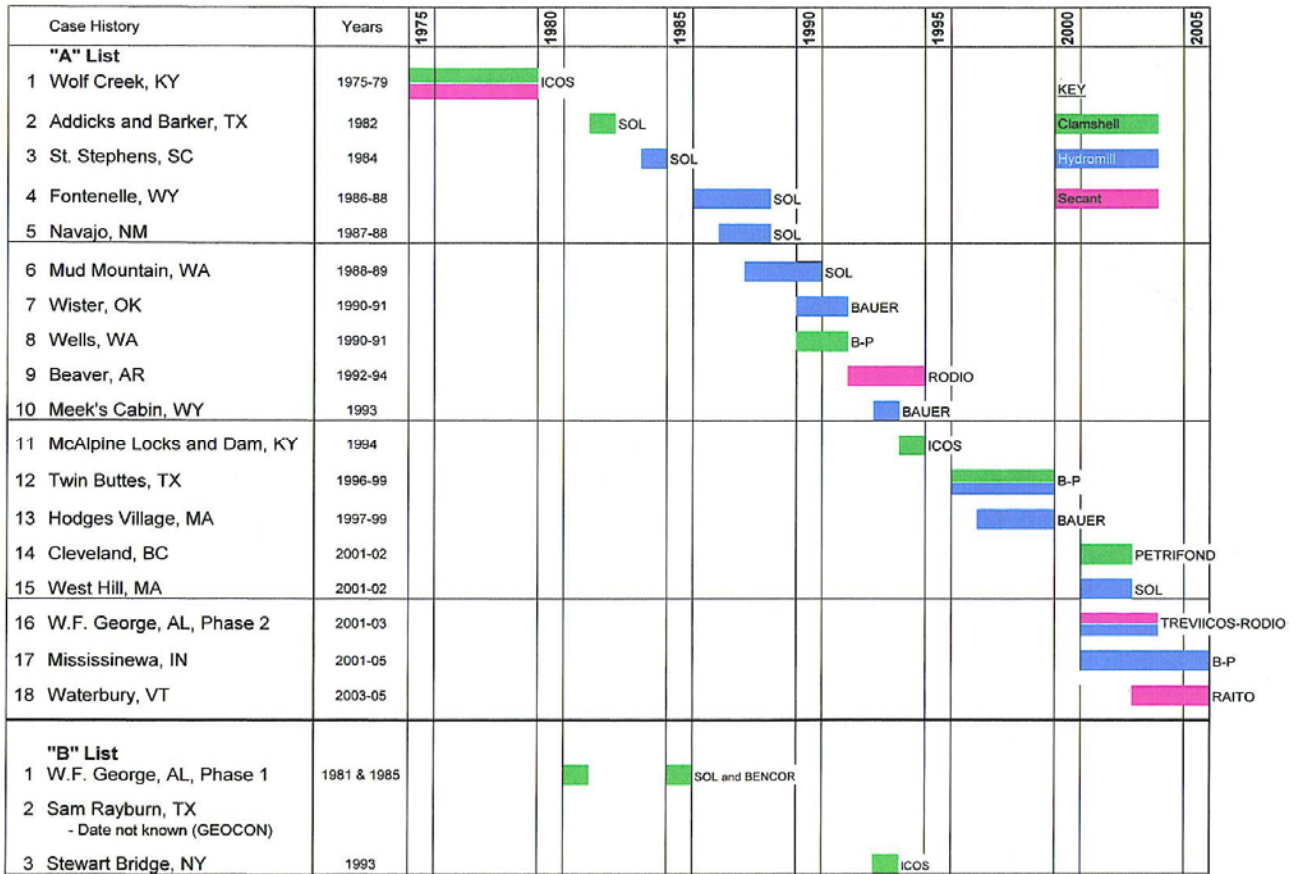
ICOS = TreviCOS
 SOL = Soletanche Bachy and Predecessors
 BAUER = Bauer Spezialtiefbau GmbH
 B-P = Bencor-Petrifond
 RODIO = Rodio
 PETRIFOND = Petrifond
 RAITO = Raito, Inc.

Figure 4. Project listing showing chronology, type and cutoff specialty contractor (Bruce 2007).

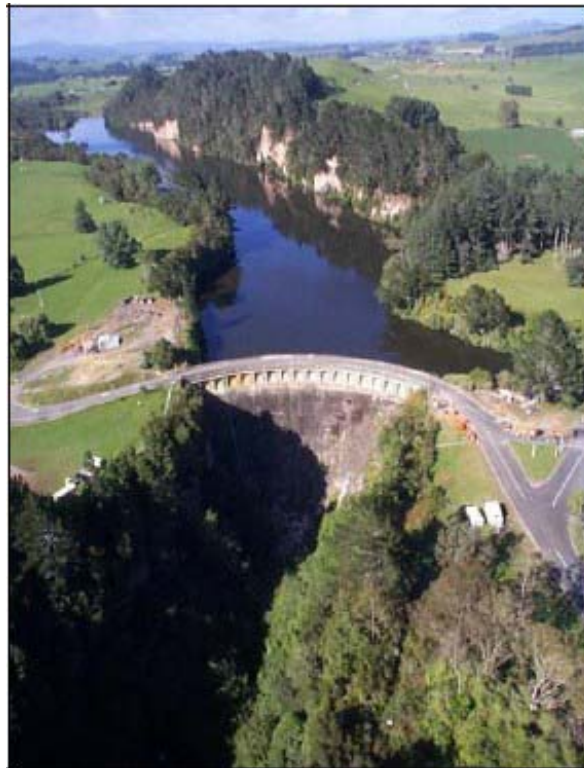
Photograph 2. Arapuni Dam, New Zealand (Amos et al., 2008).

- Seepage in the foundation rock was isolated from the abutment seepage even though the valley is extremely narrow (Photograph 2).

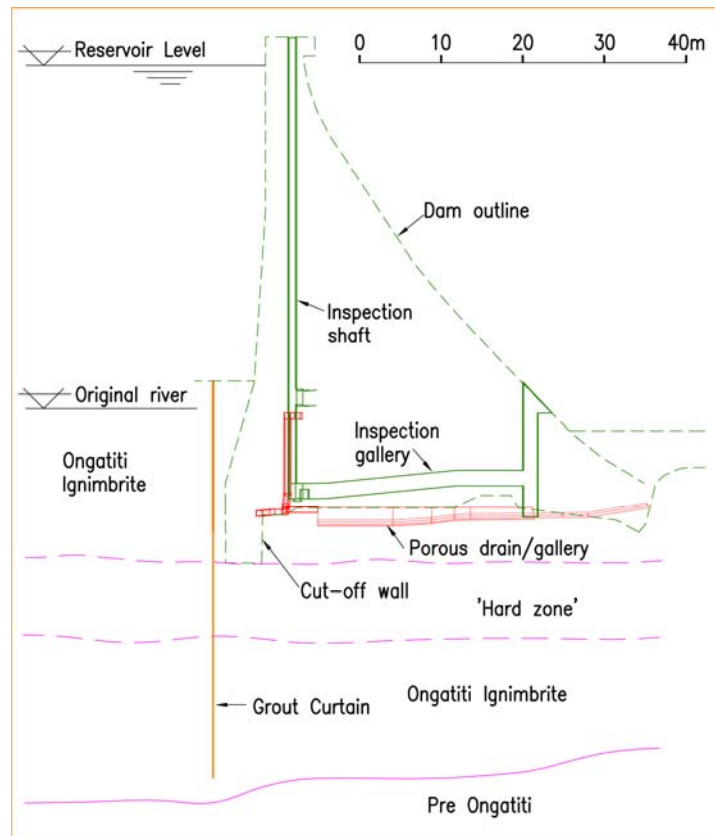
Figure 5. Cross section of Arapuni Dam looking west (Amos et al., 2008).

- There was no blanket grouting, curtain grouting or drainage curtain in the original dam construction. The remedial curtain constructed during a 1929-1932 lake lowering was,

in accordance with the U.S. practice of the day: a single row of vertical holes at 3 m centers. Furthermore, it was constructed *upstream* of the dam (Figure 5) and was not structurally connected to it, injection pressures were modest, grout mixes were unstable, and the curtain did not extend for the full depth of the permeable and problematic Ongatiti Ignimbrite sheet. However, the retrospective saving grace of the curtain was that it constituted what was basically a very intense site investigation in which the elevations of loss of drill water and “runaway” takes were meticulously recorded, allowing the locations and trends of the defects to be recognized.

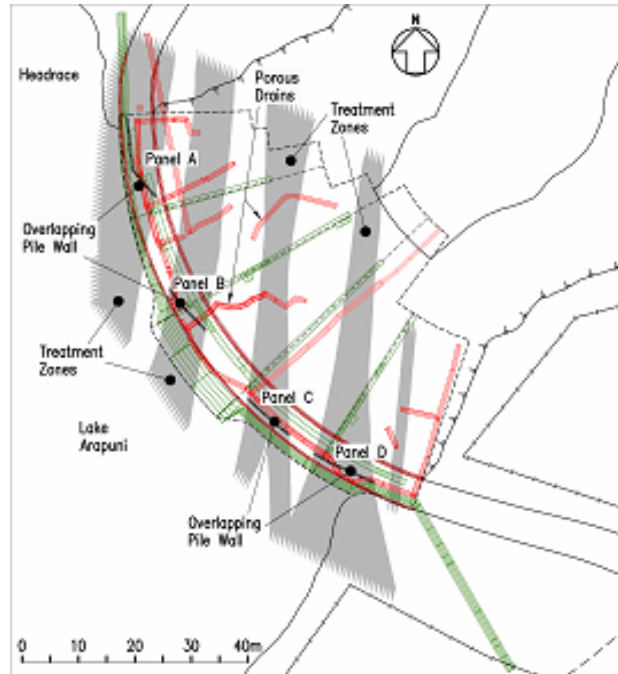
Figure 6. Plan of long-term seepage control remedial works, with cutoff walls, treatment zones and underdrain (Amos et al., 2008)
