EVALUATING POST-TENSIONED ANCHORS IN DAMS: FACTORS FOR RISK ASSESSMENT

Dr. Donald A. Bruce
GEOSYSTEMS, L.P.

Mr. John S. Wolfhope
FREESE AND NICHOLS

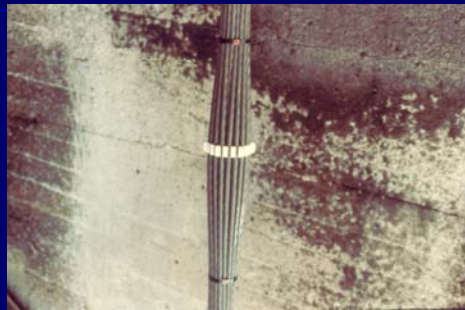
1960s – 1970s Bare Strand/Wire Throughout

- Tendon proposed/selected by Contractor/PT Supplier (wire, strand, bar)
- Grout conceived to be the only protection: 2 stages essential
- Fully bonded, and so no long-term load monitoring capability

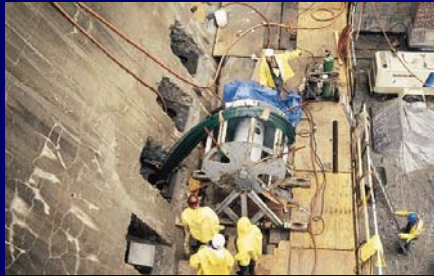
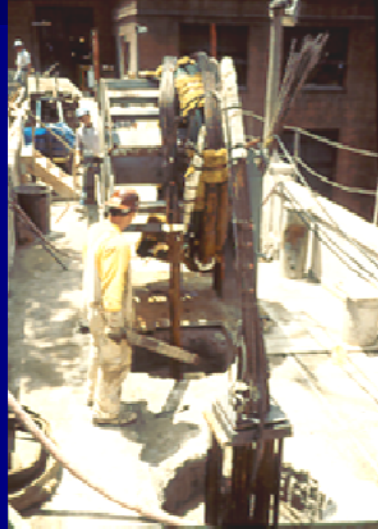
1970s – 1980s

Greased and sheathed free lengths, bare strand on bond length

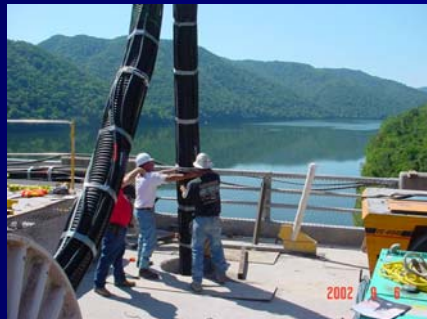
1980s Onwards

Corrugated Sheathing on Bond Length (1980s)
Extending to Full Length Protection by 1990s
