# *Design, construction and performance of seepage barriers for dams on carbonate foundations*

**Donald A. Bruce**

**Abstract** The design, construction and performance of concrete cut-offs, and grout curtains, as dam seepage remediations in carbonate foundations are reviewed. Recent experiences when attempting to build concrete cut-offs through hard and highly permeable rock masses have led the author and associates to develop the concept of “composite cut-offs” for seepage control. A campaign of high-quality drilling, permeability testing and grouting is first conducted to pretreat the very permeable and/or clay-filled zones, to seal the clean fissures and to provide an extremely detailed geological basis upon which to design the location and extent of the subsequent concrete wall (if in fact needed). Bearing in mind that the average cost of a concrete wall is many times that of a grouted cut-off, and that there is currently a shortfall in industry capacity to construct the former, the concept of a “composite wall” is logical, timely and cost-effective. Following presentation of the basic concepts, the paper provides details of a recent case history in Alabama.

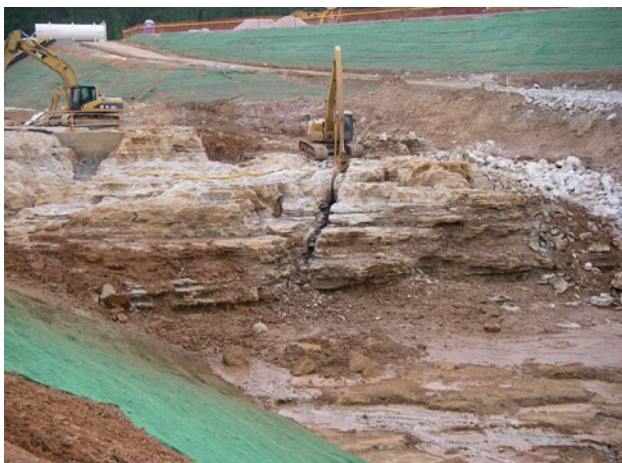
**Fig. 2** Irregular packstone surface detected in seismic refraction survey

The mapping, cleaning and surficial treatment of the foundation rock was conducted to an extremely high standard ( Figs. 2, 3, 4, 5), inspected and directed by the Engineer of Record (P.C. Rizzo Associates Inc.). The foundation preparation involved the excavation of about 40,000 cubic yards of residual soil, 25,000 cubic yards of alluvium, 6,000 cubic yards of fill and 10,000 cubic yards of moderately to intensely weathered rock. Approximately, 100 cubic yards of existing detritus was removed from solution cavities, 5,500 cubic yards of dental concrete was placed in surface irregularities and an additional 1,200 cubic yards placed to provide more level working surfaces for drill rigs and RCC placement. By integrating all observations and investigations, an extremely detailed geostructural map of the foundation was developed, which indicated the position of the major karstic features striking across the dam's axis.

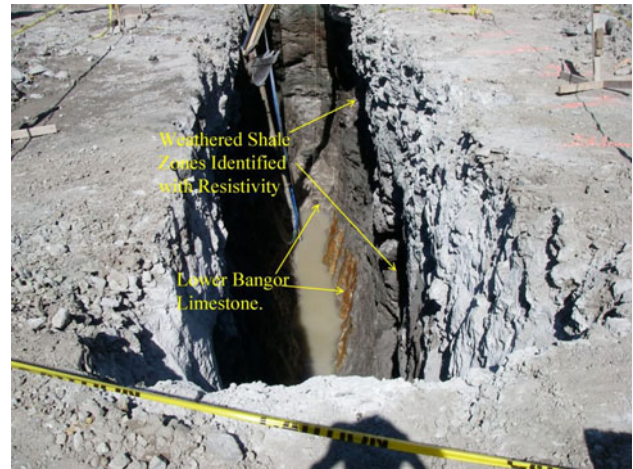
**Fig. 3** Weathered zones mapped in Bangor Shale unit C beneath historic Bear Creek channel

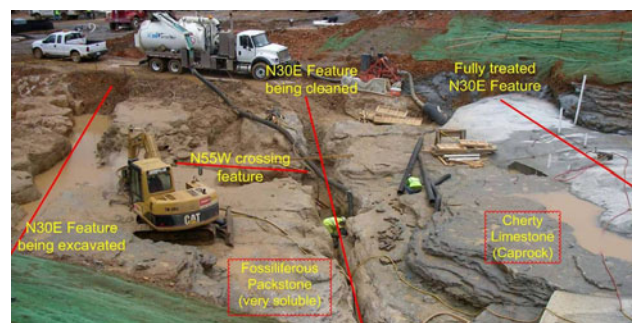
**Fig. 5** Cleaning of N30E features
