DESIGN AND CONSTRUCTION OF SEEPAGE CUT-OFF WALLS UNDER A CONCRETE DAM IN NEW ZEALAND WITH A FULL RESERVOIR

*Peter D Amos¹, Donald A. Bruce², Marco Lucchi³,
Tom Newson⁴, Nick Wharmby⁵*

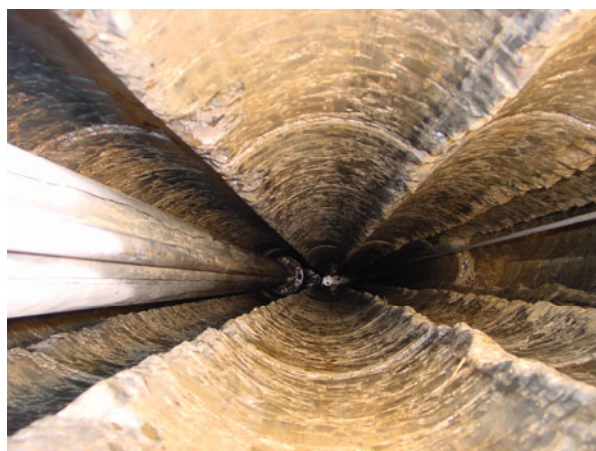
Figure 10. Downhole photograph of overlapping drill holes

A rotary tricone drill bit with reverse circulation was the preferred drilling technology. While this is acknowledged to not be the fastest available drilling method, this method was considered to improve drilling accuracy, provide a suitably rough concrete finish (Figure 10) and reduce the risk of foundation damage that might occur with other drilling tools such as down-the-hole hammer.
