DESIGN AND CONSTRUCTION OF DEEP SECANT PILE SEEPAGE CUT-OFF WALLS UNDER THE ARAPUNI DAM IN NEW ZEALAND

Peter D Amos¹,
Donald A. Bruce²,
Marco Lucchi³,
Neil Watkins⁴,
Nick Wharmby⁵

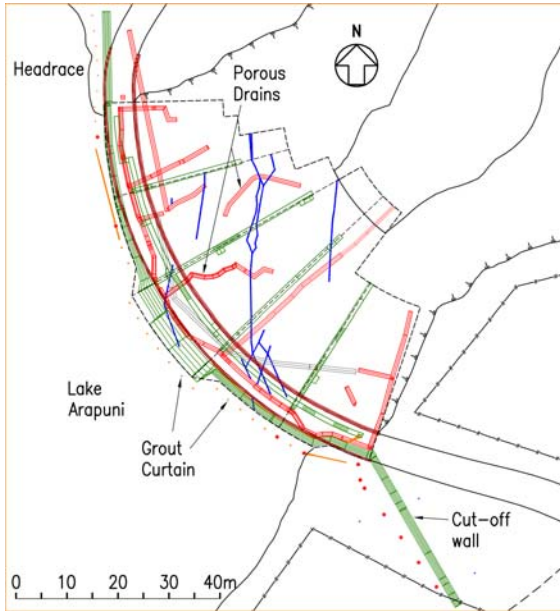
Figure 3. Plan view of Arapuni Dam (The positions of the foundation fractures noted during construction are shown. The diversion tunnel is south of the right abutment cut off wall)

Handman (1929) discusses the dam's construction. Original features of the dam include concrete cutoff walls and a network of porous (no-fines) concrete drains at the dam/foundation interface (the "underdrain"). The original cutoff walls extend beneath the dam to a depth of 65m below the dam crest and extend 20m and 33m into the left and right abutments respectively, for the full height of the dam as shown on Figure 3. There was no grout curtain constructed during original construction.

In June 1930 the reservoir was completely dewatered for a number of repairs including construction of a grout curtain along the upstream heel of the dam and along the front of both abutment cutoff walls (Furkett, 1934). The grout curtain was a single row cement curtain with mostly vertical grout holes at 3m centres. It was constructed just upstream of the dam and cutoff walls, as shown on Figure 4, but is not physically connected to the dam. Figure 3 shows the extent of the grout curtain and original dam cutoff walls.

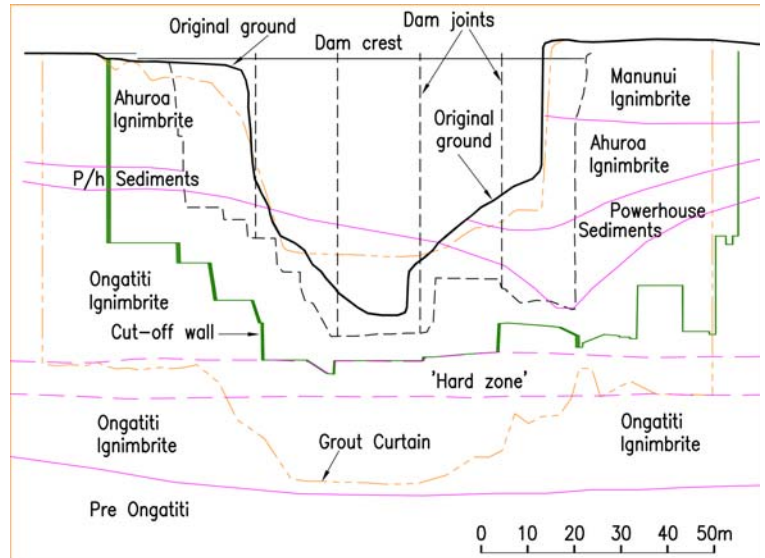
Figure 4. Elevation of Arapuni Dam, looking downstream

The dam site is in an area of multiple ignimbrite flows from volcanic eruptions over the last 2 million years. The main dam footprint is founded on a 40-50m thick sheet of Ongatiti Ignimbrite (Figure 4), a point-welded tuff. The upper part of the unit is very weak, with unconfined compressive strength of between 2 and 6 MPa, while below the original dam cutoff wall the Ongatiti is considerably stronger (up to 28MPa) and identified as the “hard zone” (Figure 4). Major sub-vertical defects in the form of cracks or fractures trending North-South are present in the Ongatiti. These fractures extend for the full depth of Ongatiti and vary in aperture from closed up to 80mm. The fractures relate to cooling (venting and contraction) of the ignimbrite after emplacement and are not tectonic in origin. Clay infill is generally present where the fracture opened around

At interfaces between ignimbrite sheets there tends to be unwelded material, either airfall tephra or unwelded ignimbrite. The most extensive interface deposit is between the Ahuroa and Ongatiti ignimbrite units, known as the Powerhouse Sediments (Figure 4), with a thickness of 4 to 8m.
