# Comprehensive Foundation Rehabilitation at Bear Creek Dam

JOHN E. CHARLTON<sup>1</sup>

*Paul C. Rizzo Associates, 101 Westpark Boulevard, Suite B, Columbia, SC 29210*

**Key Terms:** *Packstone, Grouting, Dental Concrete, Cutoff Panel, Karst*

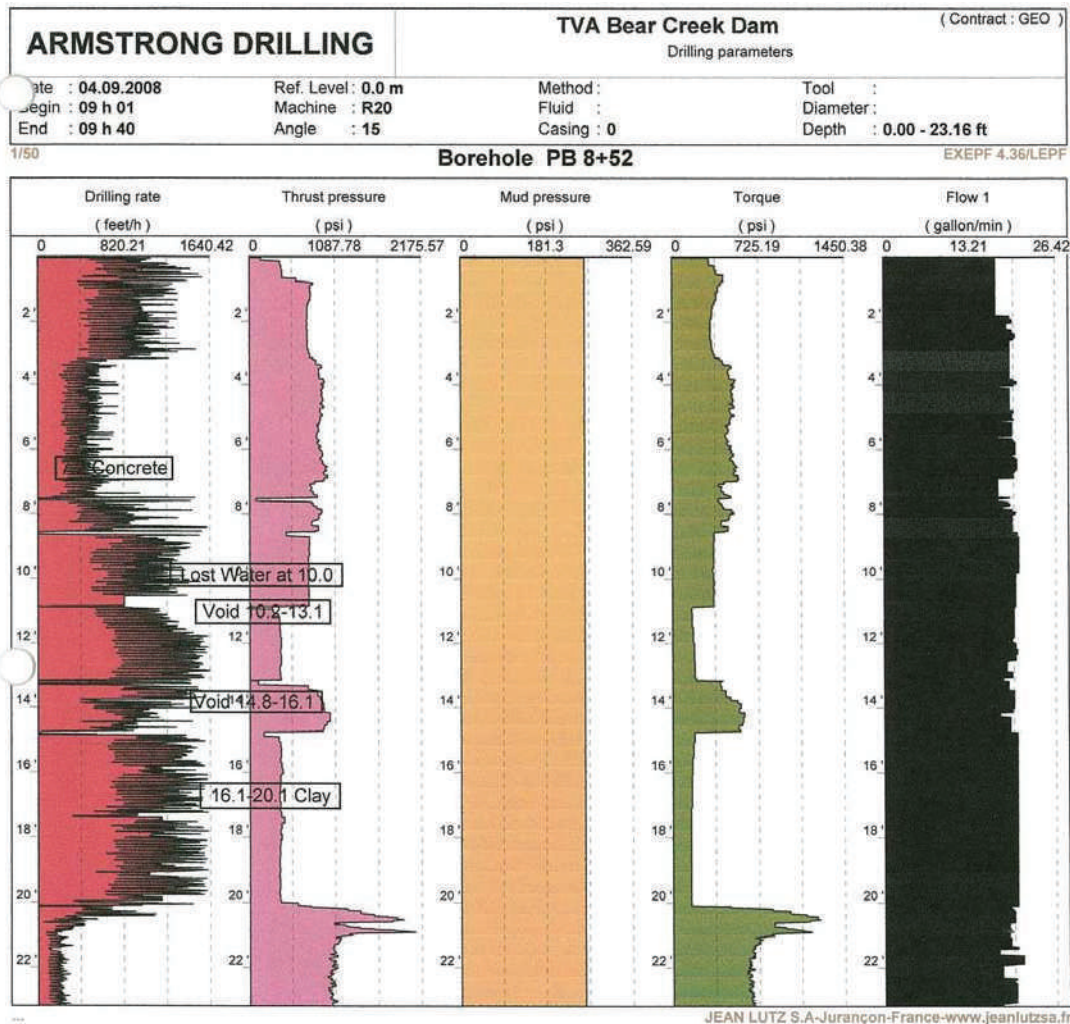
Figure 12. Typical DPR log output.

infill, and changes in stratigraphy, particularly as the driller's understanding of site-specific ground conditions improved. Figure 12 shows a typical DPR log output.

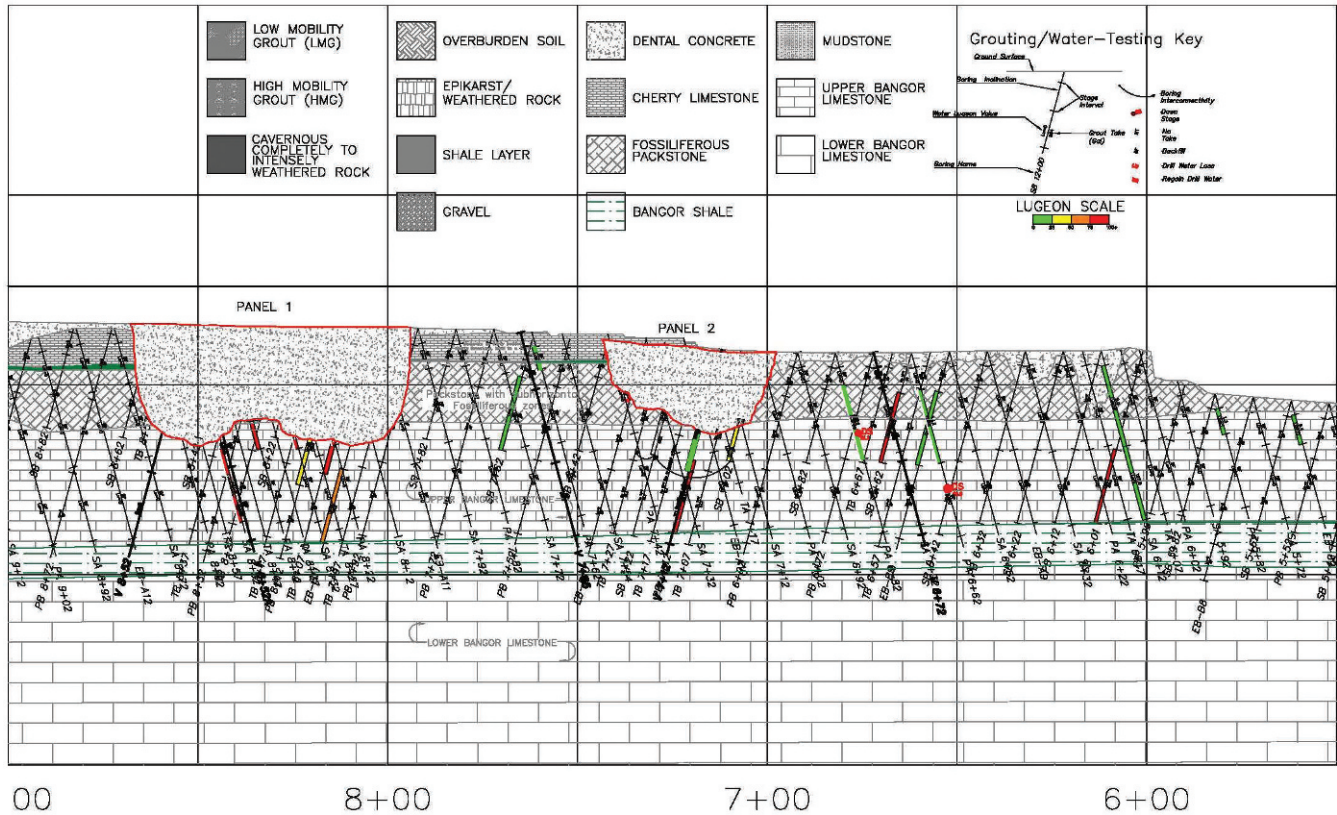
Figure 13. Example subsurface profile. Width of profile is 35 feet.

sections, daily updates regarding the drilling, water pressure test results, and grout results were required. Results of daily activities were plotted on a color-coded subsurface profile showing the existing geology, borings, stages, and takes during pressure tests and grouting. The use of a color-coded scale for water pressure test results made identification of areas of high conductivity in the foundation simple and intuitive, guiding the selection of higher order treatments and helping to further develop details in the site geologic model. An example portion of the water pressure testing and grouting subsurface profile is shown in Figure 13.

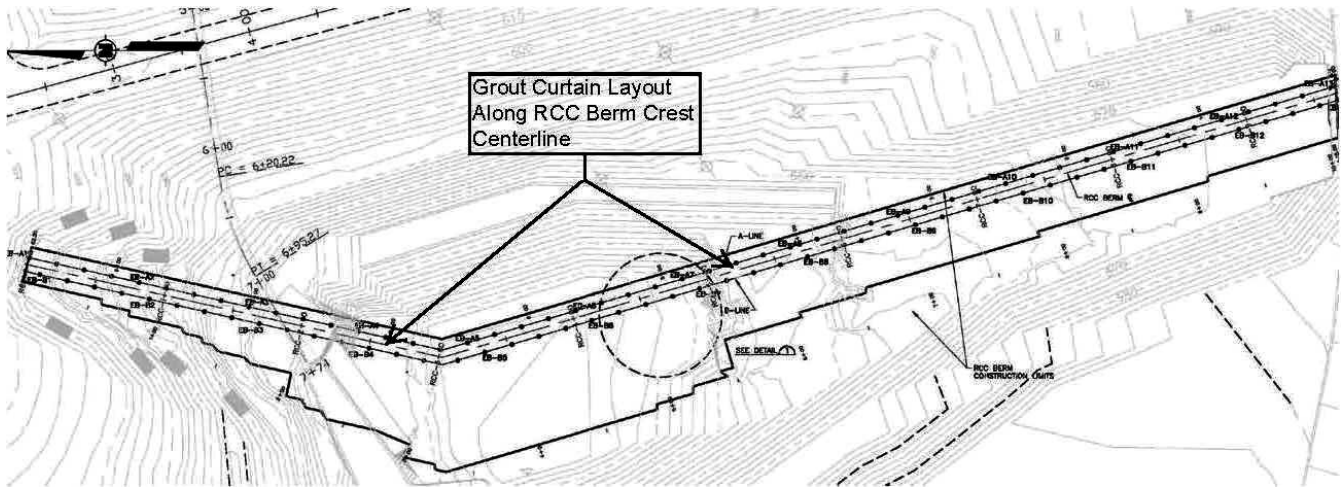
Figure 14. Drilling and grouting program layout.

foundation of the RCC berm, the two-line grout curtain extends from the area downstream of the left abutment of the existing spillway structure, and it terminates at the right abutment of the RCC berm to the north. Figure 14 shows the layout of the drilling and grouting program.

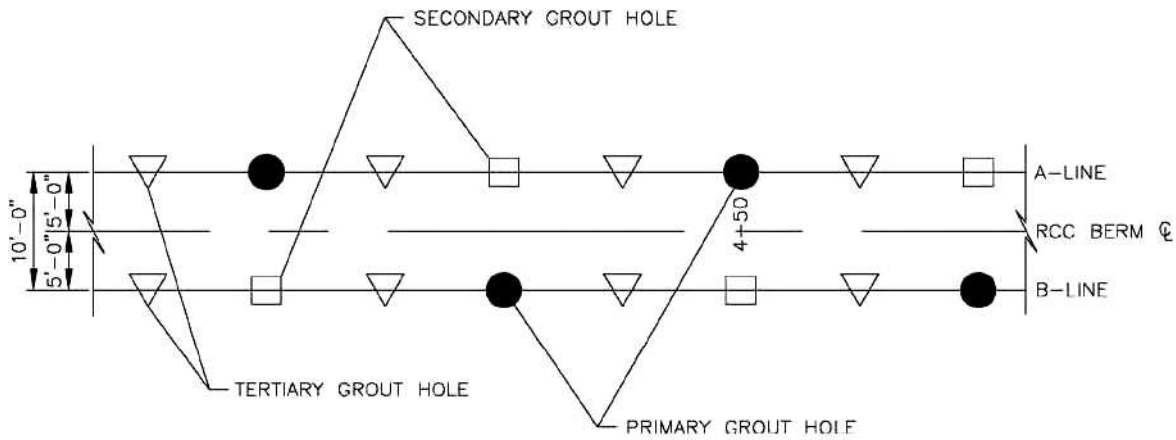
Figure 15. Typical grout hole layout.

To provide a tight-enough treatment spacing to limit the possibility of leaving untreated or untreated windows in the foundation, two grout lines (located 10 ft apart) of opposing holes inclined  $15^\circ$  from vertical were planned. The “A” line parallels the RCC centerline to the upstream, while the “B” line parallels the RCC centerline to the downstream. Primary and secondary borings on each line were set at 20-ft center-to-center spacing, with tertiaries and higher order borings split spaced, as indicated by the results of lower order holes. To provide a clear means of identifying the order of performance and location of borings, a system employing the boring order, grout line, and RCC stationing at the location was developed, as shown below: For a primary boring on the “A” line at RCC Station 4+50, the boring label is PB 4+50. Figure 15 shows the typical grout hole layout.
