THE THIRD TIME'S A CHARM

Victor M. Vasquez, P.E.¹
John L. Rutledge, P.E.³
Donald A. Bruce, Ph.D., C.Eng.⁵

M. Leslie Boyd, P.E.²
Martin J. Cristofaro, P.E.⁴
Patrick Carr, P.E.⁶

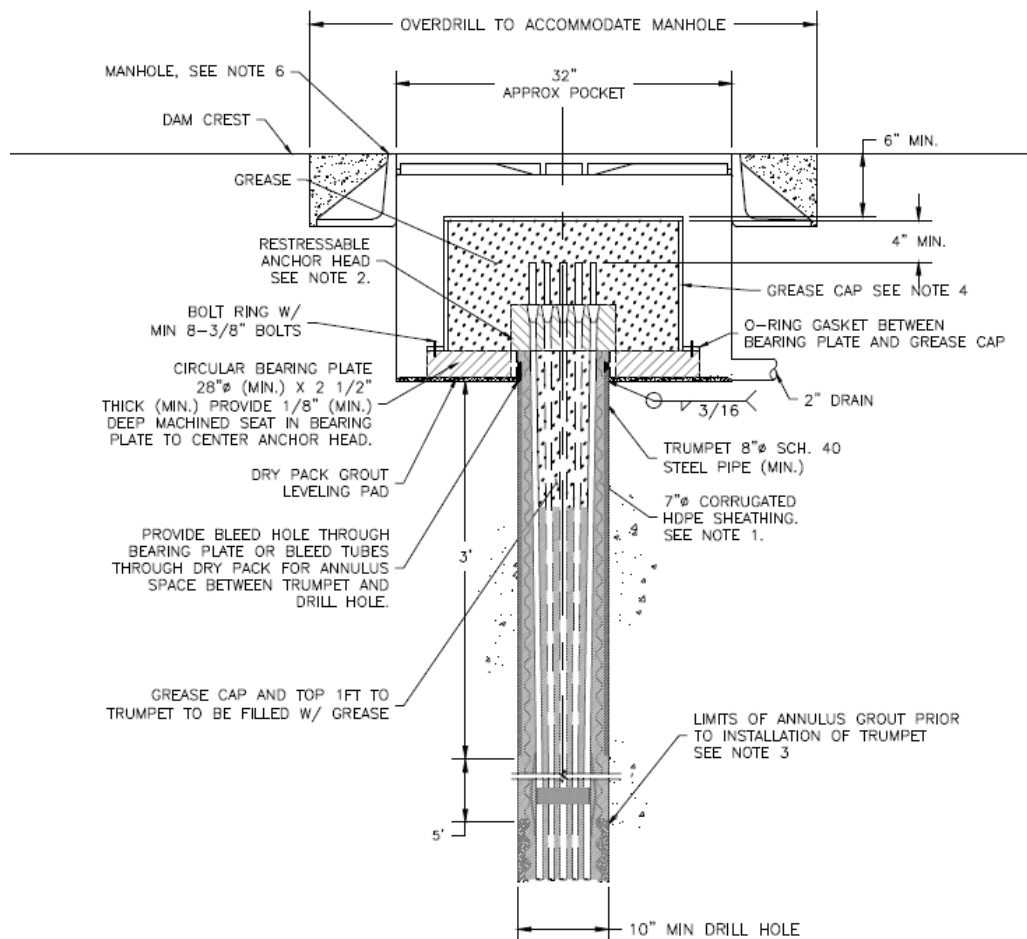
Figure 3. 20 Strand Anchor Vault

Corrosion Protection. The corrosion protection was selected to be Class I as described by PTI. It is the highest level of corrosion protection and is mandated when anchors are intended for permanent use rather than temporary use. The corrosion system consists of the entire anchor length below the trumpet being encapsulated within a 60 mil high density polyethylene (HDPE) corrugated sheath and with the entire free length of the anchor being protected by grease filled polyethylene tubing. The anchor is fully grouted inside and outside the HDPE sheathing with neat cement grout. Also, the entire head assembly is encapsulated beneath a grease filled galvanized steel cover complete with rubber gaskets. Figure 3 presents the details associated with the new Olmos anchors.

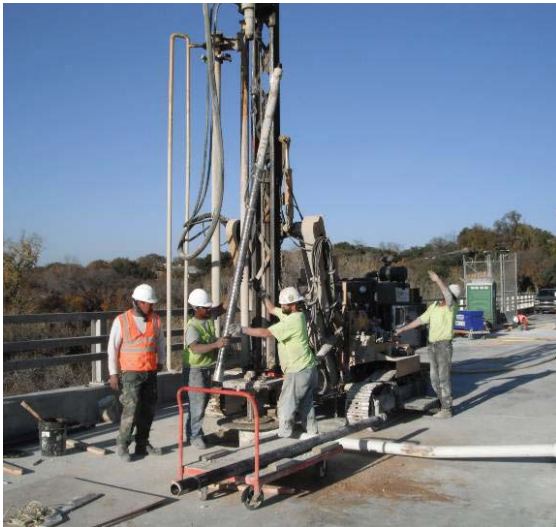
Figure 4. Drilling Rig on Left Abutment

Access Constraints. Installation of the anchors had many challenges. The most significant was access to the work areas: there were four distinct work areas and three of the four areas were severely limited in accessibility. The left abutment was easily accessible as this non-overflow portion was a 20-foot wide concrete driveway to the outlet works gatehouse. The area is accessed from a public street (Olmos Drive), and the 13 anchor holes in this area were drilled in the concrete drive near the upstream parapet using a conventional crawler drill as shown in Figure 4.

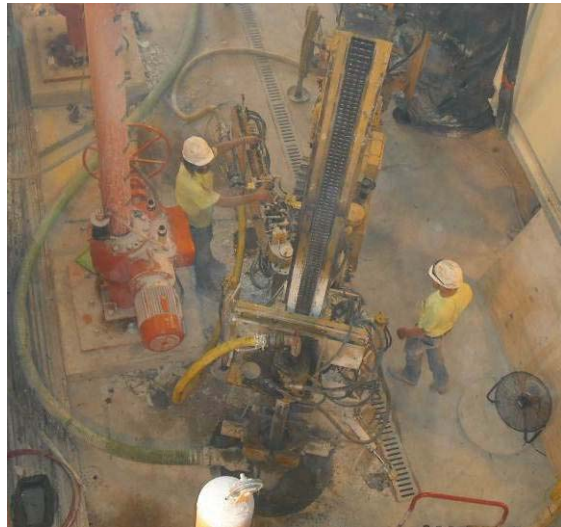
Figure 5. Limited Access Drill in Gatehouse

In the next section, known as the outlet works, there were five anchors inside the gatehouse. The anchors were located between the gates in order to fit within the splitter walls of the outlet conduits. They were so close to the existing bar anchors that the bar anchors had to be de-stressed prior to drilling the new anchor holes. It was necessary to work around the gate actuators and electrical control panels as well as beneath the roof of the gatehouse. The work area was very restricted. A limited access drill with a width of 30 inches was used to work in the highly congested area as shown in Figure 5.

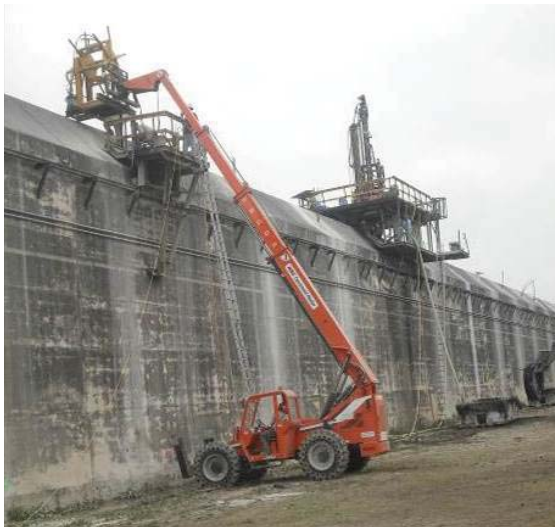
Figure 6. Access to Overflow Section

The least accessible work area was also the longest section of the work. Thirty-nine anchors were located along the 1,500-foot long ogee crest of the overflow section as seen in Figure 6. Normally dams have water upstream and access to dam crests can be obtained with barges. However, Olmos is a flood retarding structure and normally the reservoir is empty. Thus, the anchors were up to 40 feet above the reservoir floor and inaccessible to normal construction. On this project the contractor decided to construct a rolling platform for drilling the anchor holes. The platform was supported on a rail bolted to the upstream concrete face and on the concrete crest of the dam as seen in Figure 7 and Figure 8. The platform was 17 feet wide by 29 feet long providing room for a full-size crawler drill and adequate work area for crews. Wheels driven hydraulically from the drill moved the platform along the dam. The platform was built in two elevations to provide access to the tendons and pockets. Man lifts and two small rolling platforms were used to core the pockets, install and grout the tendons, and perform post-tensioning. The drill had to be lifted by a crane onto the platform, and the drill remained on the platform until all 39 crest anchor holes were drilled. A crane then removed it from the platform.

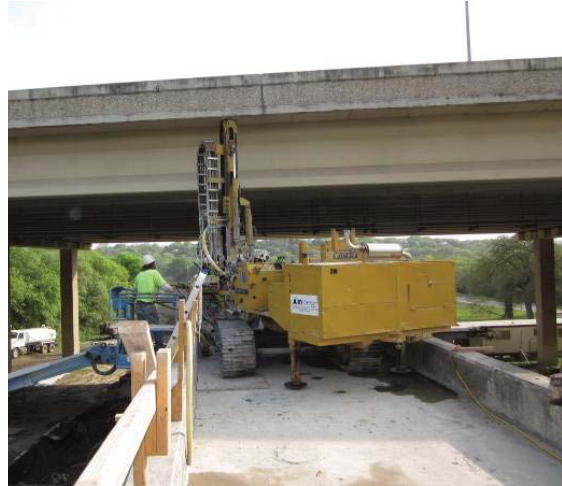
Figure 9. Rig at Right Non-overflow Section

The third work section with severe access constraints was the right abutment. This segment had the tightest vertical limitations where six of the eleven required anchors were located directly beneath the US Highway 281 bridge. The bottom of the beams was only eight feet above the concrete crest. The anchors were located between the beams to gain approximately three more feet of clearance and the contractor drilled the holes using a crawler drill with a shortened mast as seen in Figure 9.

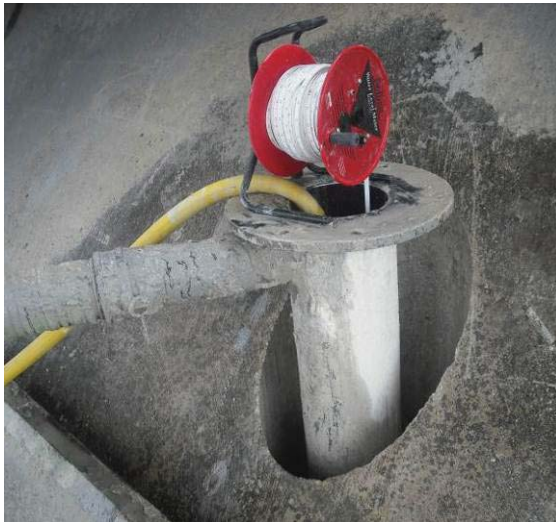
Figure 12. Water Level Probe

level probe as seen in Figure 12. Then 12 feet of water was added to the hole above the static water level, and the water surface was monitored for 10 minutes. The water take into the formation was calculated based on the drop in water level. Holes leaking more than 2.5 gallons were grouted with sanded Portland cement grout on the first grouting. The grout was allowed to harden for at least sixteen hours and then the hole re-drilled. The hole was then retested. Those failing were re-grouted with neat Portland cement grout as many times as necessary until passing the test. The number of times a hole required grouting was variable depending on location. Only a few holes passed without an initial grouting. Some holes required grouting four times before passing the falling head test.

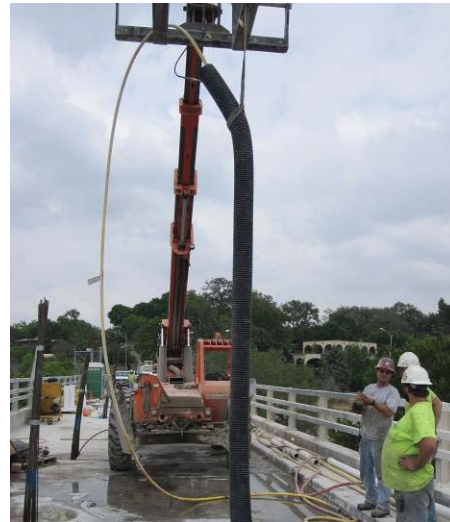
Figure 13. Corrugated 12 feet above grade for Leak Test

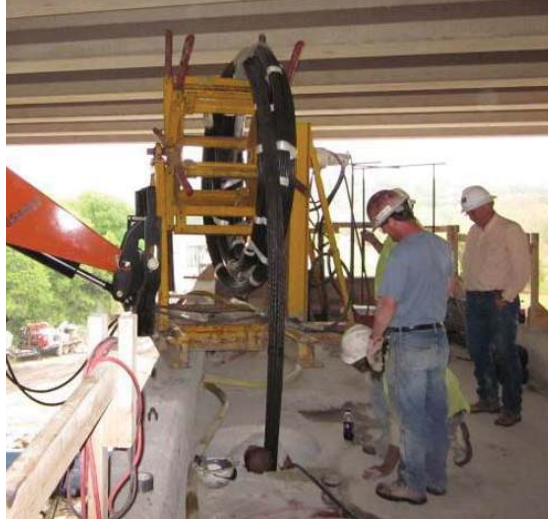
Difficulties were encountered while inserting the tendons. In some instances, the corrugation was damaged during insertion, and in some cases the tendon became wedged and could not be lowered into the hole. After several failed insertion attempts, one of the tendons was uncoiled on the surface. It was found that because of the difference in the inside and outside radius of the coils the extra length would accumulate making a large basket that would expand in the hole, as shown in Figure 15. It would damage the corrugation and wedge inside the hole. Once the problem was discovered, the bands used for assembly were cut as the tendon was inserted and the extra material worked to the top so the strands could even out. This was a slow and tedious process.

Figure 14. Installing Tendon with Uncoiler under the bridge

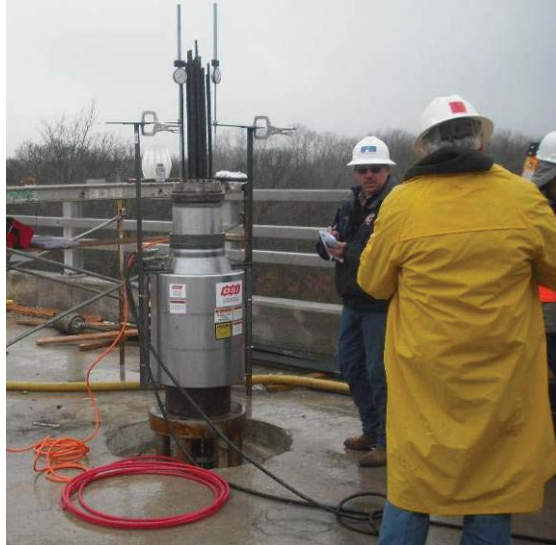
Stressing. Before setting the large stressing jack seen in Figure 16, each individual strand was stressed with a mono-strand jack to 10% of the lock off load and the wedges installed. Each tendon was Performance Tested including Creep Test. Hydraulic jack pressures and load cell readings were taken at each load. Dual dial gauges measuring to the nearest 1/1000 inch were used to measure strand elongations. After Performance Testing, the wedges were restrained, the lock off load was applied, and the wedges seated. Immediately after lock off, a lift off test was performed. The tolerance was -2% to +5%. Shims were added as needed if the lock off load was lower than the tolerance.

Figure 16. Performance Testing a 20 Strand Tendon
