THIRD POST-TENSIONED ANCHORS STABILIZATION AT OLMOS DAM

Abstract

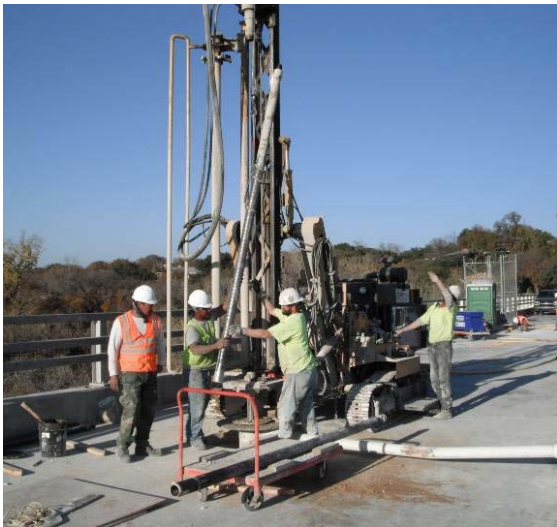
Figure 8. Drilling Rig on Left Abutment

Access Constraints. Installation of the anchors had many challenges. The most significant was access to the work areas: there were four distinct work areas and three of the four areas were severely limited in accessibility. The left abutment was easily accessible as this non-overflow portion was a 20-foot wide concrete driveway to the outlet works gatehouse. The area is accessed from a public street (Olmos Drive), and the 13 anchor holes in this area were drilled in the concrete drive near the upstream parapet using a conventional crawler drill as shown in Figure 8.

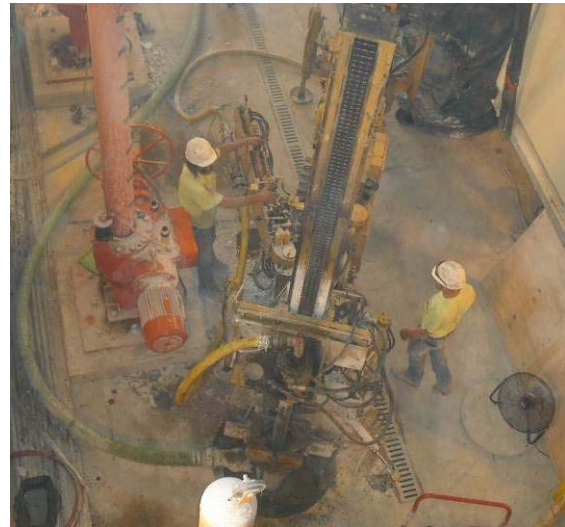
Figure 9. Limited Access Drill in Gatehouse

In the next section, known as the outlet works, there were five anchors inside the gatehouse. The anchors were located between the gates in order to fit within the splitter walls of the outlet conduits. They were so close to the existing bar anchors that the bar anchors had to be de-stressed prior to drilling the new anchor holes. It was necessary to work around the gate actuators and electrical control panels as well as beneath the roof of the gatehouse. The work area was very restricted. A limited access drill with a width of 30 inches was used to work in the highly congested area as shown in Figure 9.

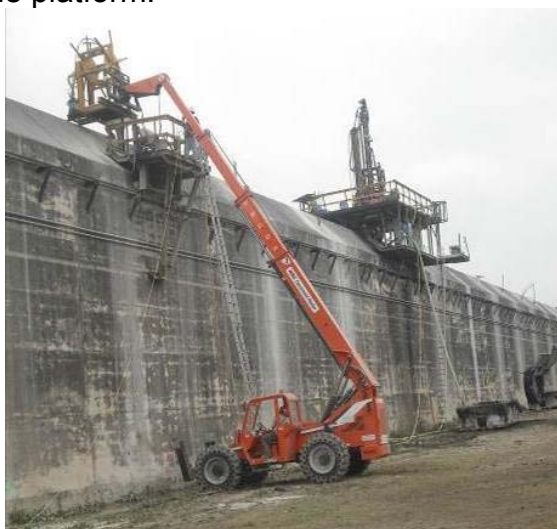
Figure 10. Access to Overflow Section

The least accessible work area was also the longest section of the work. Thirty-nine anchors were located along the 1,500-foot long ogee crest of the overflow section as seen in Figure 10. Normally dams have water upstream and access to dam crests can be obtained with barges. However, Olmos is a flood retarding structure and normally the reservoir is empty. Thus, the anchors were up to 40 feet above the reservoir floor and inaccessible to normal construction. On this project the contractor decided to construct a rolling platform for drilling the anchor holes. The platform was supported on a rail bolted to the upstream concrete face and on the concrete crest of the dam as seen in Figure 11 and Figure 12. The platform was 17 feet wide by 29 feet long providing room for a full-size crawler drill and adequate work area for crews. Wheels driven hydraulically from the drill moved the platform along the dam. The platform was built in two elevations to provide access to the tendons and pockets. Man lifts and two small rolling platforms were used to core the pockets, install and grout the tendons, and perform post-tensioning. The drill had to be lifted by a crane onto the platform, and the drill remained on the platform until all 39 crest anchor holes were drilled. A crane then removed it from the platform.

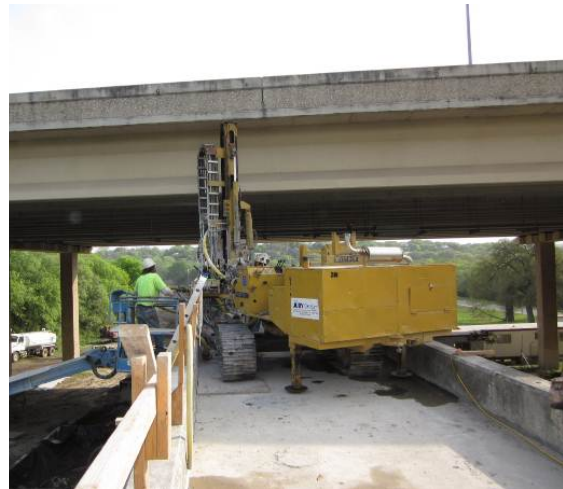
Figure 13. Rig at Right Non-overflow Section

The third work section with severe access constraints was the right abutment. This segment had the tightest vertical limitations where six of the eleven required anchors were located directly beneath the US Highway 281 bridge. The bottom of the beams was only eight feet above the concrete crest. The anchors were located between the beams to gain approximately three more feet of clearance and the contractor drilled the holes using a crawler drill with a shortened mast as seen in Figure 13.

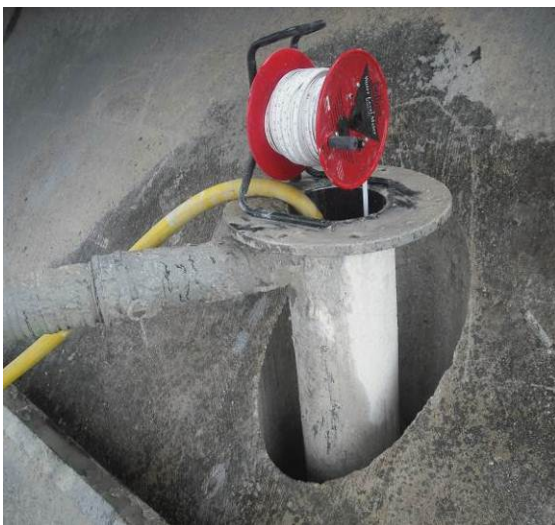
Figure 16. Water Level Probe

Water Testing and Grouting. After each hole was drilled, a water test was performed to check the hole for potential leakage. This project was unique in that there was no reservoir water upstream to establish the static surface above which leakage testing would be performed. A falling head test was used as the testing method for evaluating the leakage. After the initial drilling, the static water elevation was checked with a water level probe as seen in Figure 16. Then 12 feet of water was added to the hole above the static water level, and the water surface was monitored for 10 minutes. The water take into the formation was calculated based on the drop in water level. Holes leaking more than 2.5 gallons in 10 minutes were grouted with sanded Portland cement grout on the first grouting. The grout was allowed to harden for at least sixteen hours and then the hole re-drilled. The hole was then retested. Those failing were re-grouted with neat Portland cement grout as many times as necessary until passing the test. The number of times a hole required grouting was variable depending on location. Only a few holes passed without an initial grouting. Some holes required grouting four times before passing the falling head test.

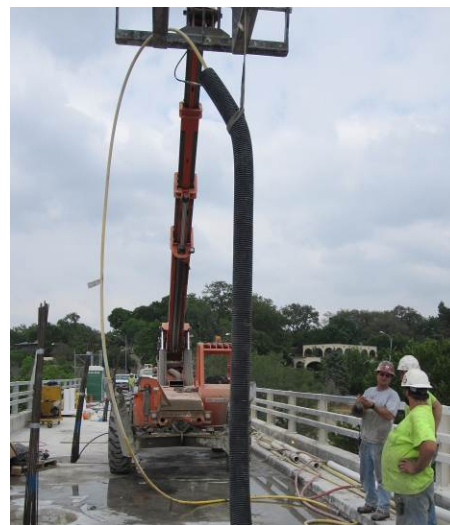
Figure 17. Corrugated 12 feet above grade for Leak Test

Corrugated Sheathing. All anchors utilized HDPE corrugated sheaths for the Class I corrosion protection. When the drilled hole passed the water test, it was deemed ready for installation of the corrugated sheathing. There was also a requirement for water testing the corrugated sheaths. Getting the sheath to pass was one of the more difficult and elusive tasks on the project. The 20 strand tendons used 6-inch diameter sheathing and the 6 strand used 4-inch diameter. The HDPE sheathing was 60 mils thick. The specifications required testing the sheathing for leakage prior to and after installation in the drill hole. On the surface testing, the open end of the sheath was lifted 12 feet above the lower end cap and filled with water, as shown in Figure 17. The leakage test was then simply measuring the water loss in the sheath over a ten minute time period. It was difficult to get all the air out of the sheathing as air would become trapped in the corrugations and only slowly work its way to the top. Filling with a hose inserted to the bottom worked best.

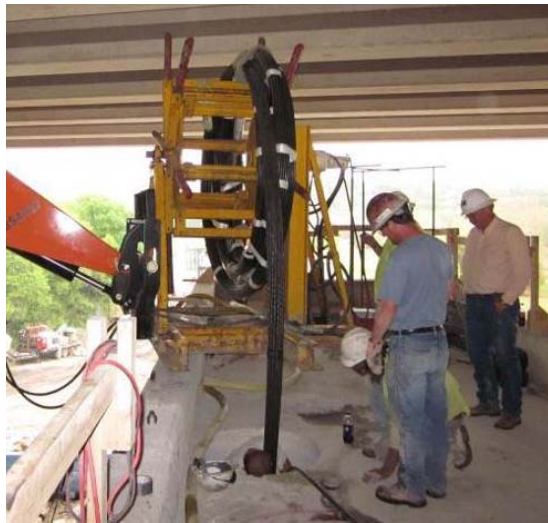
Figure 18. Installing Tendon with Uncoiler under the bridge

Difficulties were encountered while inserting the tendons. In some instances, the corrugation was damaged during insertion, and in some cases the tendon became wedged and could not be lowered into the hole. After several failed insertion attempts, one of the tendons was uncoiled on the surface. It was found that because of the difference in the inside and outside radius of the coils the extra length would accumulate making a large basket that would expand in the hole, as shown in Figure 19. It would damage the corrugation and wedge inside the hole. Once the problem was discovered, the bands used for assembly were cut as the tendon was inserted and the extra material worked to the top so the strands could even out. This was a slow and tedious process.

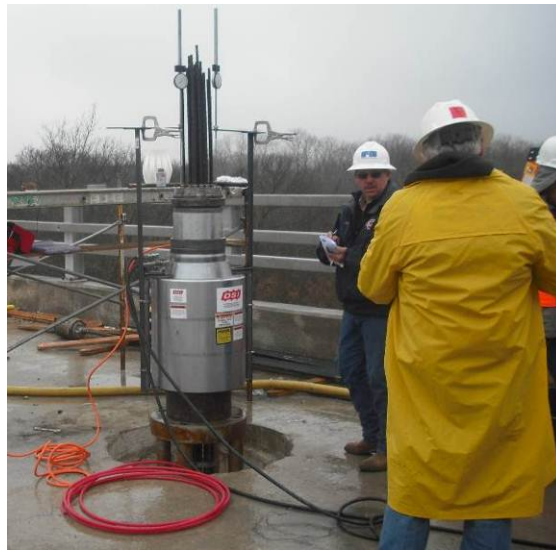
Figure 20. Performance Testing a 20 Strand Tendon

Stressing. Before setting the large stressing jack seen in Figure 20, each individual strand was stressed with a mono-strand jack to 10% of the lock off load and the wedges installed. Each tendon was Performance Tested including Creep Test. Hydraulic jack pressures and load cell readings were taken at each load. Dual dial gauges measuring to the nearest 1/1000 inch were used to measure strand elongations. After Performance Testing, the wedges were restrained, the lock off load was applied, and the wedges seated. Immediately after lock off, a lift off test was performed. The tolerance was -2% to +5%. Shims were added as needed if the lock off load was lower than the tolerance.
