EVOLUTION OF GROUTING IN KARST AT LOGAN MARTIN DAM, ALABAMA

DONALD A. BRUCE

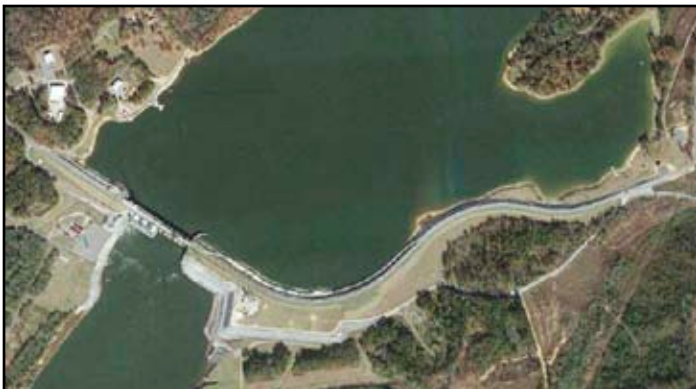
FIGURE 1. AERIAL VIEW SHOWING FROM LEFT TO RIGHT, THE WEST EMBANKMENT, CENTRAL POWERHOUSE, AND EAST EMBANKMENT WITH BOLSTER. TOTAL DAM LENGTH IS 6,133 FT (1,869 M). NORTH IS TO THE TOP OF THE PHOTOGRAPH.
