# Unique Use of Grout Column Support of Karst Features below Logan Martin Dam, AL

Findlay, R.C., Findlay Engineering; Greene, B.H., Consultant; Bruce, D.A., Geosystems, L.P.;  
Williams, B.E., Southern Company Services; Williams, J.H., Southern Company Services;  
Mickwee, R.L., Southern Company Services.

## I. PROJECT DESCRIPTION AND GEOLOGY

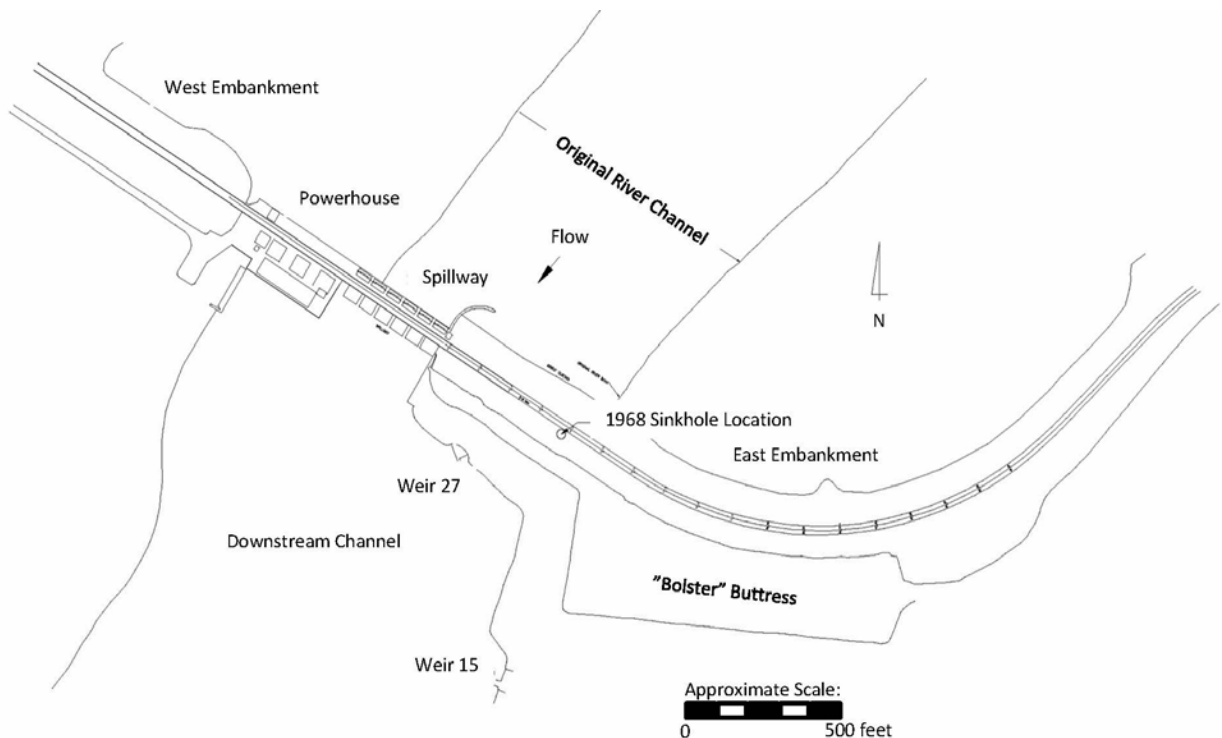
Figure 1. Project Layout Plan View (not to scale)

Immediately upon initial filling of the reservoir in 1964, mud flows were noticed downstream of the earthen portion of the eastern embankment. Boils also began forming in the tailrace area. In June of 1966, seepage was noted at the toe of the east embankment. Weir 27 (Figure 1) was built to monitor flow at that point. On February 23, 1968 the weir began discharging mud. For a period of 40 days, mud flows were observed. On April 9, 1968 a sinkhole approximately 20 feet (6 m) in diameter and 16 feet (5 m) deep opened just downstream of the east embankment crest and was referred to as the “chimney sink”. Immediate action by site personnel to shut down the roadway across the dam and backfill the hole likely prevented failure of the dam. This sinkhole was a clear manifestation of the karstic subsurface conditions at the site. Numerous exploratory holes were drilled surrounding the sinkhole to determine its extents. In addition, piezometers were installed across the site to further monitor water levels and temperatures. This event also highlighted the need for further grouting programs. Several campaigns of remedial grouting, mostly for seepage control, were conducted and presently grouting programs continue to be conducted. The history of the grouting programs to date has been summarized in two recent (as of this writing) technical papers,<sup>1,2</sup> as well as several other earlier papers.
