**21ST CONGRÈS
DES GRANDS BARRAGES
Montreal, 2003**

SEEPAGE EVALUATION AND REMEDIATION UNDER EXISTING DAMS

2. SETTING OF ARAPUNI DAM, NEW ZEALAND

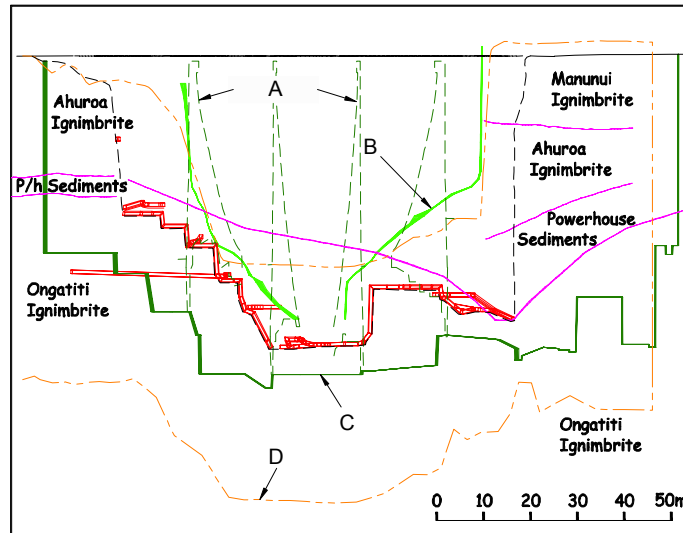
Figure 2. Elevation of Arapuni Dam, New Zealand.

Close cooperation with local geological specialists helped to supplement the data available from published sources. The dam is located in a region with extensive ignimbrite (welded tuff) flows which erupted during the last 2 million years. At the dam site (Figure 2), three principal ignimbrite flows are recognized. The dam foundation is located on the Ongatiti Ignimbrite dated at 0.9- 1.1 million years. In the abutments the Ongatiti Ignimbrite is overlain by Powerhouse Sediments, a mixture of alluvial and airfall tephra deposits, the Ahuroa Ignimbrite and the Manunui Ignimbrite.

Hydraulically, the Powerhouse Sediments act as an aquiclude with seepage in the Ongatiti Ignimbrite isolated from the overlying units. The dam cutoff walls extend down through the overlying units into the Ongatiti Ignimbrite appear very effective in controlling abutment seepage through the upper units, and the foundation seepage in the Ongatiti Ignimbrite is therefore largely isolated from the abutment seepage even though the valley is very narrow.
