# **HIGH PRESSURE SEEPAGE AT ARAPUNI DAM, NEW ZEALAND A CASE HISTORY OF MONITORING, EXPLORATION AND REMEDIATION**

## **ABSTRACT**

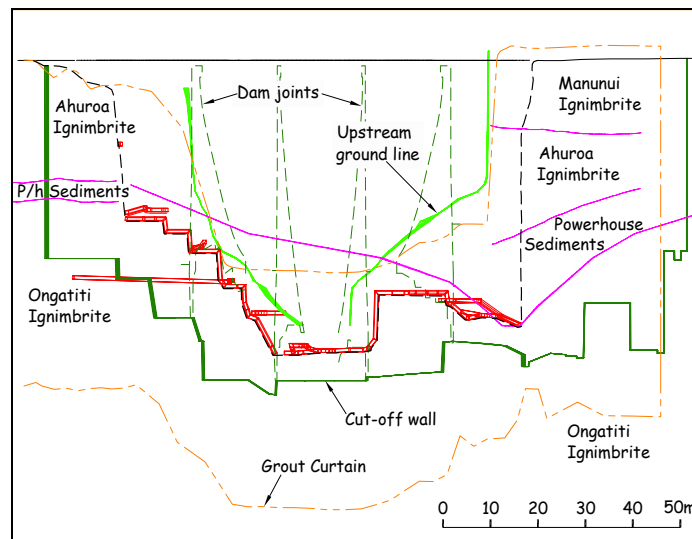
Figure 2. Elevation of Arapuni Dam, New Zealand.

The dam is located in a region with extensive ignimbrite (welded tuff) flows which erupted during the last 2 million years. At the dam site (Figure 2), three principal ignimbrite flows are recognized. The dam foundation is located on the Ongatiti Ignimbrite dated at 0.9- 1.1 million years. In the abutments the Ongatiti Ignimbrite is overlain by Powerhouse Sediments, a mixture of alluvial and airfall tephra deposits, the Ahuroa Ignimbrite and the Manunui Ignimbrite.

The Ongatiti Ignimbrite in the dam foundation is a very weak, coarse pumice breccia with an unconfined compressive strength of between 1 and 5 MPa. Joints are rare, subvertical where present, and spaced at greater than 6m. A set of three sub-parallel cracks or fissures (Figure 1) were recorded on the dam foundation as-built drawings forming a feature that runs obliquely across the foundation from the upstream right abutment to the downstream left abutment.
