HIGH CAPACITY MICROPILES IN MINED GROUND FOR BRIDGE SUPPORT: A CASE HISTORY OF INVESTIGATION, DESIGN, CONSTRUCTION AND PERFORMANCE: PAPER 4 LOAD TESTING

ABSTRACT

This is the fourth paper in the series describing the various stages of the micropile works conducted for new bridge piers in Joplin, Missouri, for both Verification Tests, conducted preconstruction, and Proof Tests, conducted on production piles. The paper therefore describes the installation and testing (in two cases to failure) of 4 full-scale Verification Test Piles, and of 16 production piles, at the rate of one test per bridge bent. All tests were in tension. All the Proof Test results indicated minimal debonding and a very stiff performance to the Test Load of 1.2 times design load.

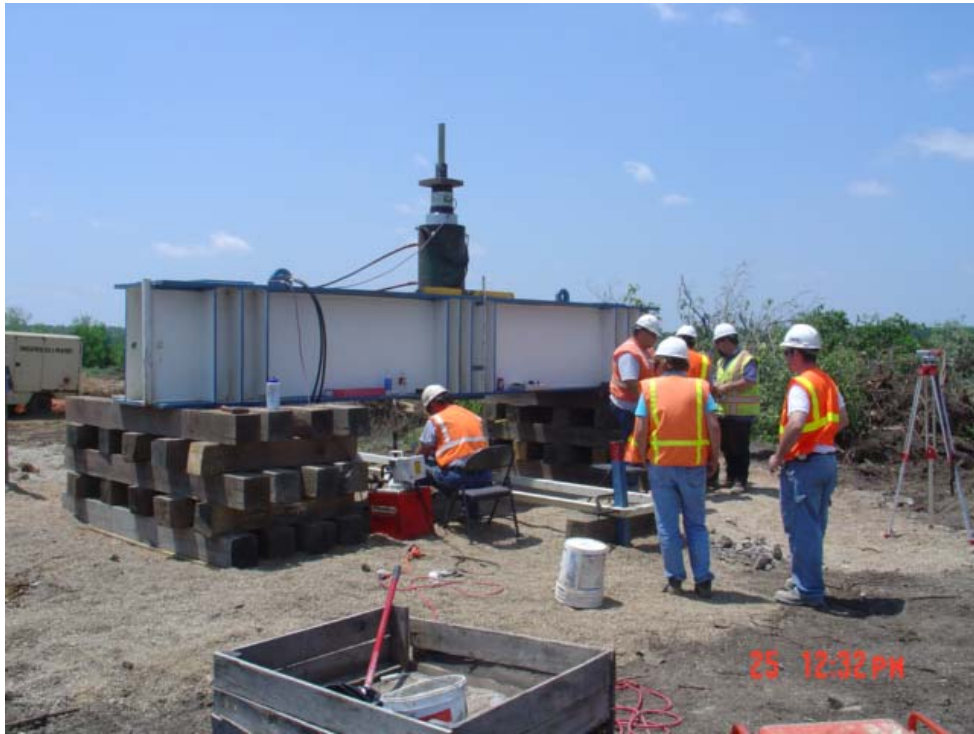
Figure 4. Load testing in progress.

Figures 4 and 5 show the testing underway in the field.

- Align hydraulic center hole jack over bar on top of frame. The jack was a 620-ton capacity Simplex. Calibration records were provided.
- Place temporary plate and hardware on top of ram to tension bar.
- Set 3 dial gauges at 120° intervals, accurate to 0.001 inch at top of casing (later increased to 4 gauges).
- Perform test in accordance with ASTM D3689 Quick Test, as modified by the specifications.

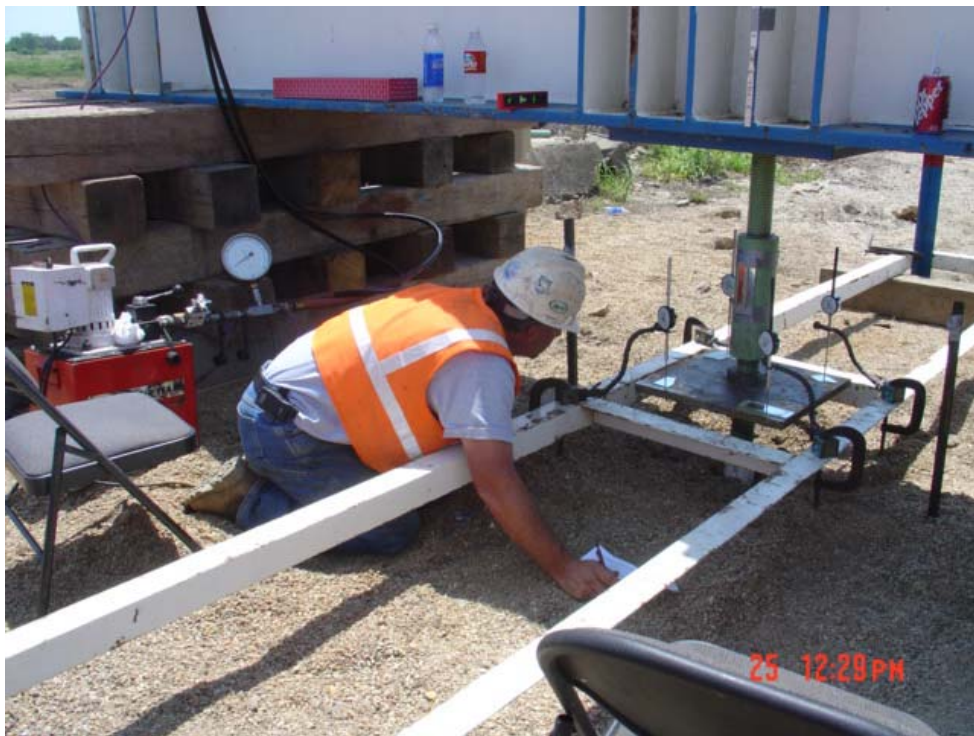
Figure 5. Load testing in progress.

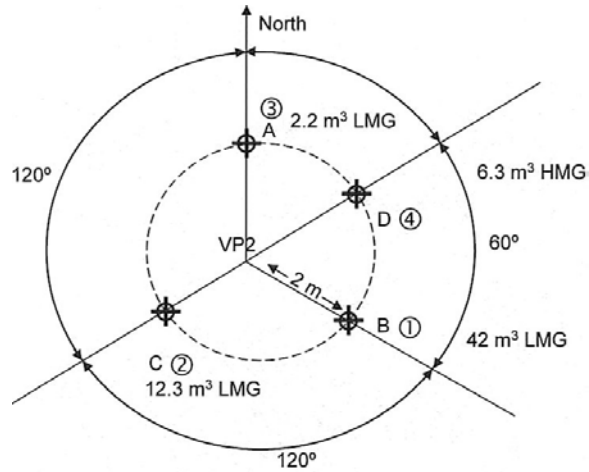
(Specific for Test Pile 2)

① = order installed

Figure 6. Layout of Pretreatment Holes for Verification Test Pile 2.

Pretreatment of the rock mass surrounding the VP2 was conducted in the pattern shown in Figure 6. Details of the pretreatment are summarized in Table 5:

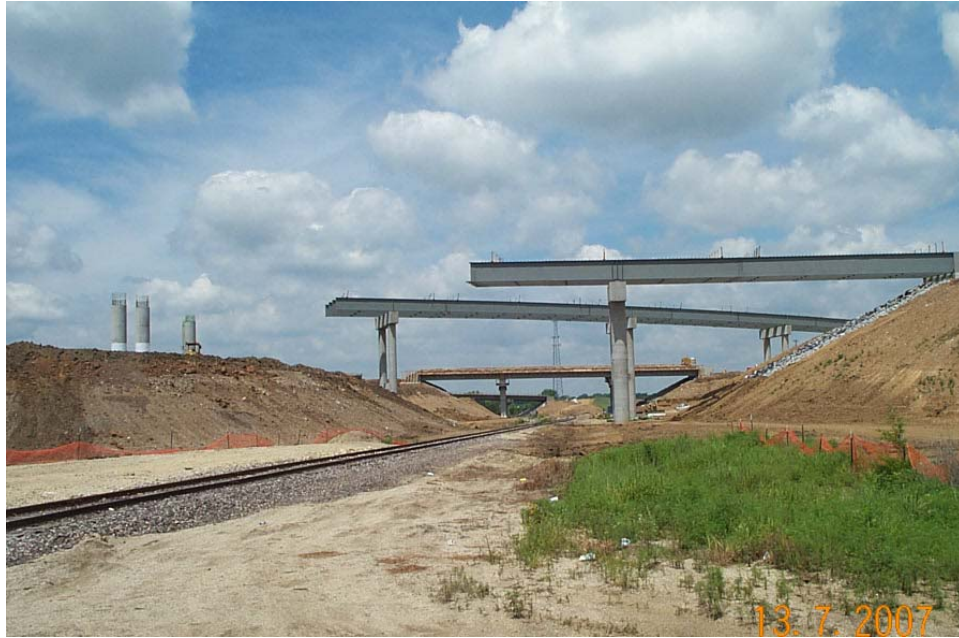
Figure 7. View of Piers being Built above the Micropile Foundations.

The Proof Tests, conducted at a frequency of one per production bent, confirmed that the production piles performed in a manner consistent with design requirements. Indeed, their exceptionally stiff behavior, due to limited load transfer lengths through the upper cased pile section, will assure that service movements of the finished bridge piers (Figure 7) will be minimal.
