The History of Grouting at Wolf Creek Dam, Kentucky

Dr. Donald A. Bruce¹
Brook E. Brosi²
Trent L. Dreese³
Michael W. Terry⁴

ABSTRACT

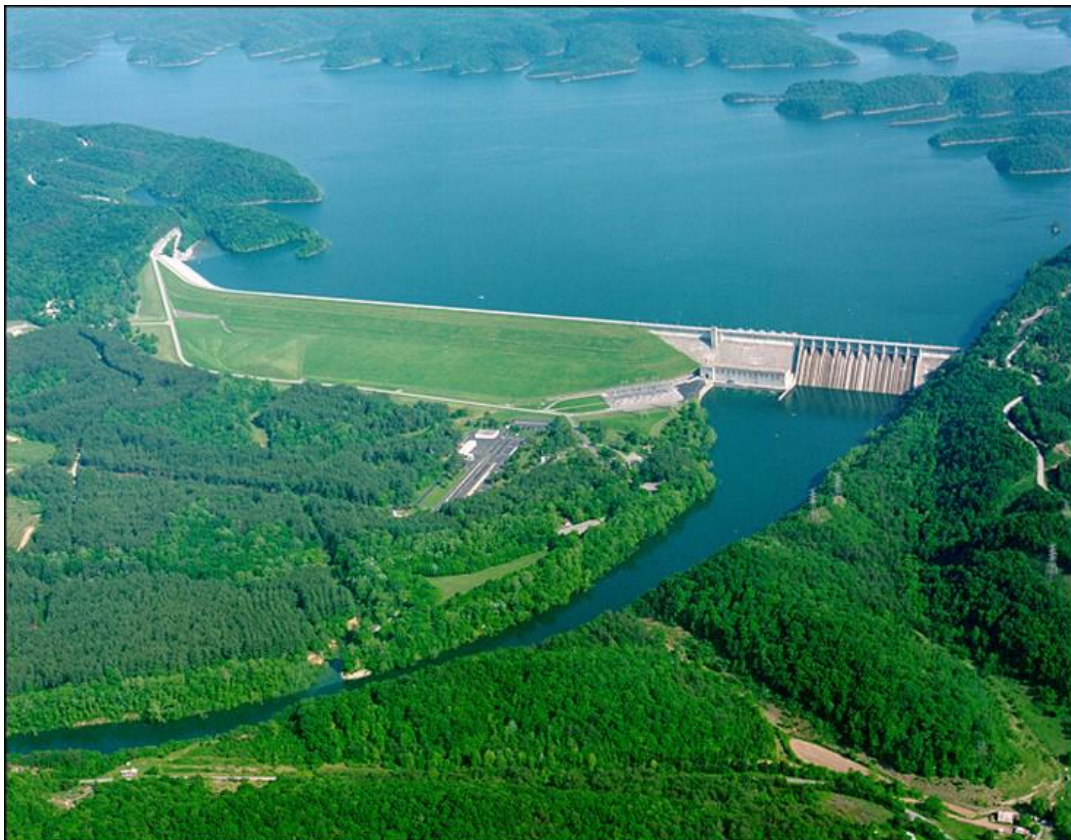
Figure 2. Aerial View of Wolf Creek Dam showing the concrete gravity section (including powerhouse) on the Left Abutment and the embankment section to its right (Source: USACE).

Wolf Creek Dam is located in south-central Kentucky. The nearest town is Jamestown, KY (Figure 1). This U.S. Army Corps of Engineers (USACE) dam is comprised of a 1,796-foot-long concrete gravity section, and a 3,940-foot-long embankment section, founded on karstic limestone. Wolf Creek Dam can hold back 6-million-acre-feet of water, at full reservoir level. This makes it the largest reservoir, by volume, in the eastern United States, and is the ninth largest pool, by volume, in the entire United States (Simmons, 1982). Figure 2 shows an aerial view of the dam. The dam was built during

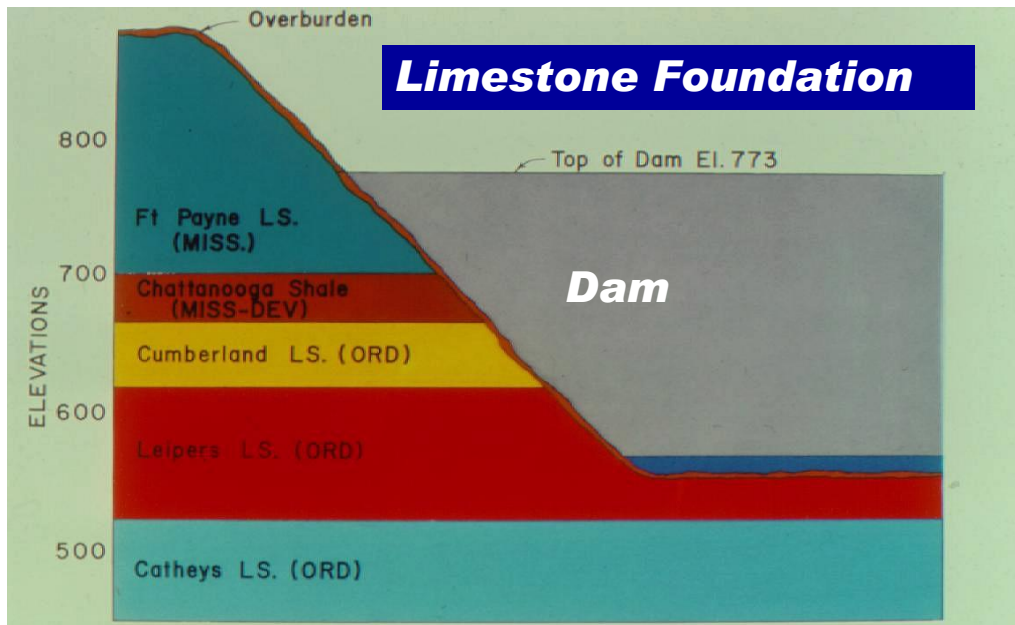
Figure 3. Summary of site geology. View of the site stratigraphy at the left abutment / concrete dam interface, looking downstream (Source: USACE).

The dam is founded on Ordovician-age limestones (Kellberg and Simmons, 1977). The abutments include younger rocks of Silurian to Mississippian age, but they make up a very small portion of the foundation. Figure 3 summarizes the stratigraphy at the dam site. The vast majority of the grouting onsite has been in the Liepers Formation, with many holes terminating in the upper Catheys Formation.

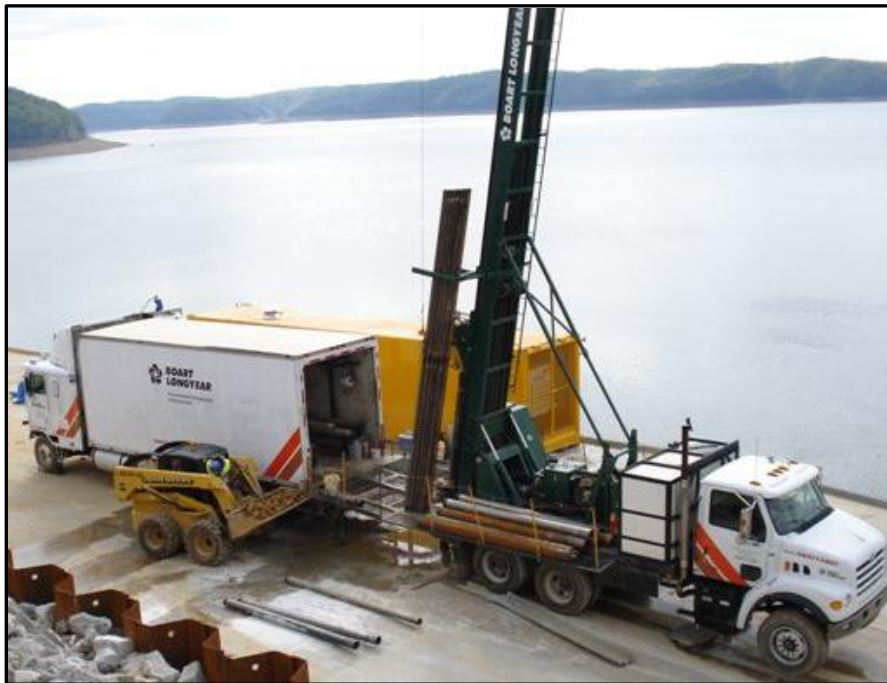
Figure 12: Truck mounted Sonic Drill.

Grout holes were completed in a progressive multi-phase process, the first of which involved drilling of the overburden material to gain access to the rock foundation. Due to the requirements set in ER 1110-1-1807 for drilling and advancing holes within earth embankments, there were very few acceptable drilling methods that were able to drill dry to the depths between 150 to 225 feet, as required by the contract. Sonic drilling methods were, therefore, chosen as the best method to advance the holes through the embankment, and drilling work began in April of 2007 (Figure 12). Every hole was continuously sampled and logged by a trained geologist. The overburden information recorded on the logs were compiled, and added to the As-Built Drawings to be used for the subsequent work involved in the construction of the proposed cutoff wall.

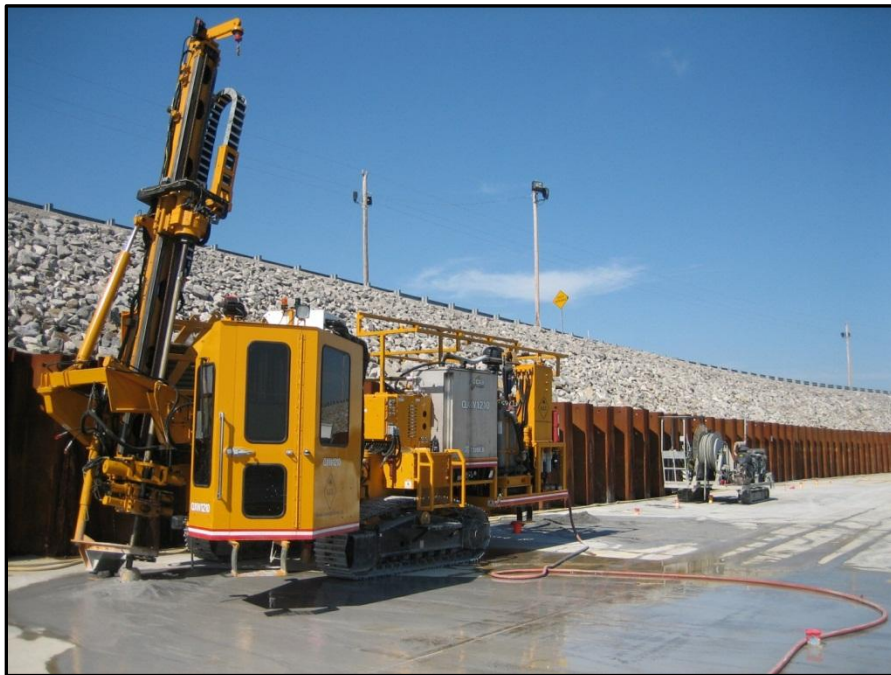
Figure 13. Crawler drill rig with Water-Powered Down-the-Hole (WDTH) Hammer.

Rock was drilled with Water-Powered Down-the-Hole (WDTH) rotary percussion drills that used water to both actuate the percussion hammer as well as to remove the drill cuttings from the hole. The use of WDTH drills allowed for the fast and accurate drilling of numerous holes to depths of 350 feet (Figure 13). Quality control of drill hole alignment was performed with the use of high resolution borehole imaging equipment also fitted with deviation survey sensors. The high resolution borehole equipment was also used to create detailed image logs of selected exploratory and production holes. Approximately 33% of the holes drilled (as measured by linear feet) were surveyed and checked for deviation. Approximately 2% of the holes drilled (including verification holes) were recorded with the high resolution video imaging equipment.

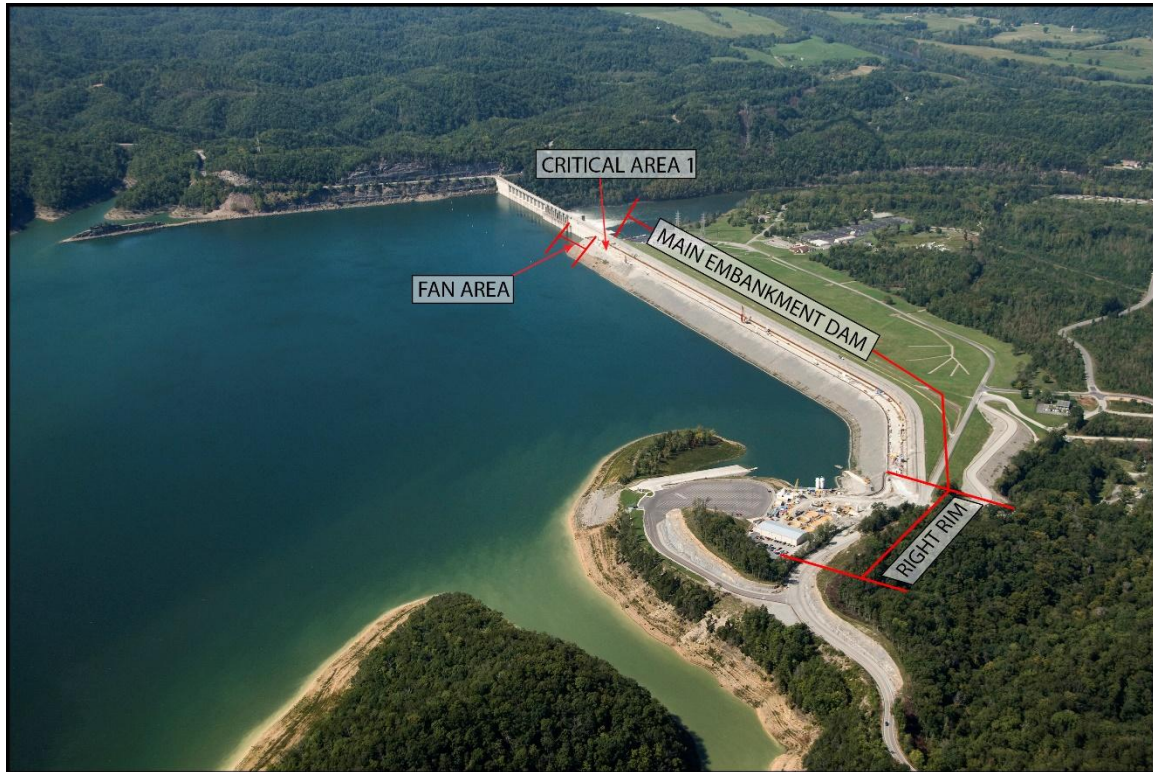
Figure 14. Wolf Creek Dam during construction in September 2009. TSJV Plant in foreground – HMG grouting program and barrier wall construction installation in background.

2. Main embankment dam double line High Mobility Grout (HMG) curtain grouting program as seen in Figure 14 (May 2009 - November 2011).

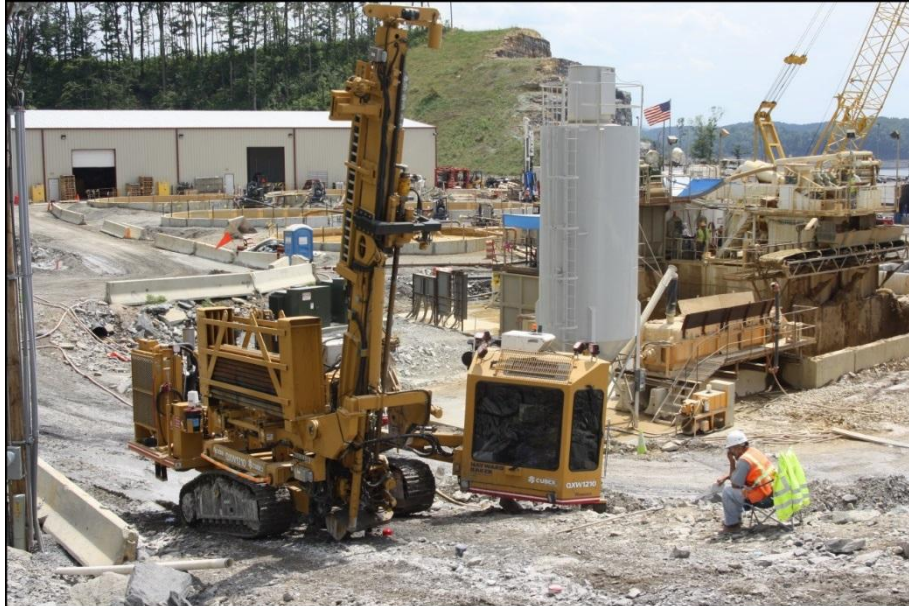
Figure 16. Right Rim - Rock drilling with TSJV cut-off wall slurry and desanding plant in background.

As an additional security measure, the grouting program was extended beyond the cut off wall on the right rim between Stations 72+00 and 83+00 as seen in Figure 16. The right rim consisted of very little overburden soil and access casing placement, generally less than 40 feet. The right rim Grouting Scope consisted of a single row of holes installed to a 3 Lugeon acceptance criterion. As anticipated due to the relatively competent rock observed during the investigation phases of work, a single line grout curtain was planned to allow for adequate remediation in this zone. Split spacing with 2.5-foot center-to-center hole spacing down to an eventual quaternary pattern along the single line was required to achieve the required closure criterion. A total of 516 grout holes were used over the 1,151-foot-long right rim treatment length.

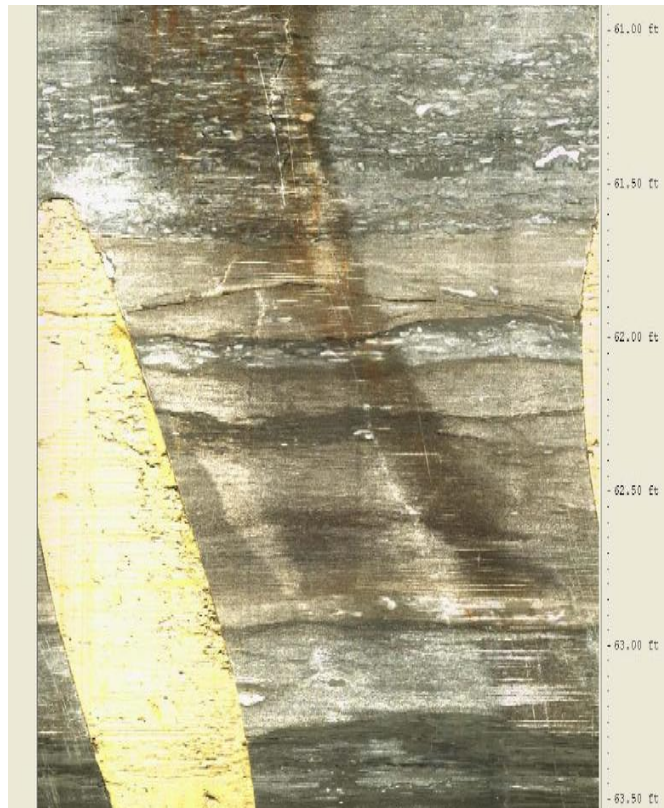
Figure 18. Down-hole camera image (360-degree view) showing dyed grout in an intersected grout hole. Depth is 61.0 to 63.5 feet (Source: The Judy Company).

A suite of balanced-stable grout mixes were used, mixed with colloidal mixers. The grout was injected under computer-control and monitoring. All of the grout for this project was dyed yellow (Brosi and Rathbun, 2013) to differentiate the 2011-2012 grouts from the 1968-1975 grouts encountered in the foundation. Figure 18 shows dyed grout from an Optical Televiewer Log in a Verification hole.
