The role of real-time monitoring in controlling the installation and assessing the performance of a Plastic Concrete Cut-off

The construction of a plastic concrete cut-off through the core of a newly completed embankment dam is a comparatively rare practice. This paper discusses the design, procurement, construction and performance of the cut off wall and the role of real-time monitoring in securing success of the works.

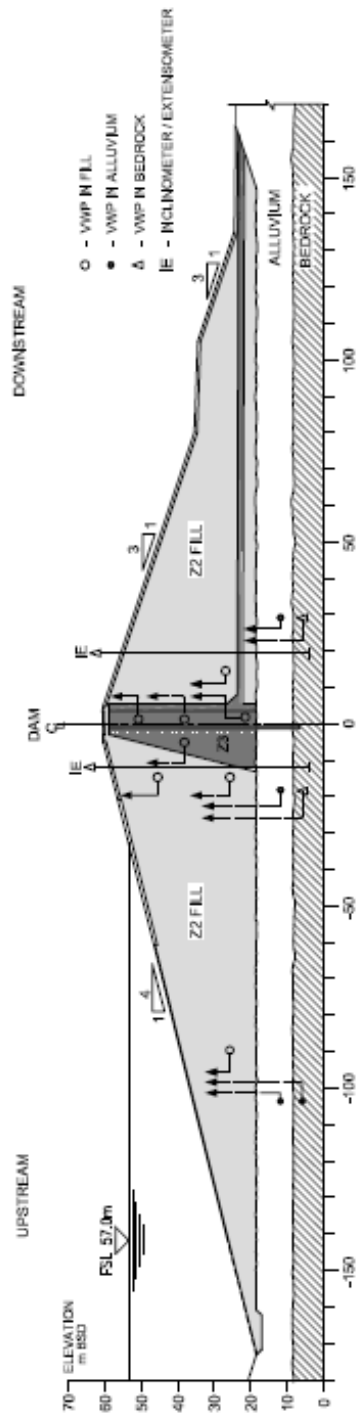
FIGURE 1. INSTRUMENTATION AT MID-SPAN CH 210 (N.T.S)

The embankment dam is constructed from site won material predominately cut from the spillway excavation. It is of zoned construction with shoulder fill of mudstone/sandstone and central core of reworked mudstone, (Figure 1). The upstream slope is 1 in 4, crest width is 10m and the downstream slope is 1 in 3 with a 12m high, 25m wide toe berm. A vertical wall drain and drainage blanket are located immediately downstream of the core.

As the dam was not yet constructed, the behaviour of the embankment and foundation was unknown. A detailed understanding of site conditions was obtained from instrumentation and monitoring before the PCC works was finalised. Three cross sections of the dam and foundation were instrumented (Figure 1). Vibrating Wire Piezometers, VWP, were installed in the founding soil and embankment fill in key locations at each cross section to record pore pressure. In total 24 Heavy Duty High Air Entry Ceramic Filter VWP were installed in the fill and 16 Heavy Duty Low Air Entry Ceramic Filter VWP in the founding soils. A non-vented vibrating wire pressure transducer was provided to enable corrections for barometric pressure to the raw monitoring data. A portable vibrating wire readout/logger was used to obtain readings from the VWP. All the instrumentation was provided, installed, maintained and read by a specialist subcontractor. Monitoring revealed two key issues, namely a large relic slip and high construction pore pressures.

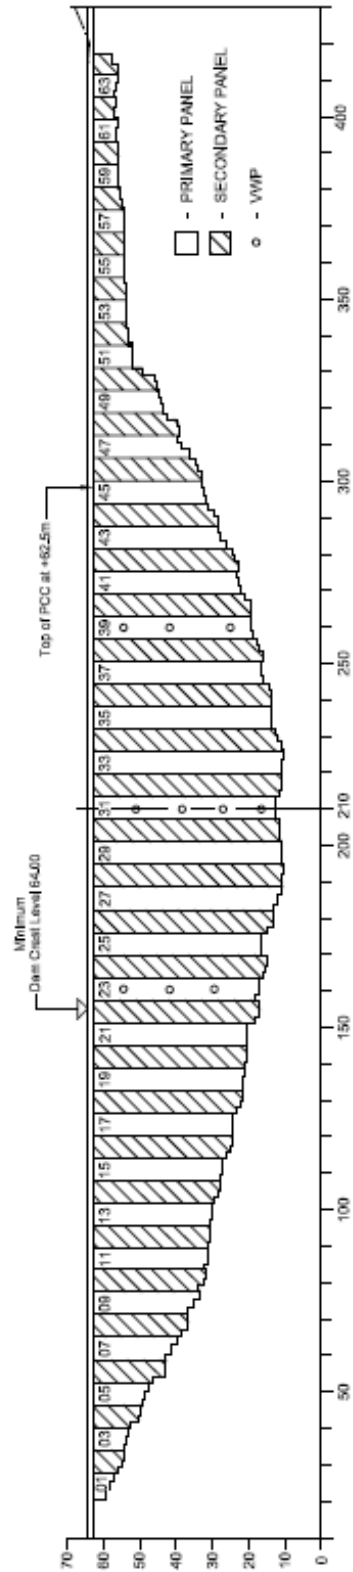
FIGURE 2. PCC LONG SECTION VIEW UPSTREAM TO DOWNSTREAM (N.T.S)

VWPs were located either side of the core in each material at three panels 23, 31 and 39 (Figure 2). The frequency of readings via the data loggers varied from 5min to hourly depending on the nature of the works. All readings were monitored against trigger levels. Plots of increase in piezometric level from start of excavation until completion of concreting are given below for the three instrumented panels (Figure 3). Start and end times for excavation, cleaning and placing of concrete are also shown. Excavation was seen to cause a modest increase in piezometric levels by up to 1.4m, some 4%. Trigger levels were not exceeded and pwp was observed to dissipate during cleaning. Chiselling coupled with placement of temporary backfill (to panel 31) caused a significant increase in piezometric level of up to 5.3m, some 16%. Although trigger levels were not exceeded careful control of the chiselling procedure was required. Placement of plastic concrete caused the greatest increased in piezometric level of up to 7.3m, some 22% as pressure was exerted by the wet plastic concrete on to the walls of the excavation.

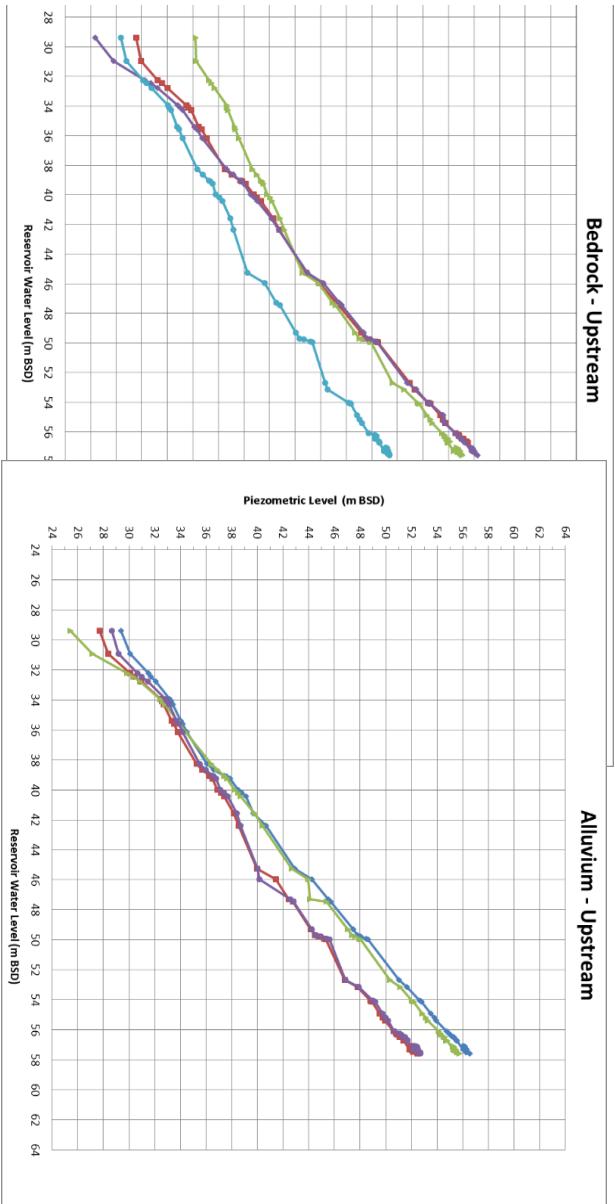
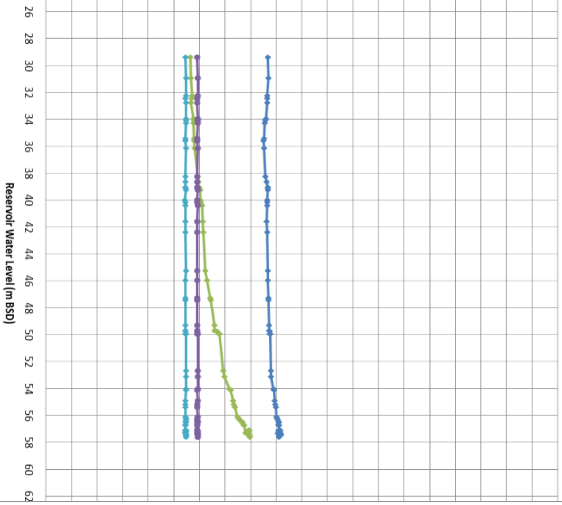
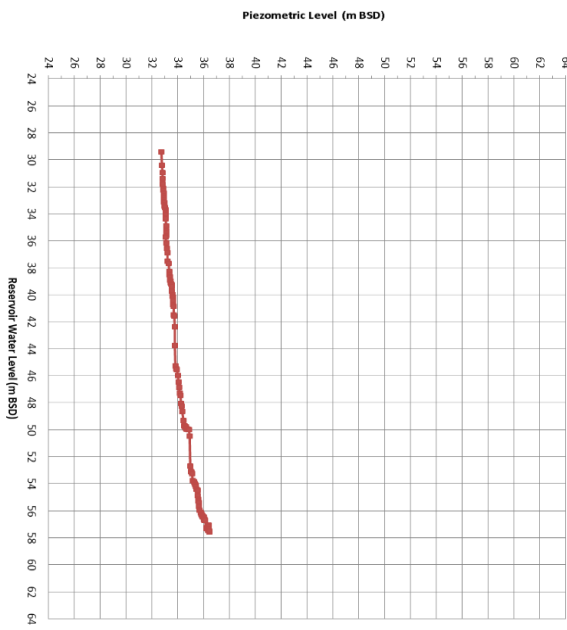
Figure 4. Piezometric Levels Upstream and Downstream

Upon completion the performance of the wall was monitored as the reservoir impounded by comparing pore pressure readings upstream and downstream of the cut-off.

- **Figure 4: Upstream bedrock - Downstream bedrock**

- **Figure 4: Upstream alluvium - Downstream alluvium**
